Santa Clara Unified
School District

Casa Del Maestro Facility Assessment Summary

3445, 3455, 3459 & 3465 Lochinvar Avenue | Santa Clara, CA 95051 | 9/8/23

PHYSICAL NEEDS ASSESSMENT

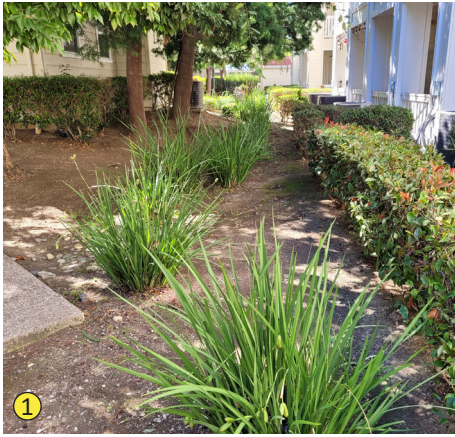
Drought resistant planting.

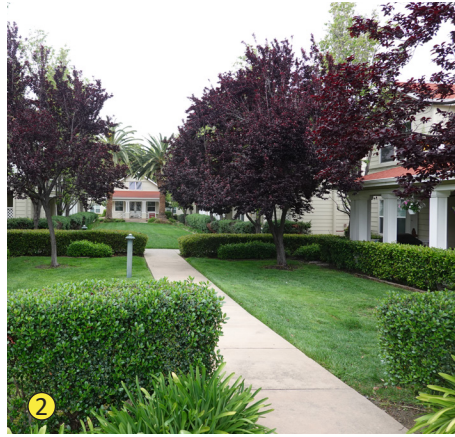
Common lawn path from Lochinvar Avenue to recreation building.

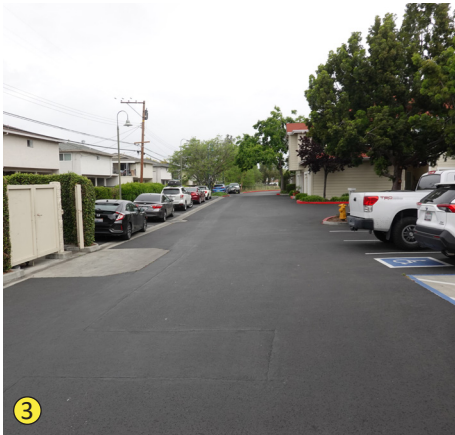
Driveway by Building 3445 to Lochinvar Avenue.

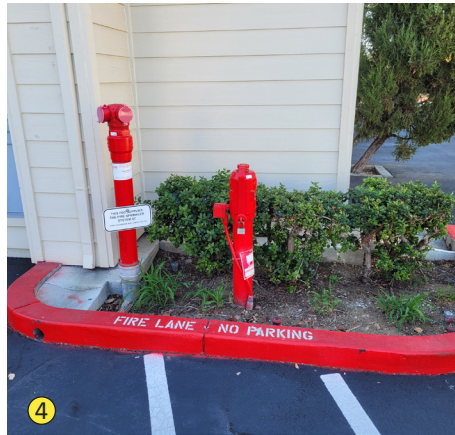
Fire Department Connection.

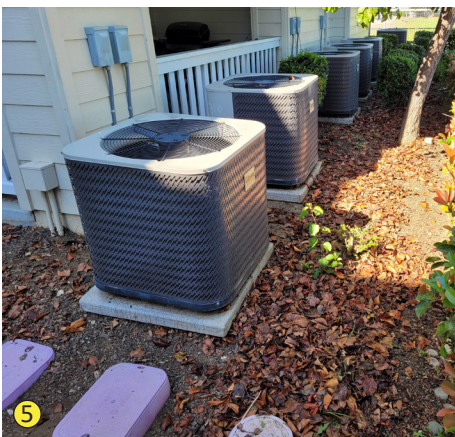
Irrigation boxes and HVAC units.

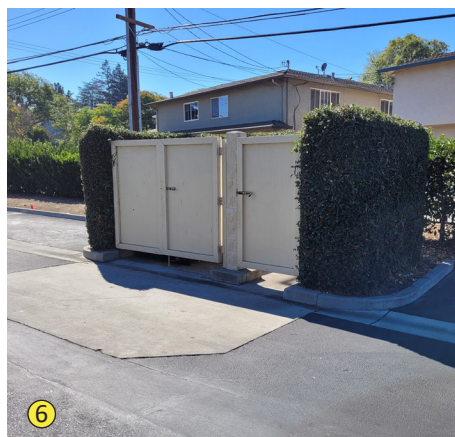
Trash enclosure provided at each apartment building.

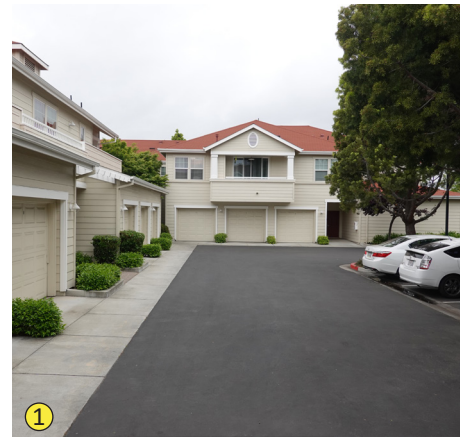
Asphalt driveway to enclosed garages and open air parking spaces.

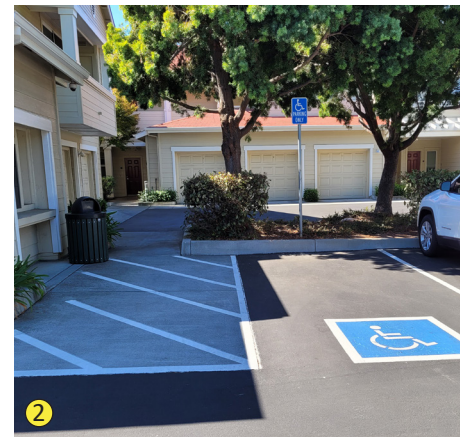
Accessible parking provided at each residential building.

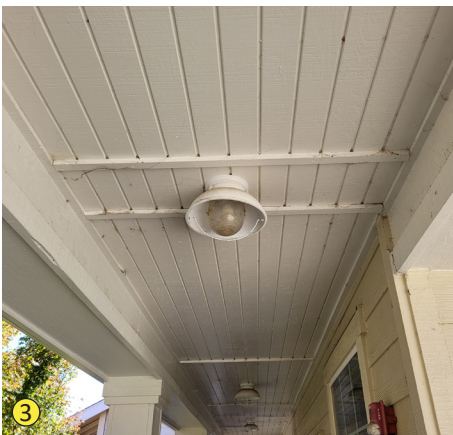
Fluorescent lights at common walkways.

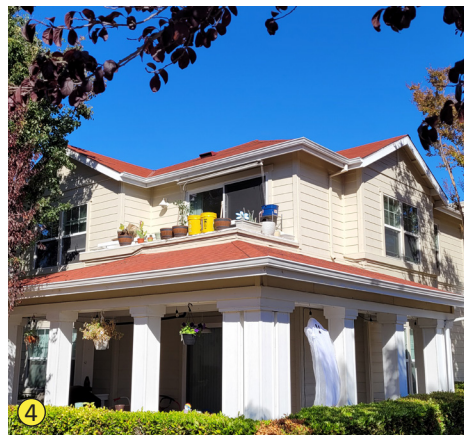
Exterior elevation.

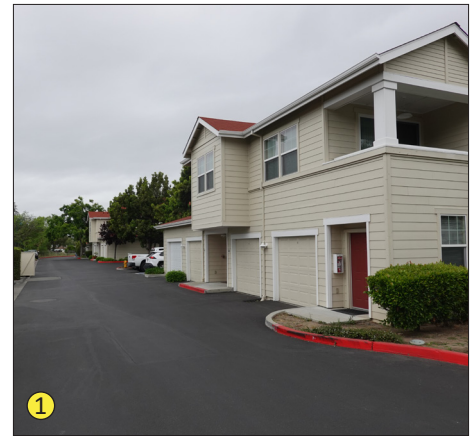
Building 3465 driveway and facade.

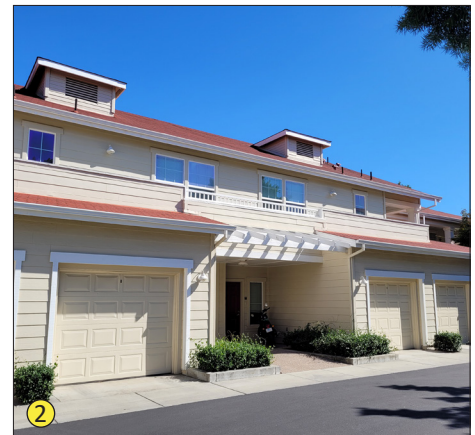
Building exterior.

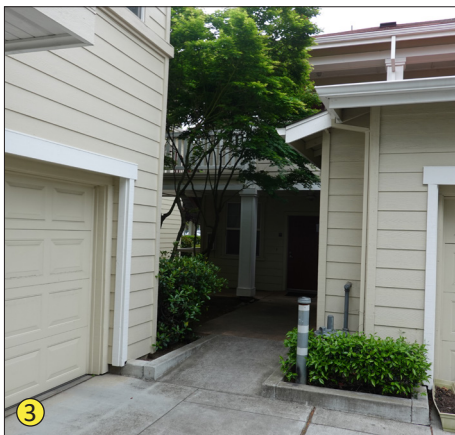
Apartment complex offers multiple points of entry to apartments and access between detached garages and apartments.

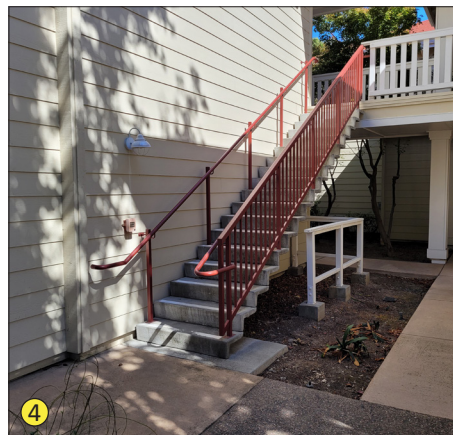
Exterior stairs to second floor apartments.

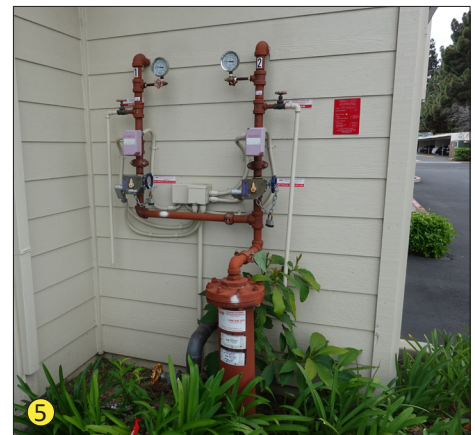
Fire sprinkler system provided at each building.

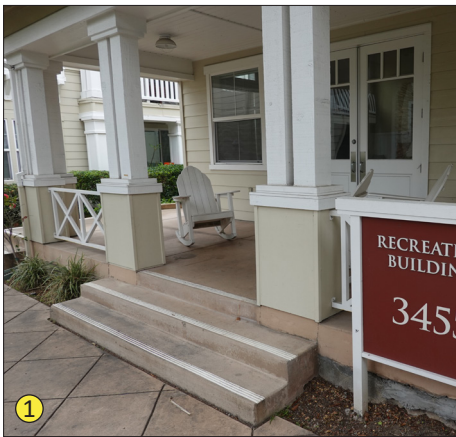
Recreation building porch with exterior seating.

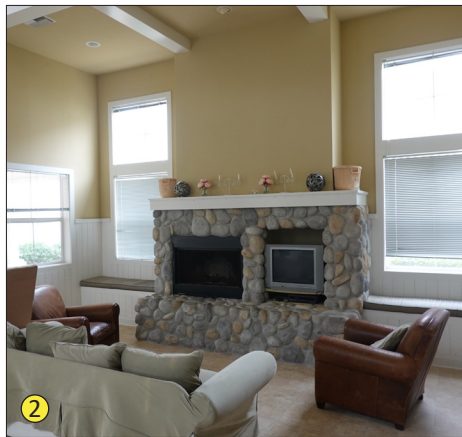
Community room.

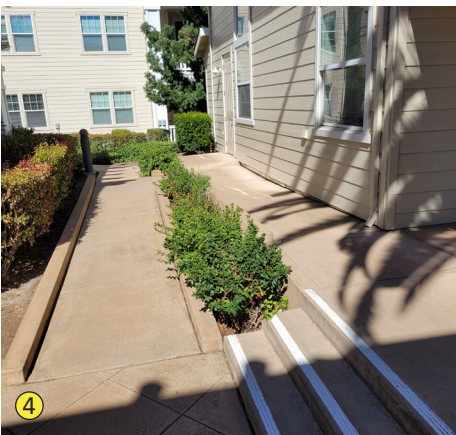
Outdoor ramp leads to back custodial room and front porch of the recreation building.

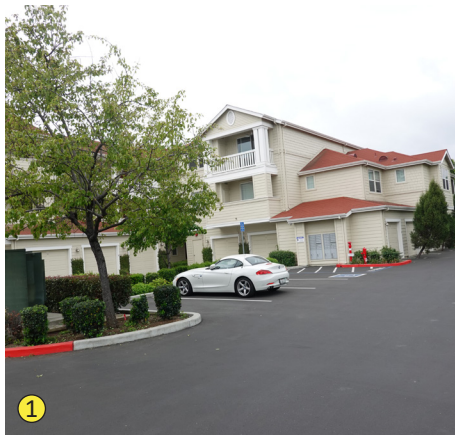
1
Uncovered parking adjacent to Building 3459.

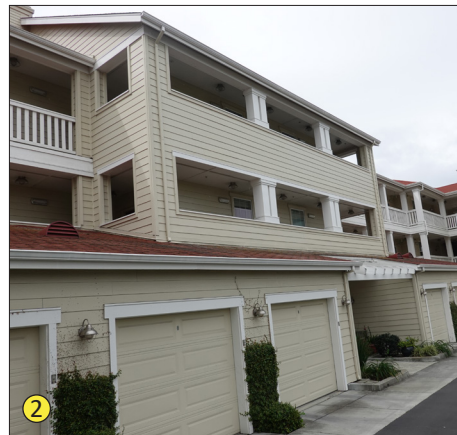
2
Balconies provided on 2nd and 3rd floor.

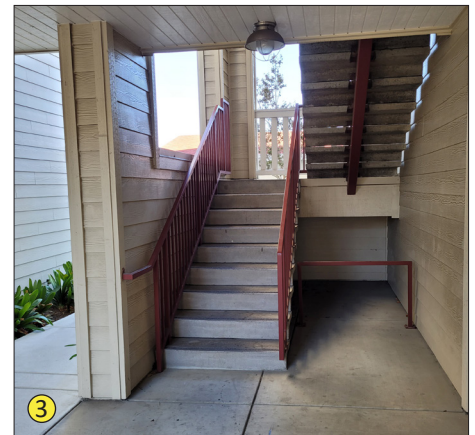
3
Typical stairs and landing to 2nd and 3rd floor. No elevator access provided.

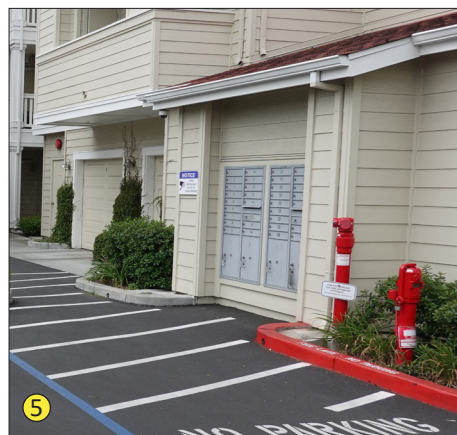
5
Mail boxes and Fire Department Connection. Accessible mail box is provided.

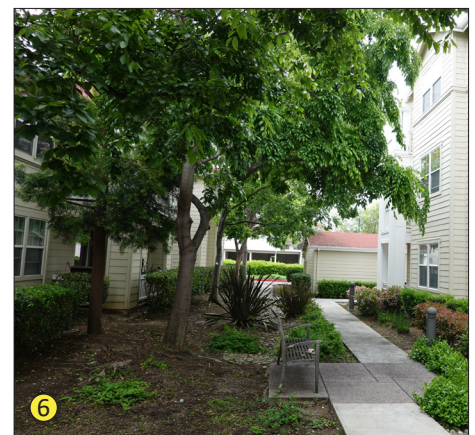
6
Walkway with mature tree shade between buildings.

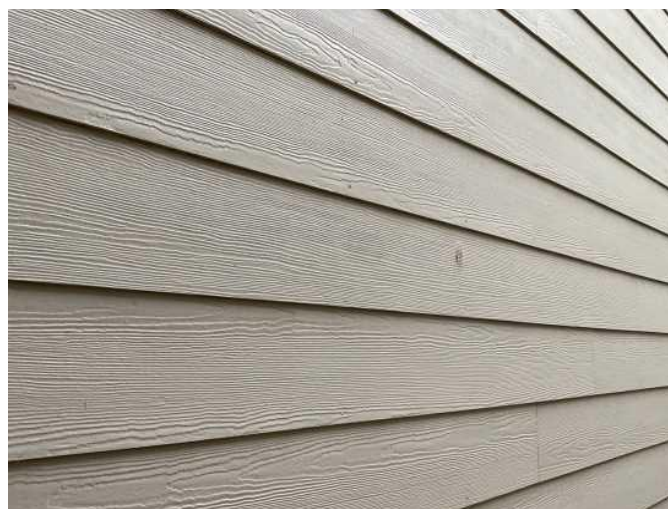
10 - Siding nails

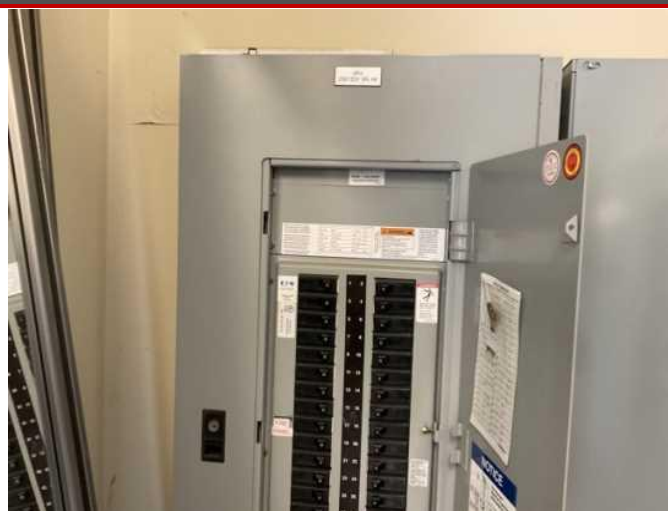
20 - 3459: Distribution panel

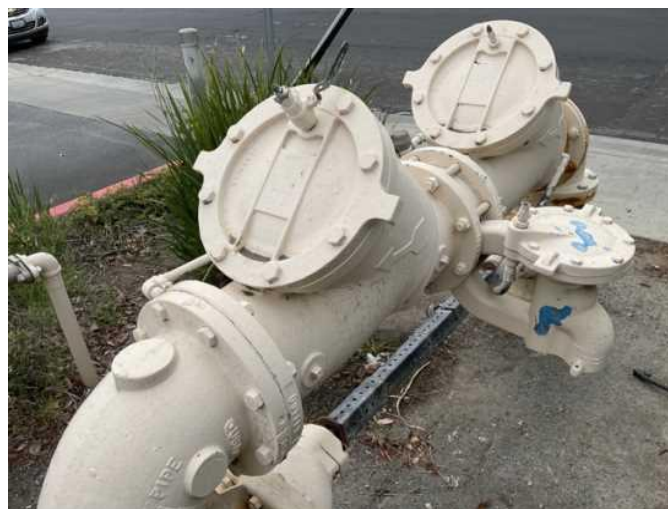
22 - Back flow preventer

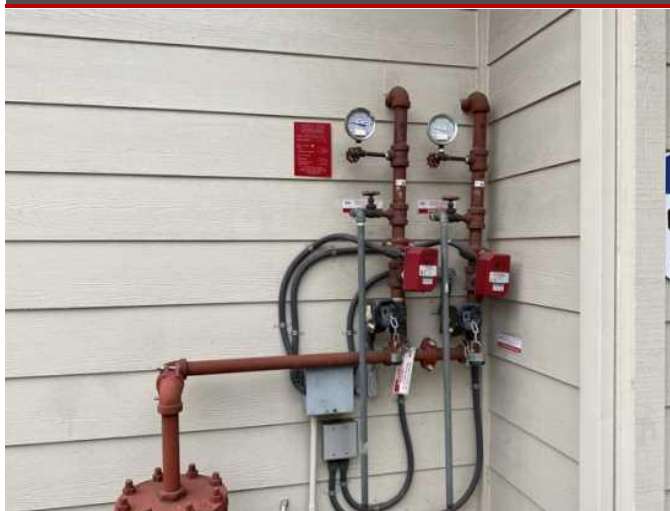
25 - 3445: Back flow preventer

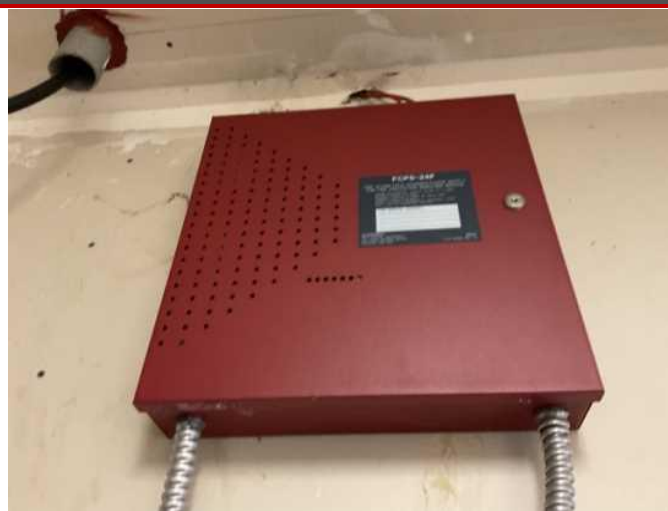
26 - 3445: Fire alarm panel

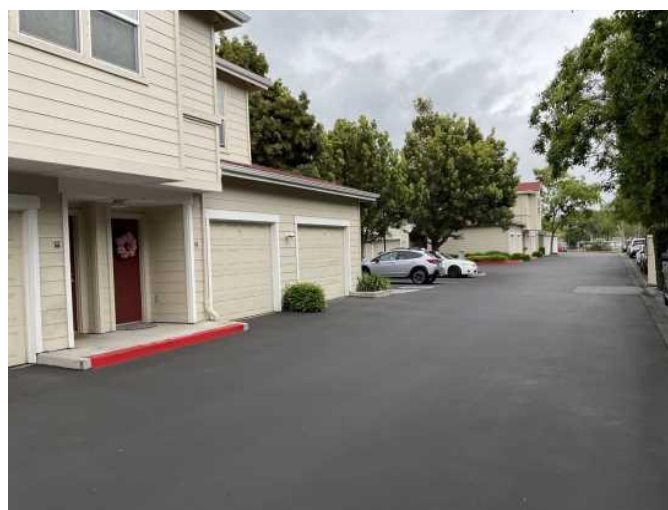
30 - Asphalt paving

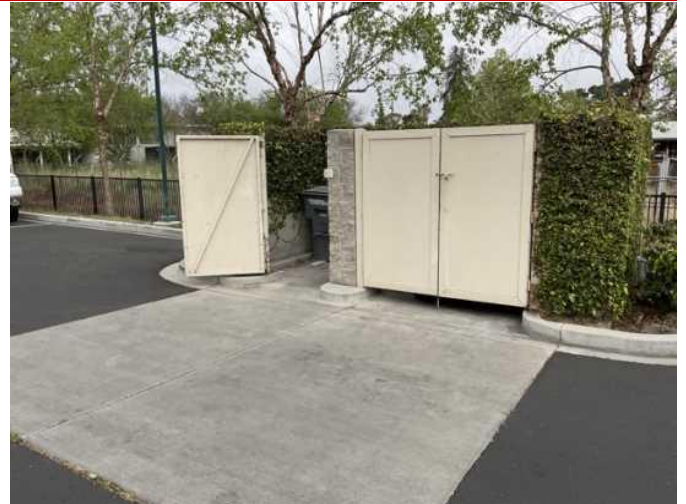
32 - Dumpster enclosure
