EAST HELENA PUBLIC SCHOOLS FACILITIES CONDITIONS REPORTS

EAST HELENA, MONTANA
EAST HELENA PUBLIC SCHOOLS MASTER PLAN
NOVEMBER 2023

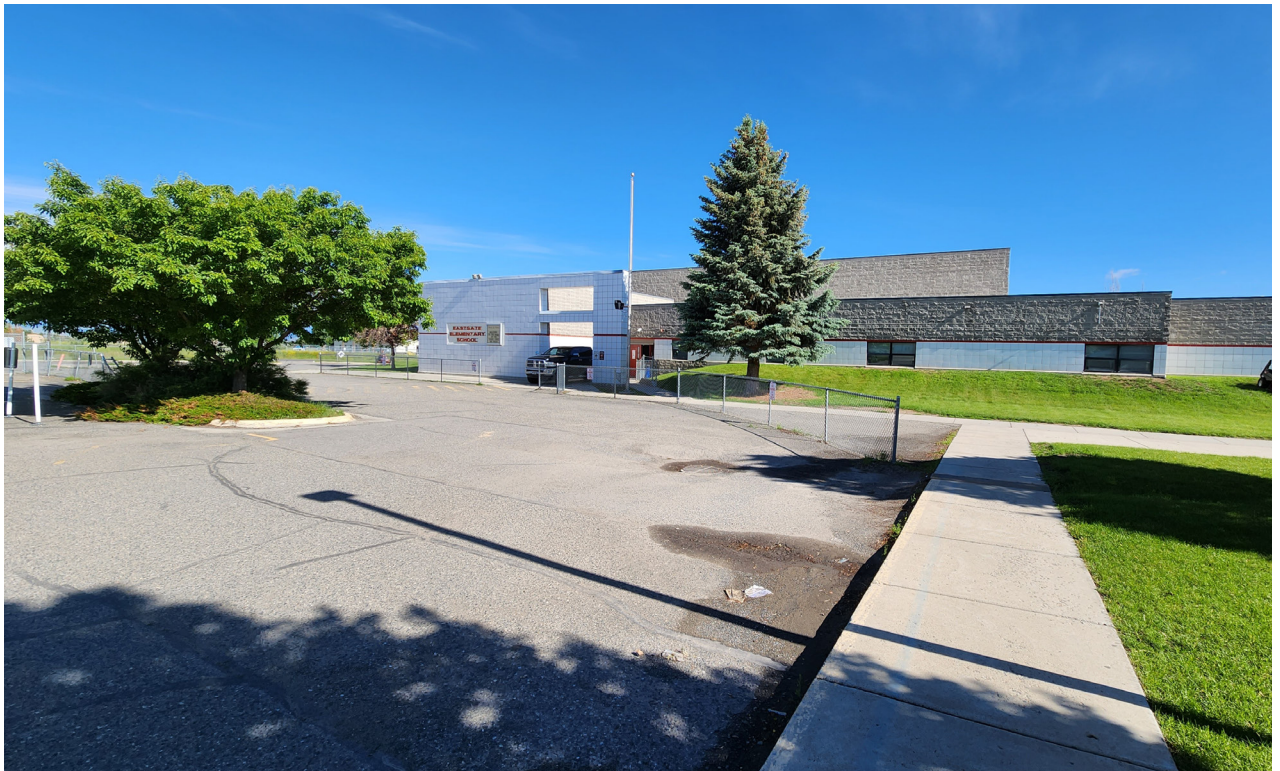
Drop off loop and sidewalk at main entry.

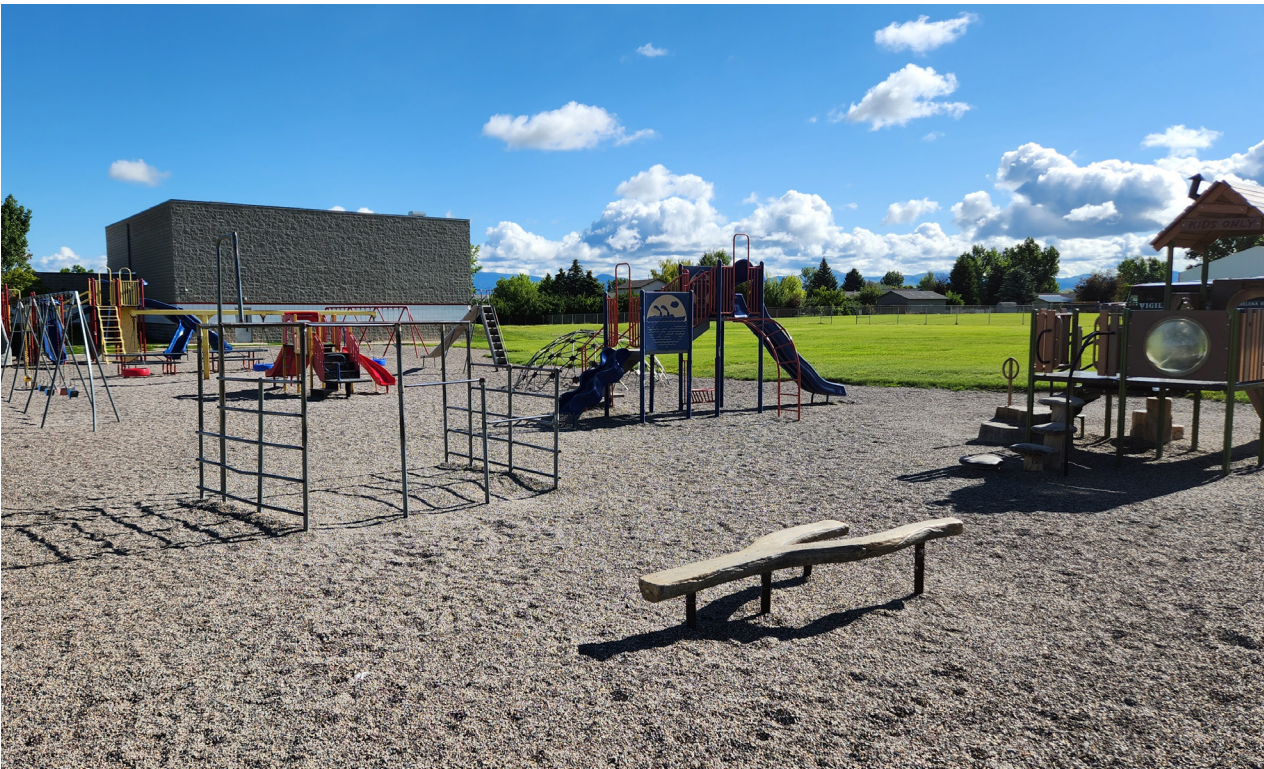
View of play equipment.

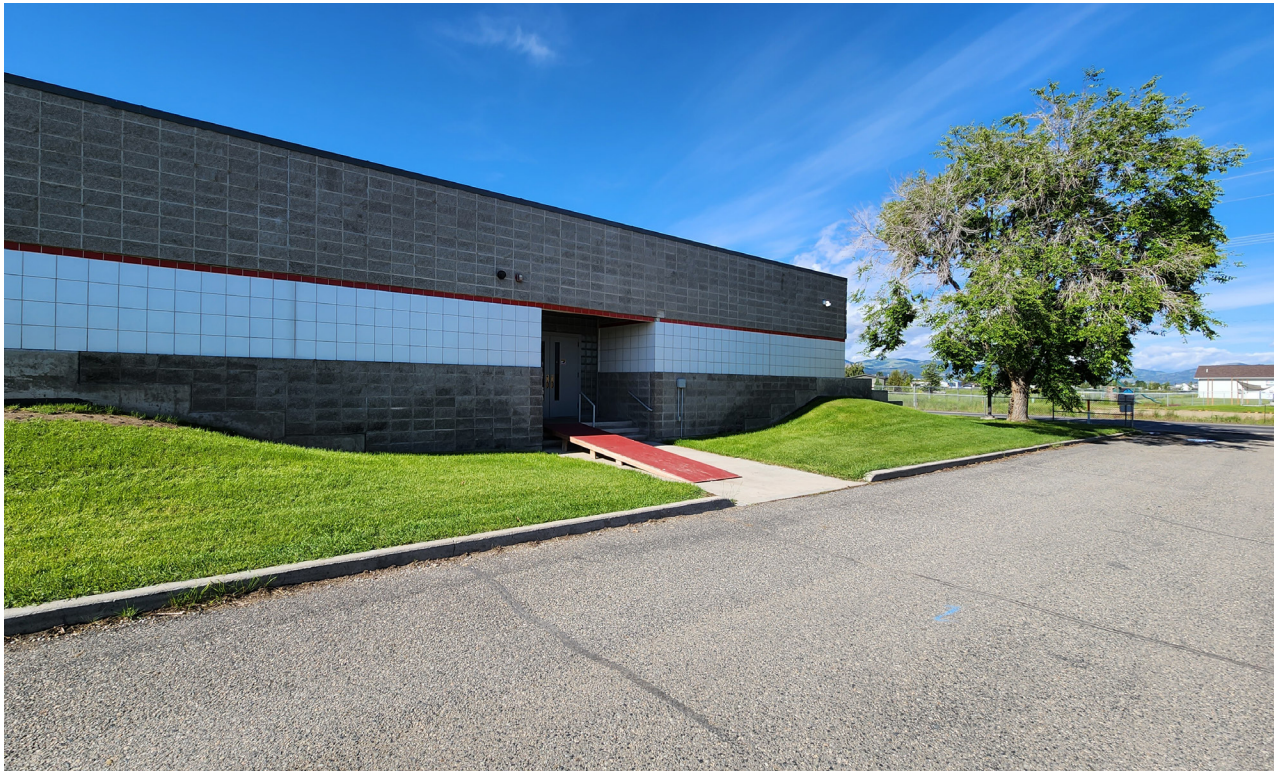
View of northwest exit door with wood-framed ramp.

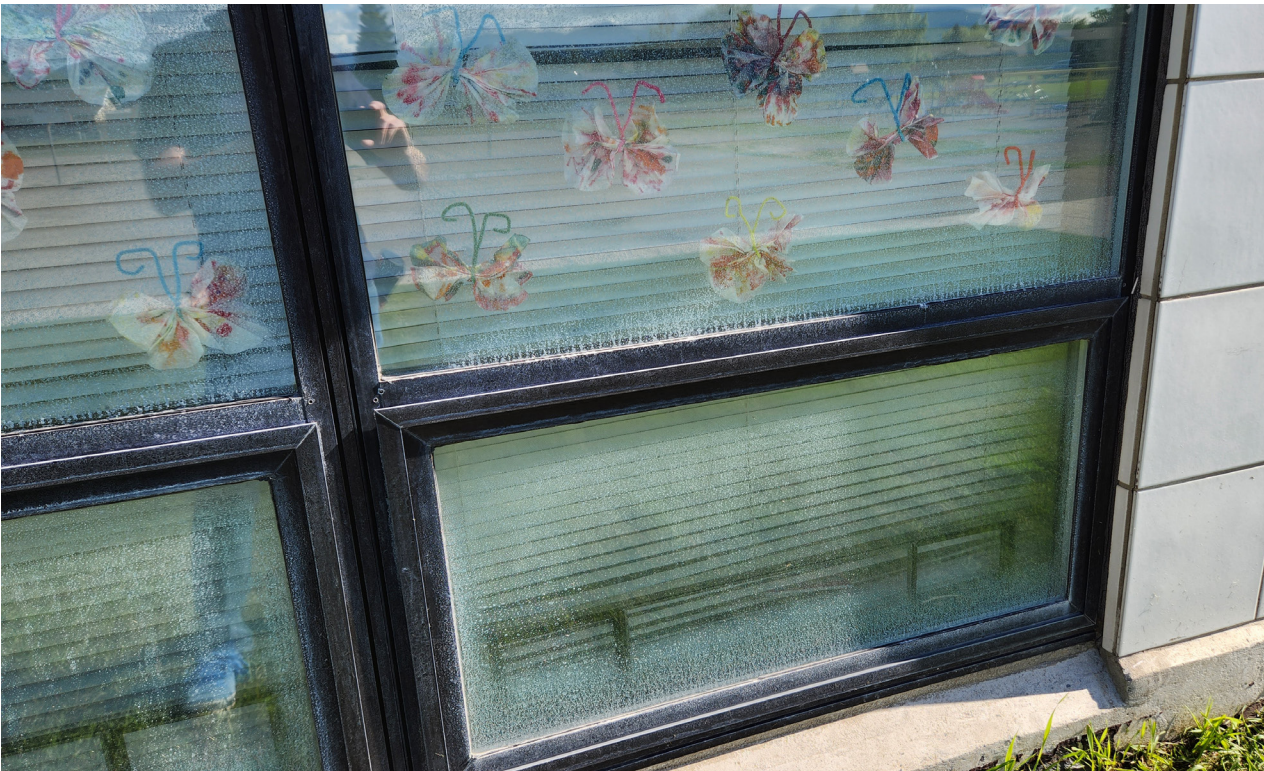
View storefront windows with oxidation.

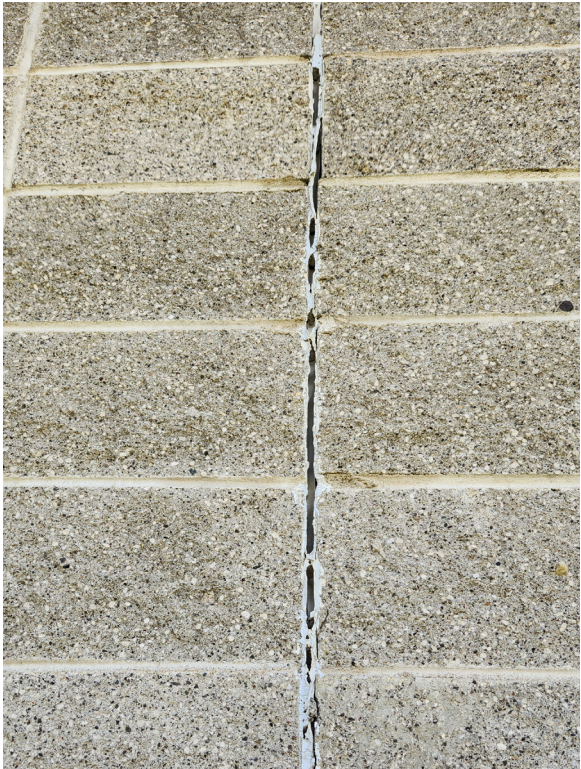
Typical masonry control joint that needs to be re-sealed.

- Ongoing maintenance and upkeep of the building's exterior elements.
- Ongoing maintenance of the foundation damp-proofing.
- Ongoing maintenance and repair of the CMU veneer control joints.
- Repair/replacement of the cracked and broken glazed exterior finish tiles.
- Replacement of hardware that does not meet ADA accessibility requirements.

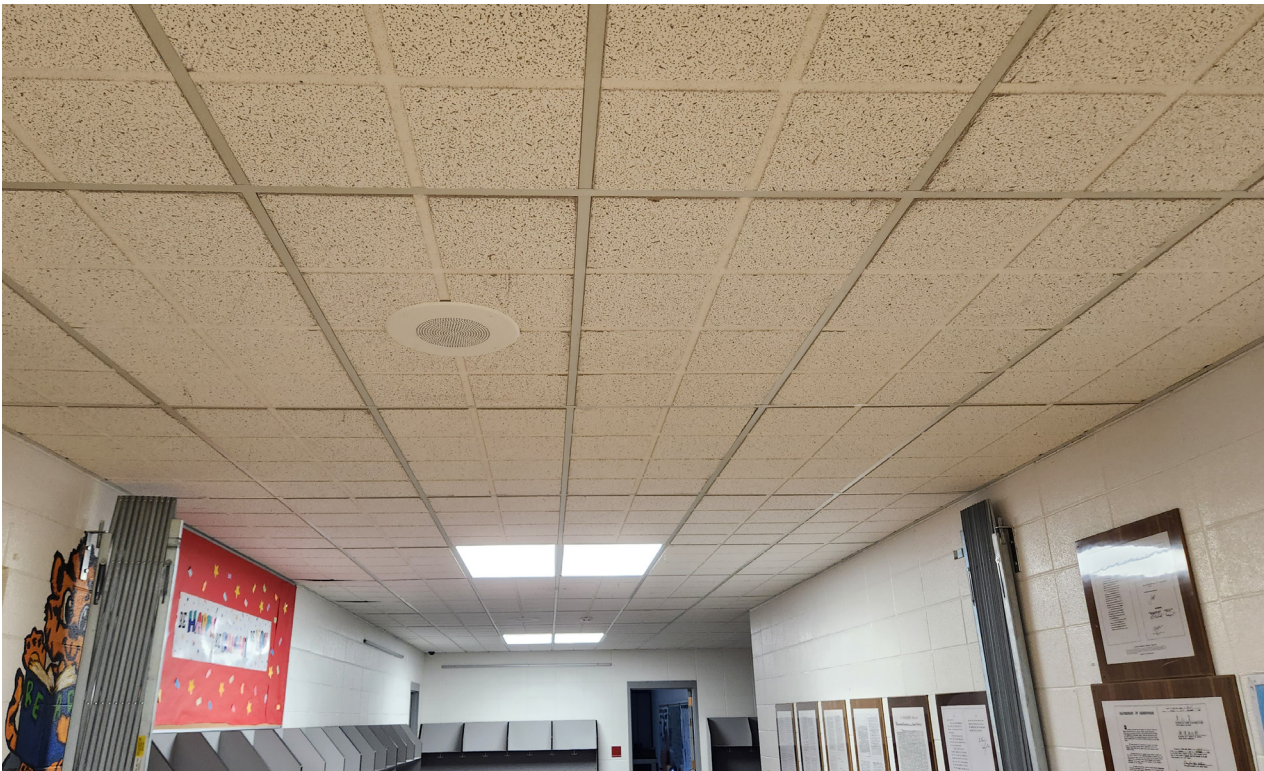
Typical hallway suspended acoustical tile ceiling.

determined, we would recommend update of interior finishes including ceilings and lighting.

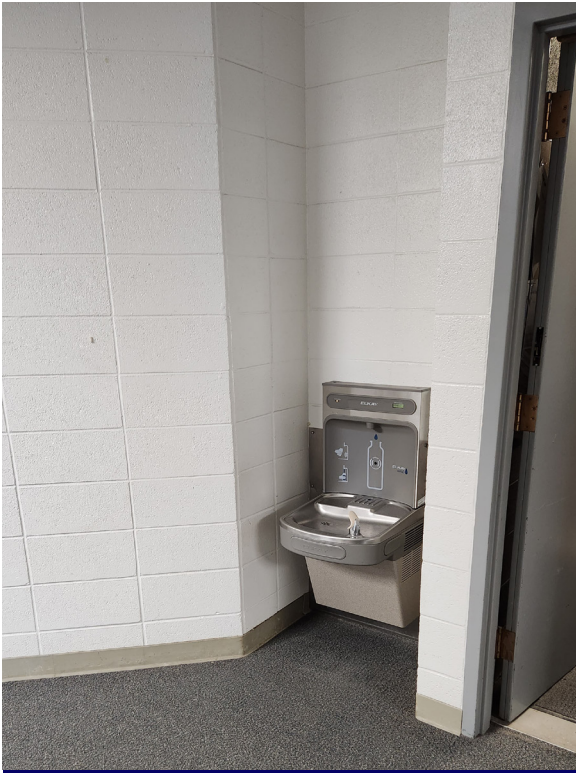
View of carpet under hallway drinking fountain.

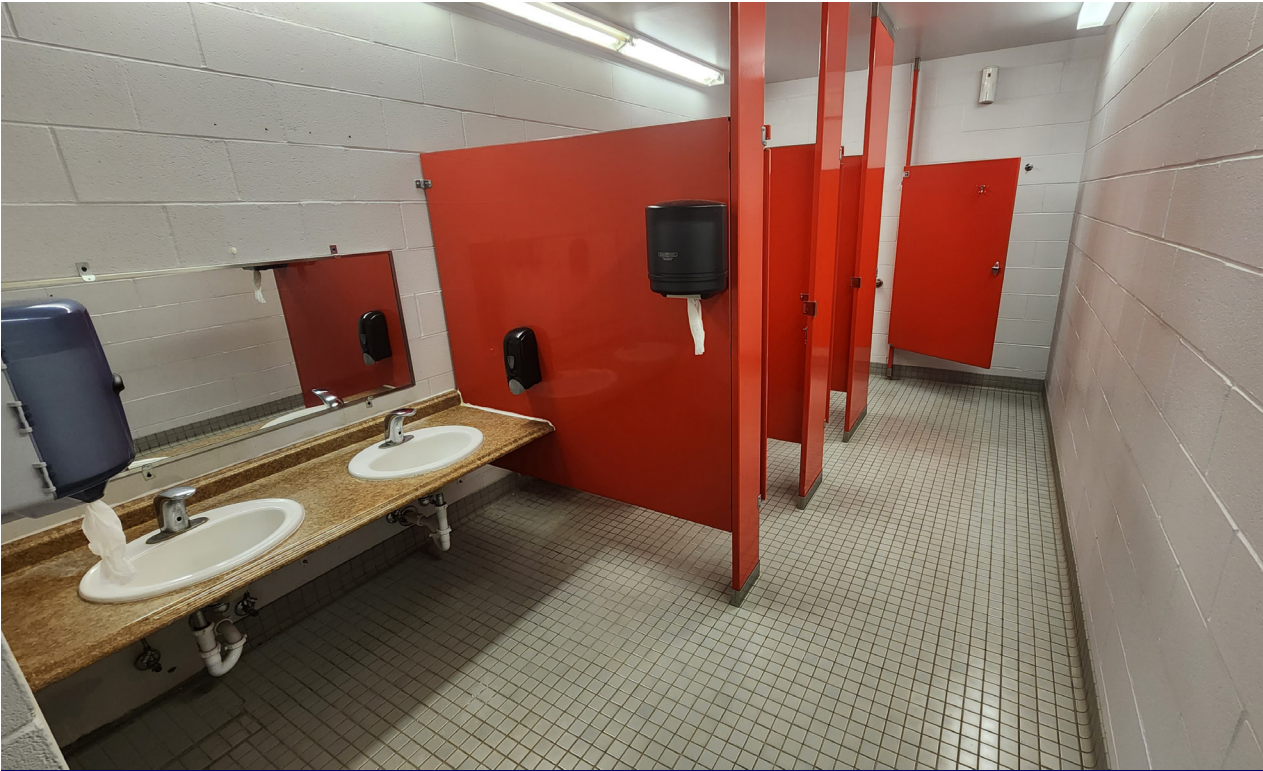
View of typical restroom finishes and fixtures.

- Continued upkeep and regular maintenance to ensure the building remains in good condition.
- Update and/or replacement of toilet room fixtures and finishes.
- If a significant renovation or addition to this school is

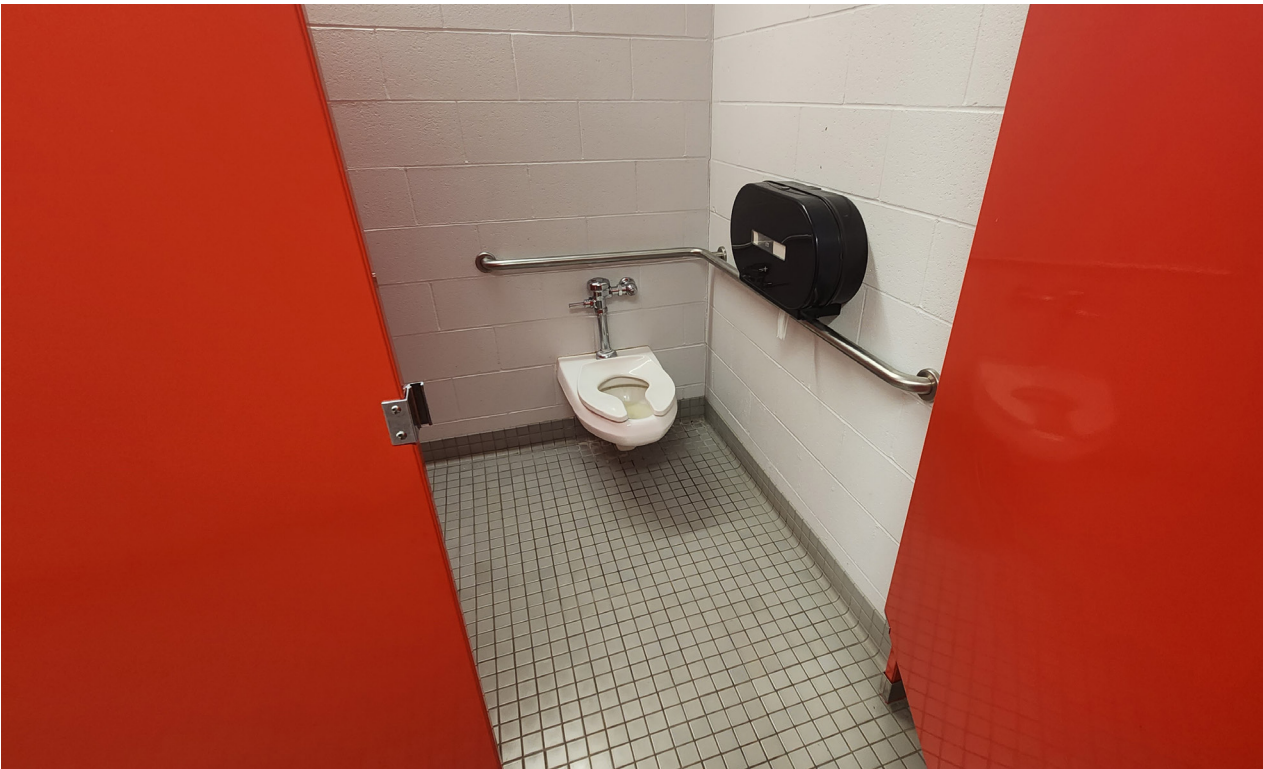
View of typical non-compliant ADA toilet stall.

- Replacement of door hardware that does not meet requirements for ADA accessibility.

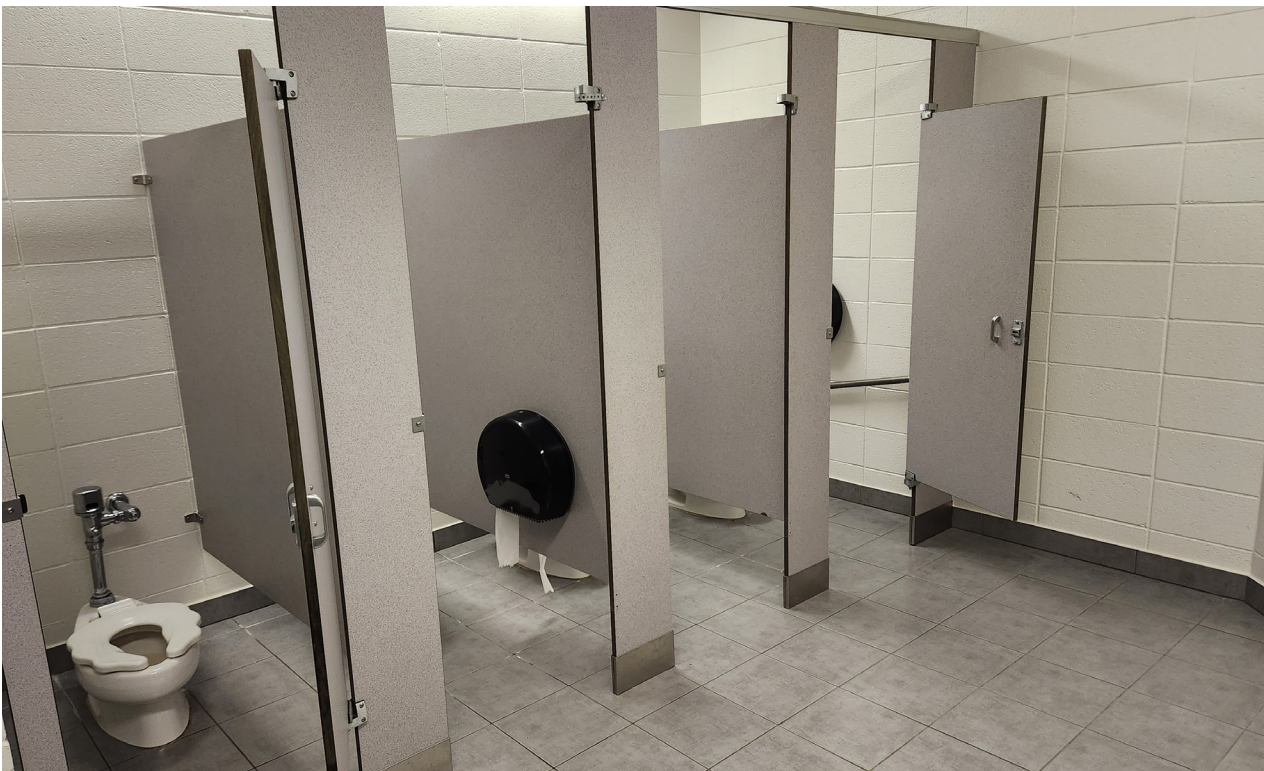
View of typical restroom finishes and fixtures.

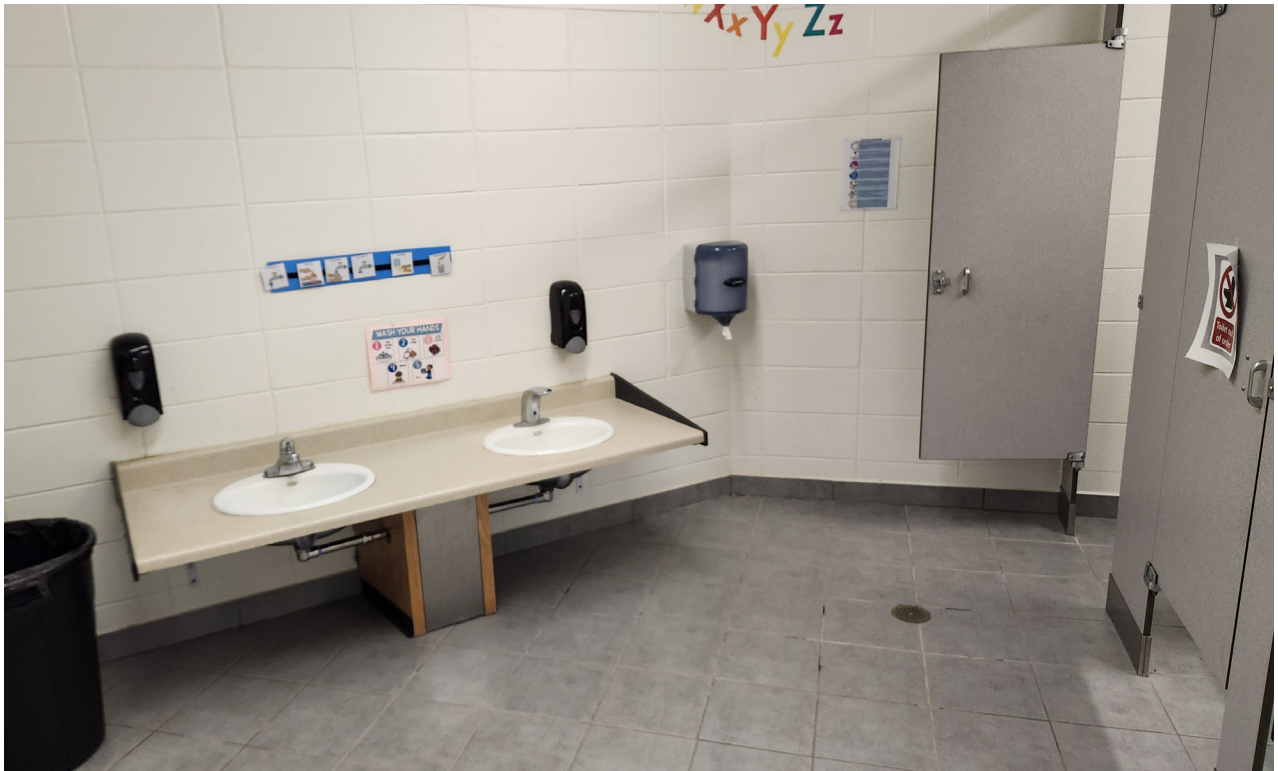
View of typical restroom finishes and fixtures.

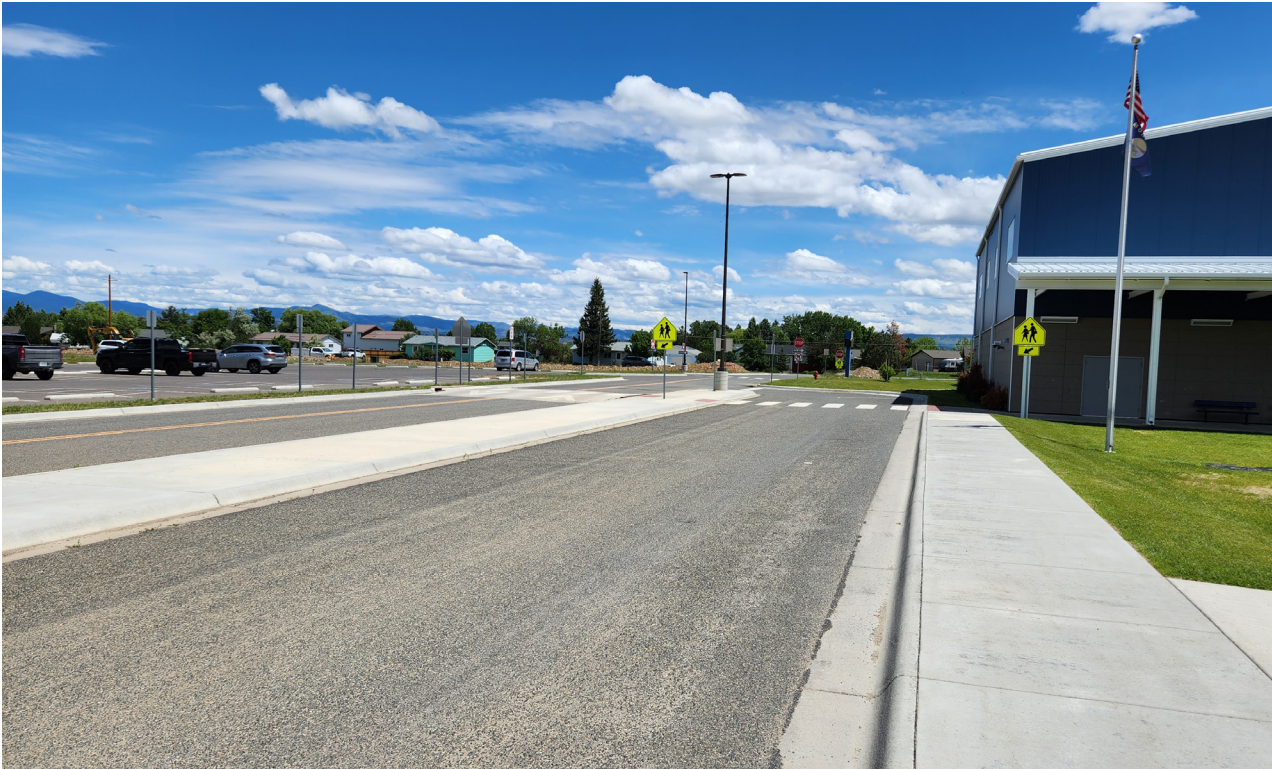
Although the school was newly developed in 2018, site access, parent, and bus drop-off and parking circulation is convoluted and confusing, causes traffic issues before and after school. The district has worked to clarify traffic patterns and provide signage, but the problem is still significant.

View of access drive, drop-off, and parking from entry looking east.

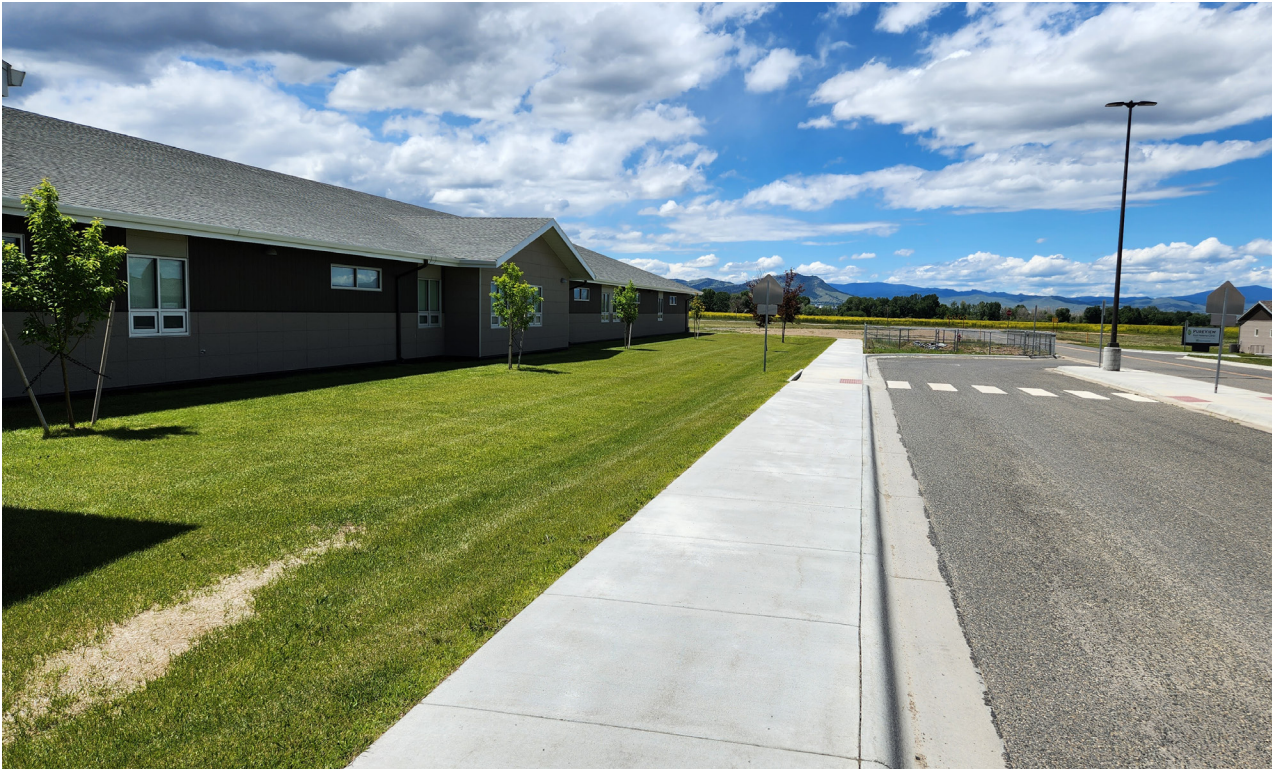
View of access drive, drop-off, and parking from main entry looking west.

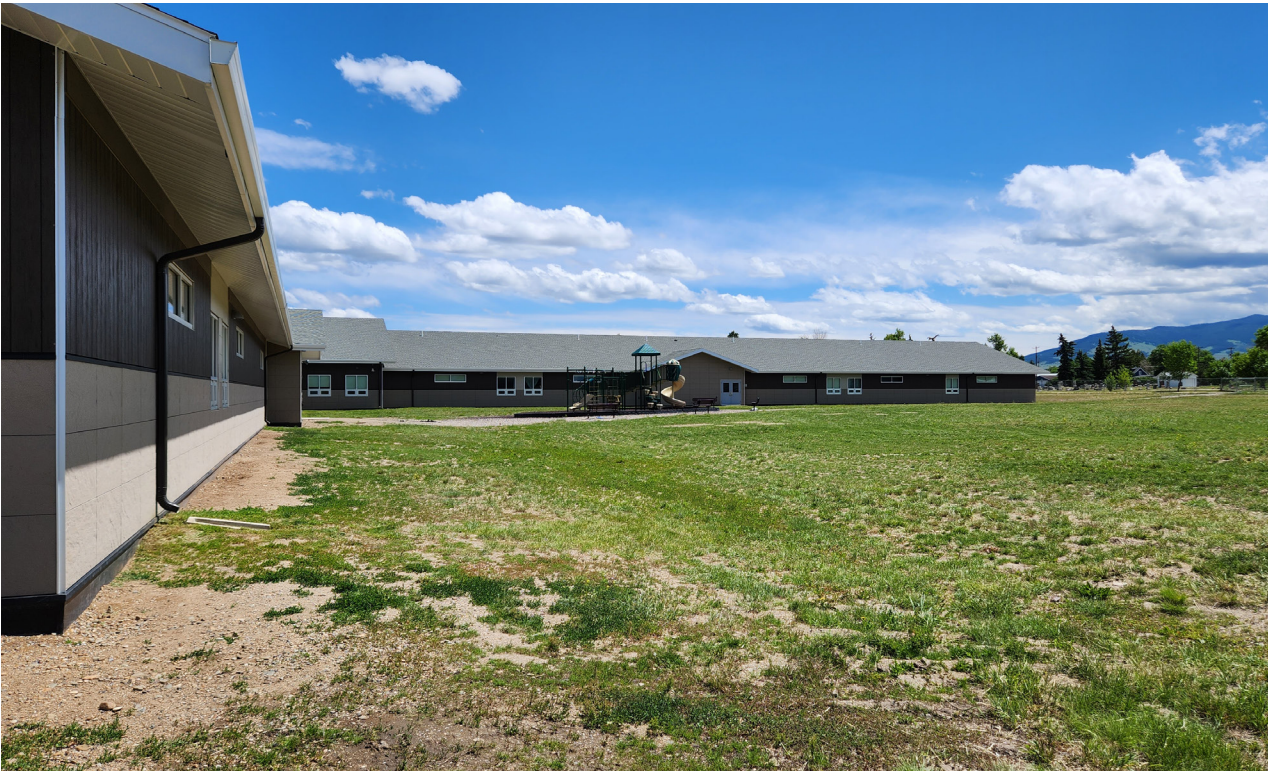
The size of the site play area is currently smaller than recommended with only the east portion of the overall playground area having been developed. The district is currently working on plans to further develop the western portion of the play areas. The play equipment is in good condition.

View of southwest play area and building looking east.

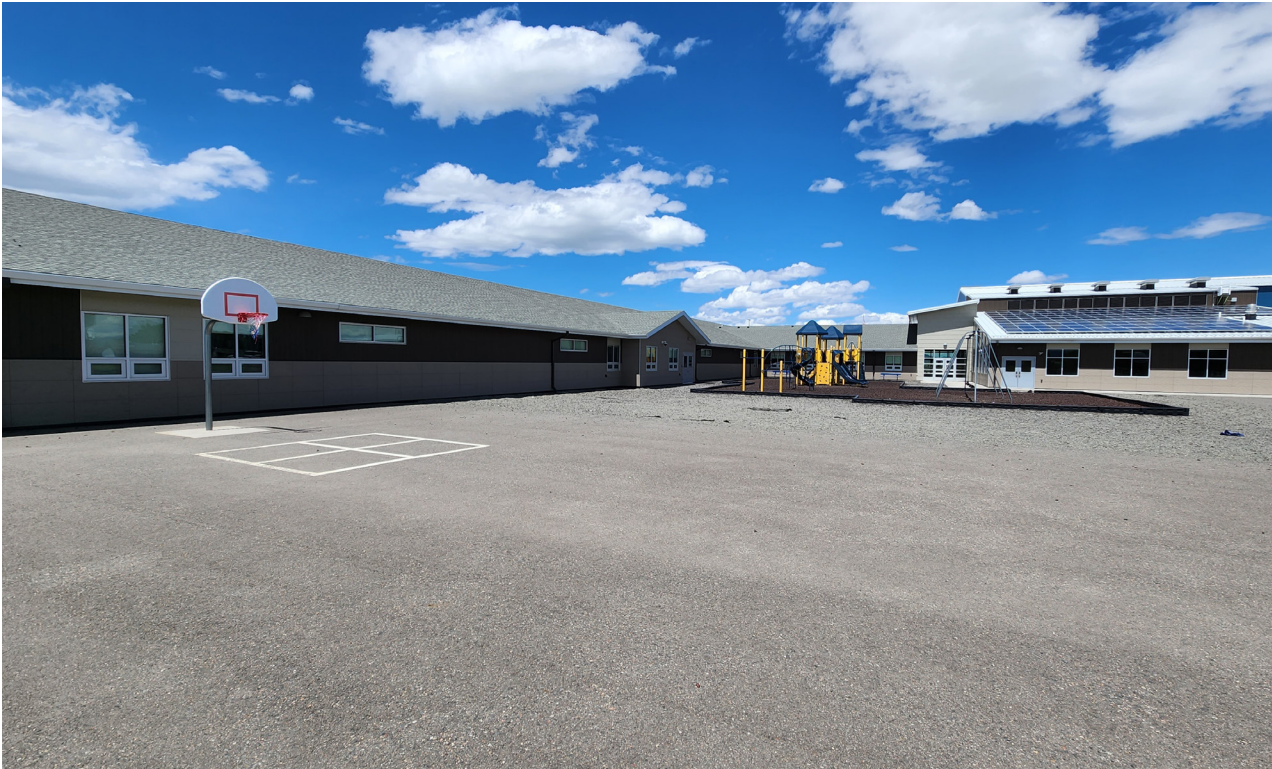
View of southeast play area looking north.

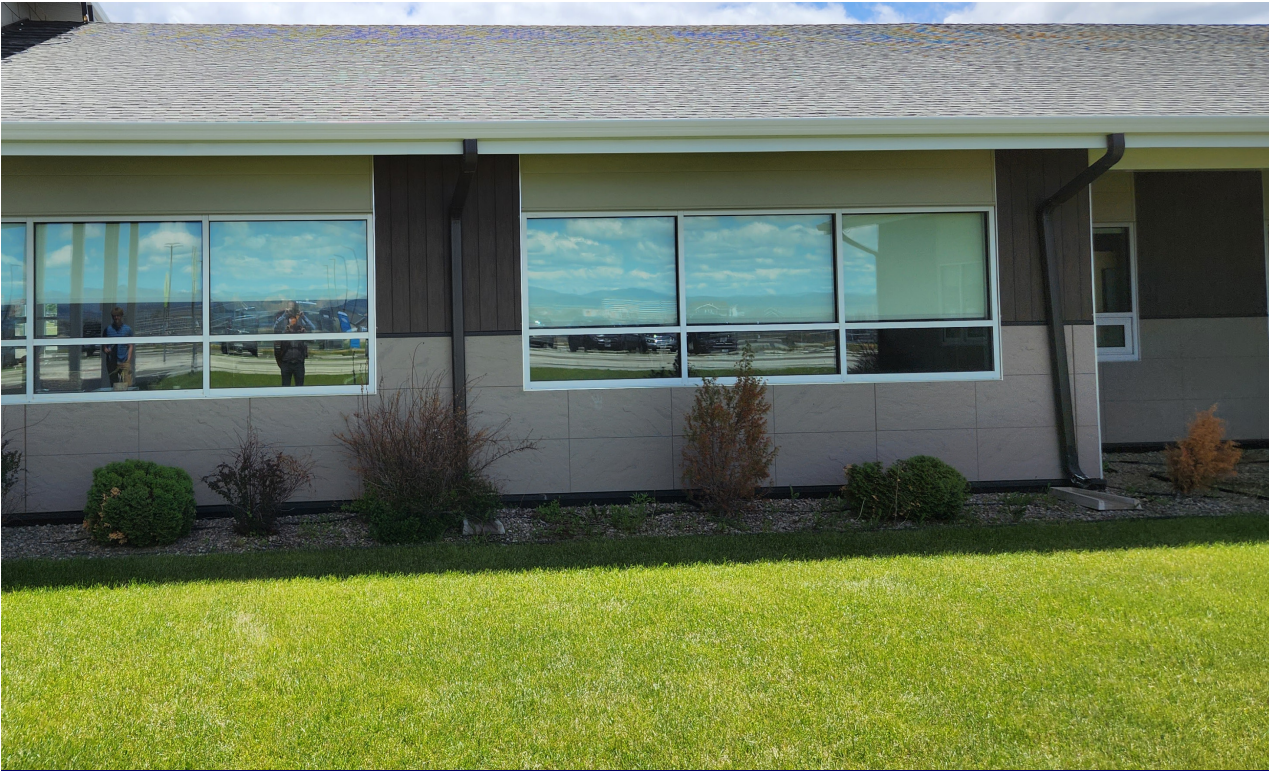
The aluminum storefront windows appear to be in good condition along with all visible flashings. Aluminum awning window inserts appear to be operational and in good condition.

View of typical building materials and aluminum windows.

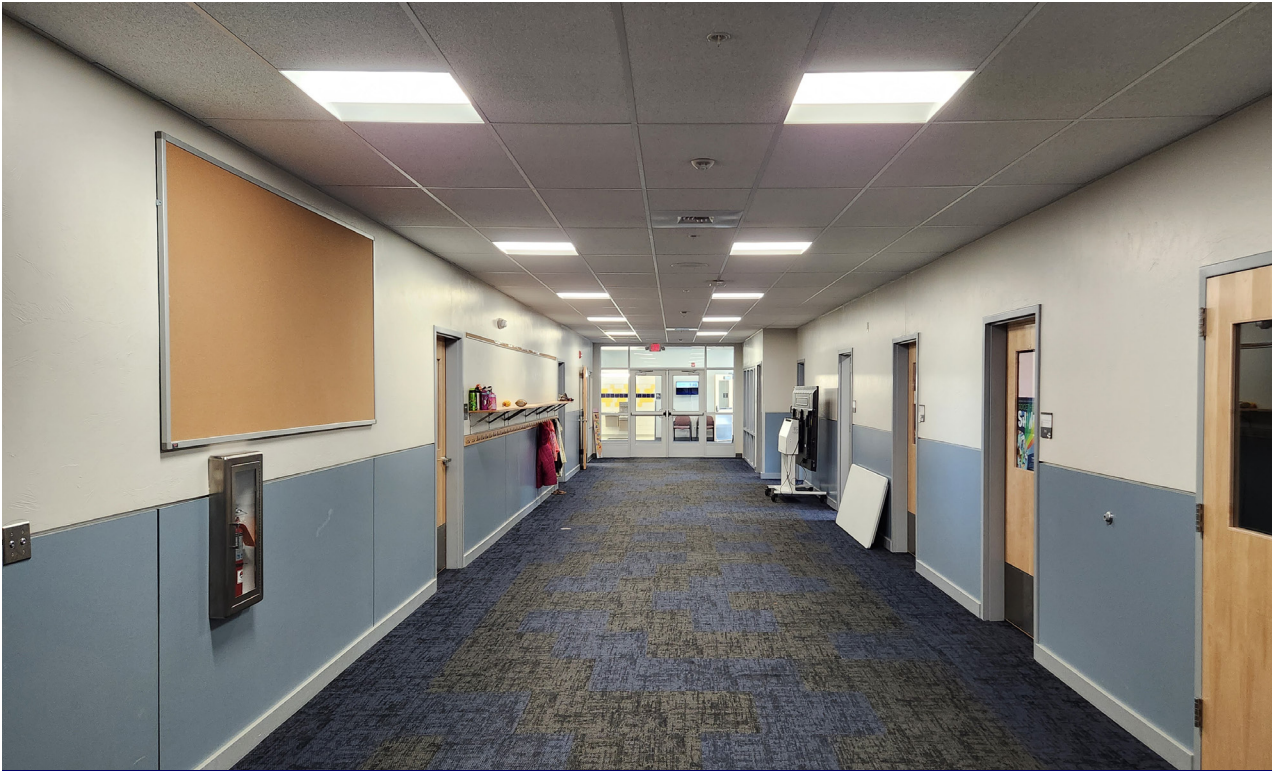
The finishes in the circulation spaces are in good to excellent condition and have been well maintained. The flooring is a newer carpet tile with rubber base. Wall finishes in the hallways are painted gypsum board with painted MDO plywood wainscot. Overall, the painted surfaces are in good, well maintained condition, but some need for paint touch-up was noted.

View of typical hallway finishes.

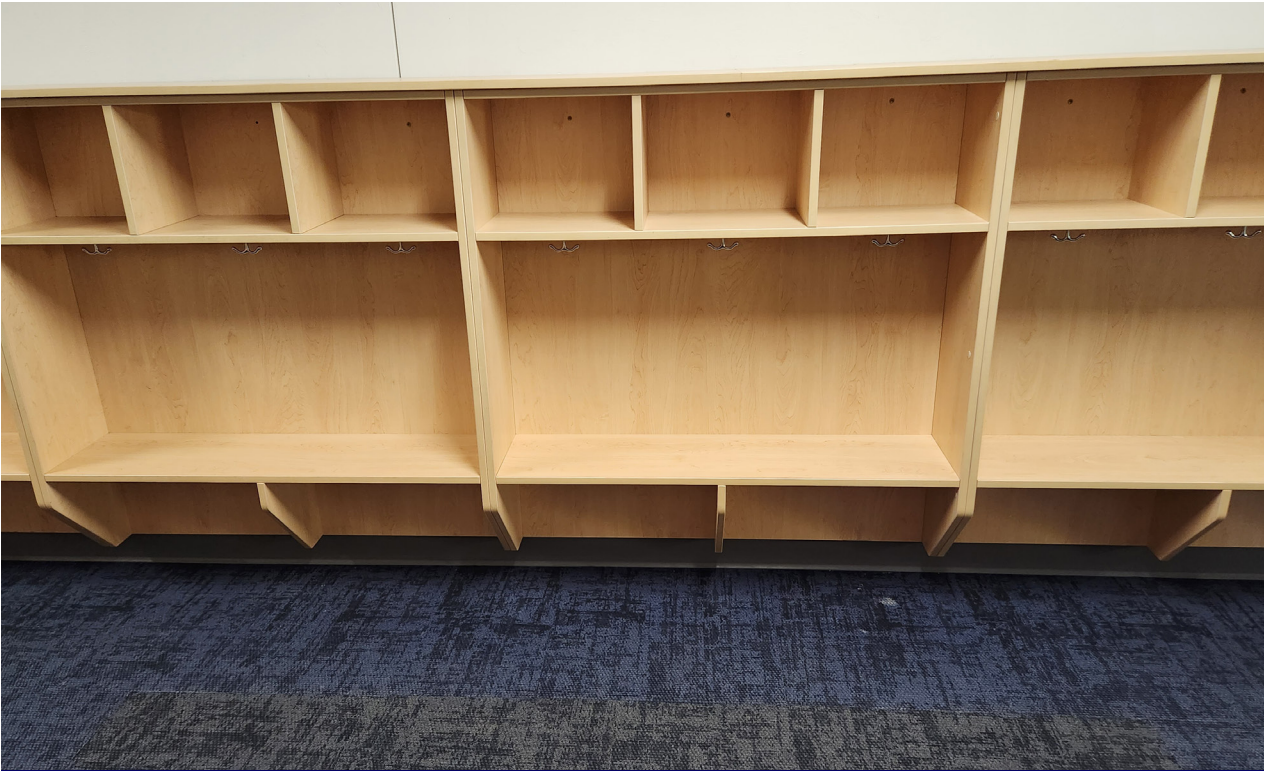
The hallways also have custom casework student storage areas. This casework is in good condition.

View of typical hallway student storage casework.

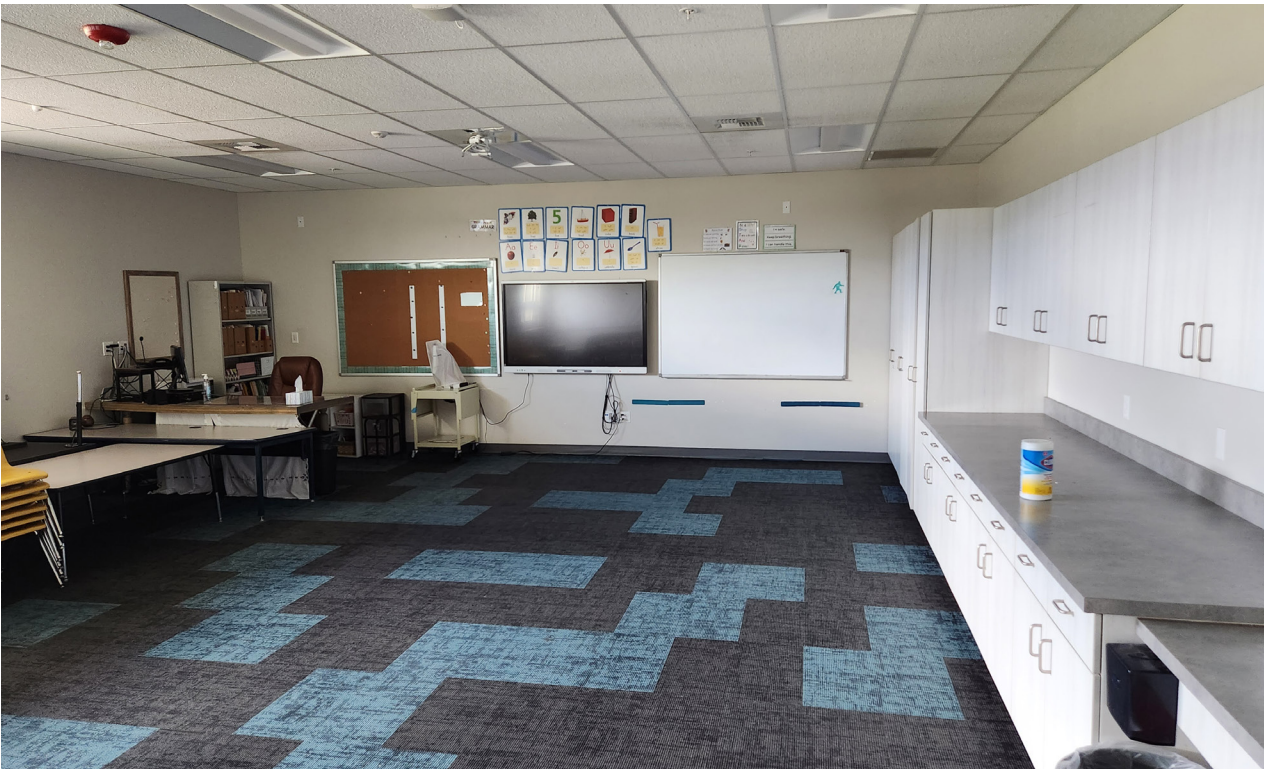
The finishes in the classrooms are in good condition and have been well maintained. Flooring throughout the classroom spaces is carpet tile with rubber base. Wall finishes are painted gypsum wall board and are in good condition. It was noted at several locations that the paint and wall texture had been damaged by moving of furniture or other items hitting the walls.

View of typical classroom.

- Continued upkeep and regular maintenance to ensure the building remains in good condition.
- Drywall repair and paint touch-up where walls have been damaged by moving furniture and equipment. ■

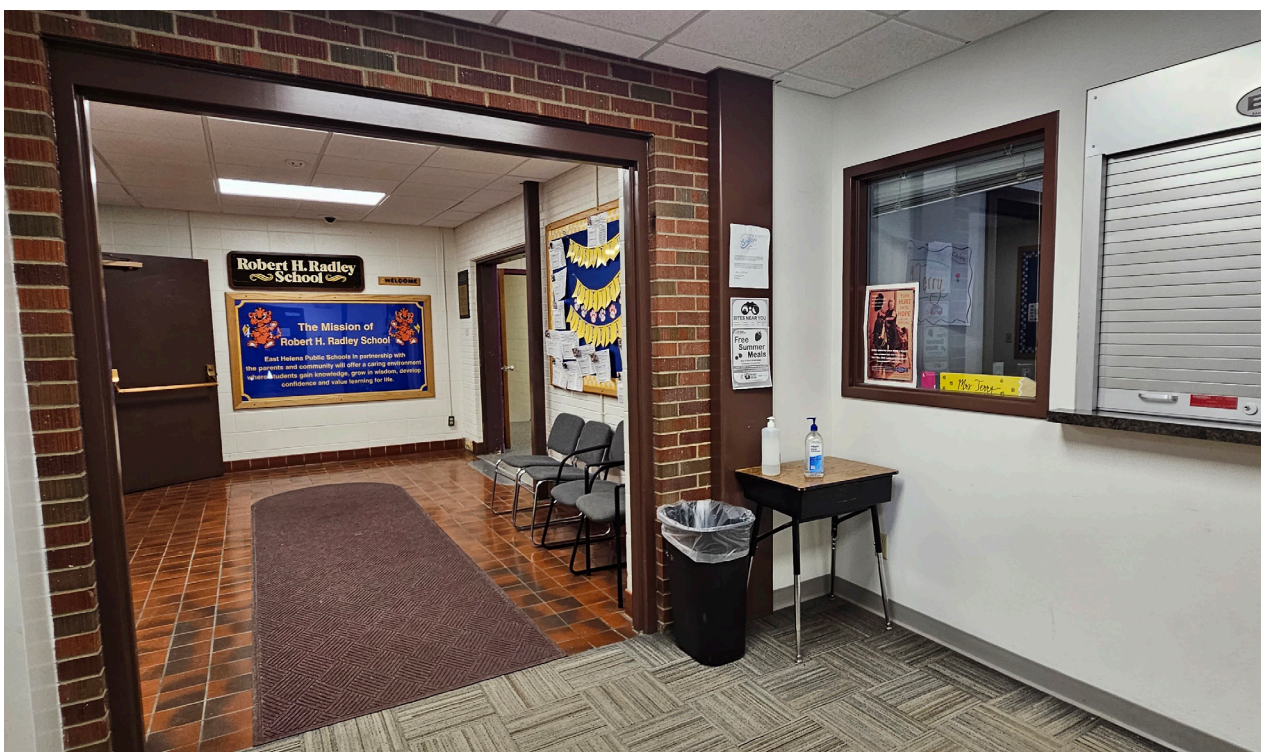
Further inside Main Entrance, showing visibility from secured Main Office, but no secured second door before entry to the school.

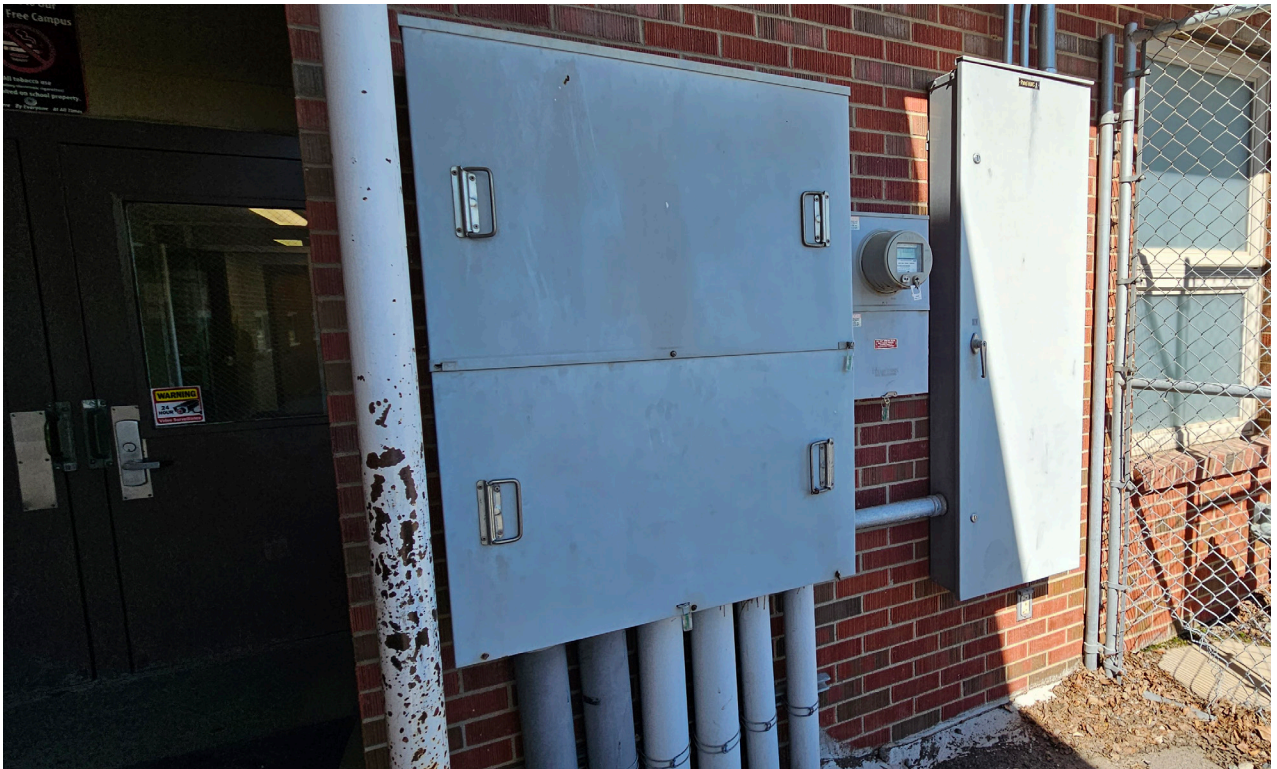
Unsecured building utilities, adjacent to play areas.

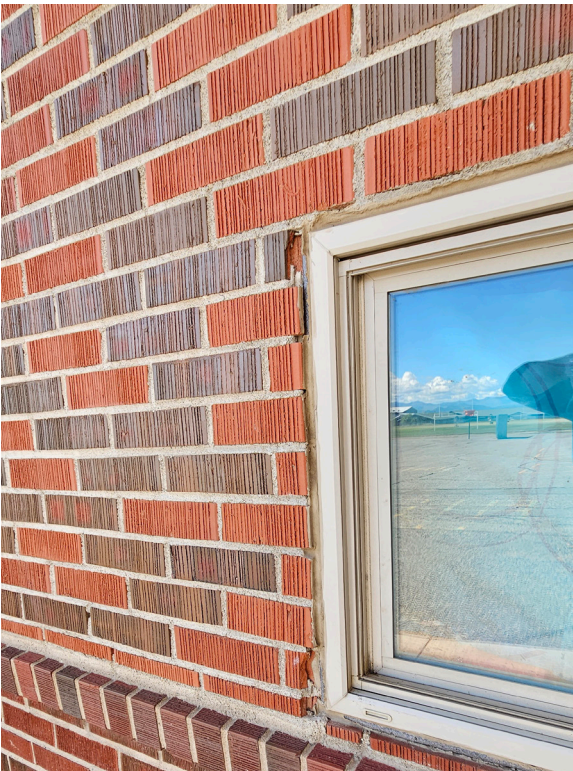
General view of exterior brick condition.

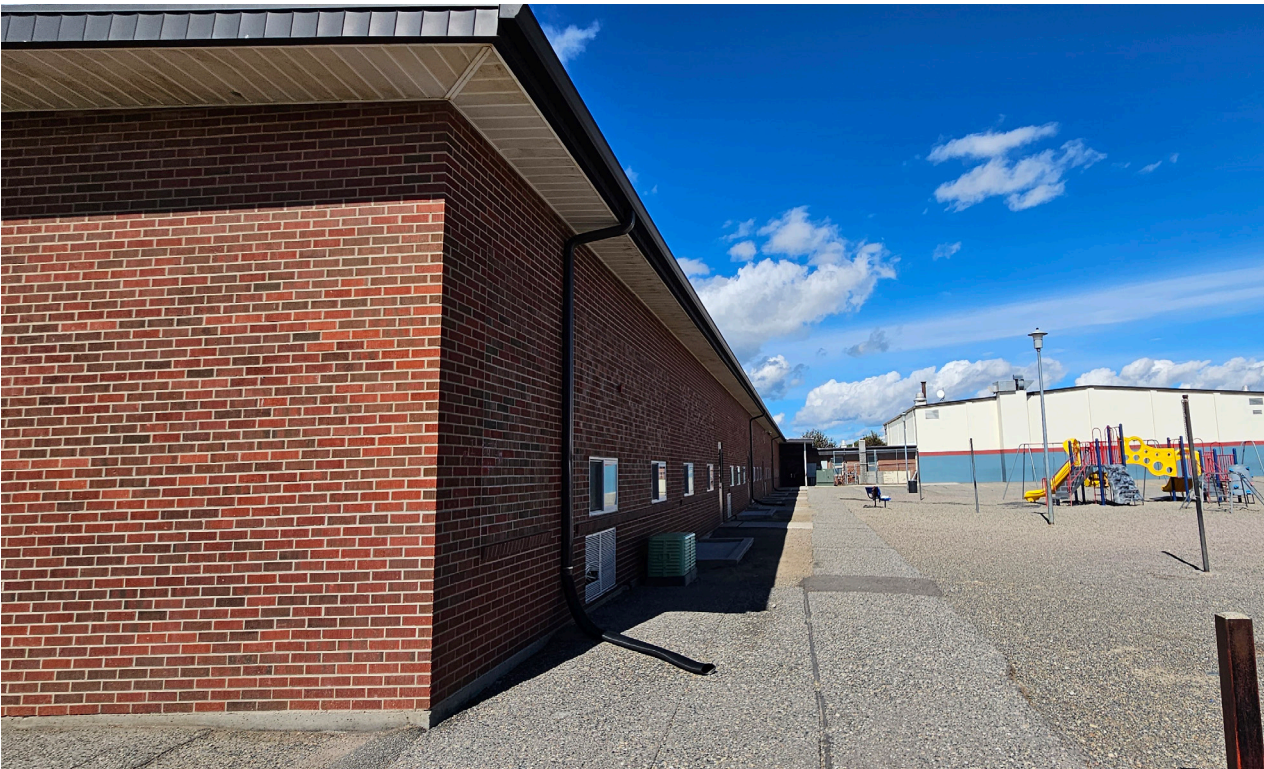
Exterior stairs, ramps, and concrete sidewalks appear to be in good condition with minimal cracking and spalling; paths of asphalt (especially on the north and east sides of the building) show deep cracking and unevenness.

North side of East Wing, showing play yard, uneven asphalt path and general condition of brick walls.

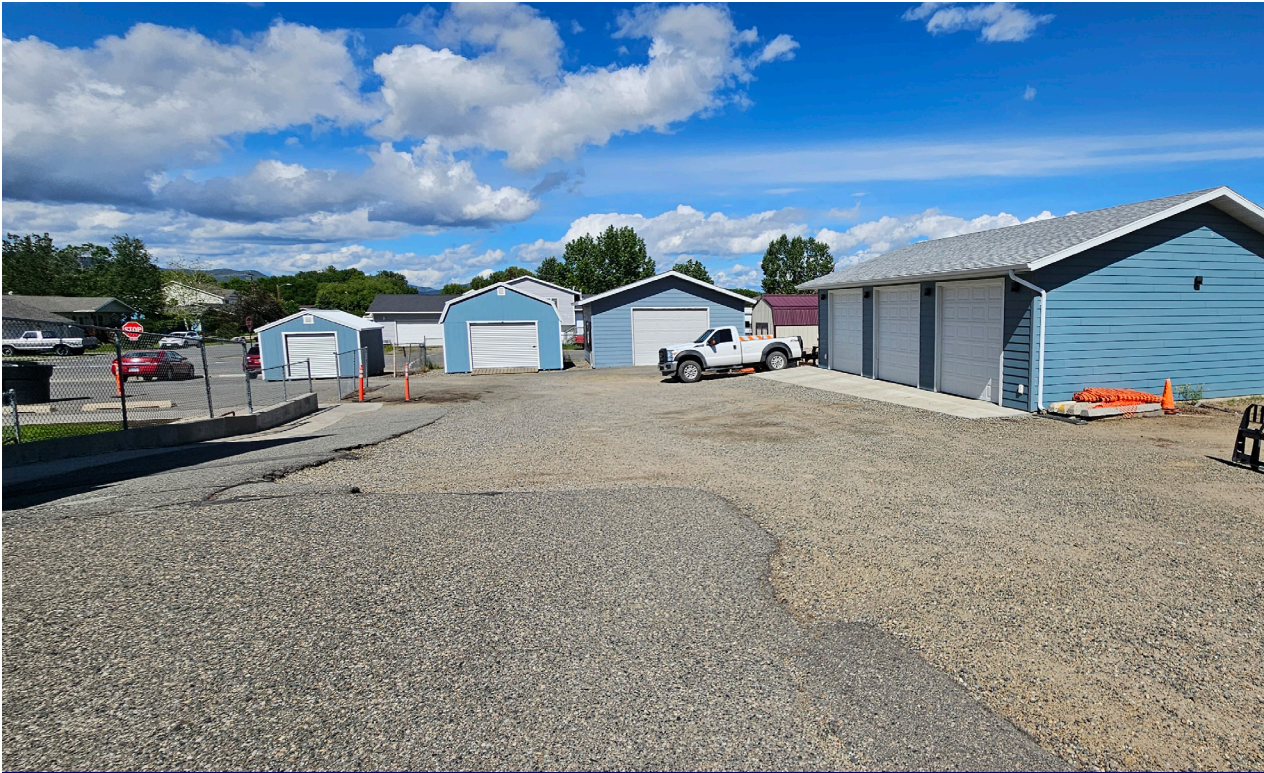
The playground area is of adequate size, and the equipment is in aged but functional condition. The asphalt blacktop in the play area is extensively cracked and uneven. There is little separation between the play areas and service or storage areas on the site. Additionally, the play yard lacks complete fencing and gates, raising potential security and supervision issues.

View of delivery and storage areas, connected directly to play yard.
