EAST HELENA PUBLIC SCHOOLS FACILITIES CONDITIONS REPORTS

EAST HELENA, MONTANA
EAST HELENA PUBLIC SCHOOLS MASTER PLAN
NOVEMBER 2023

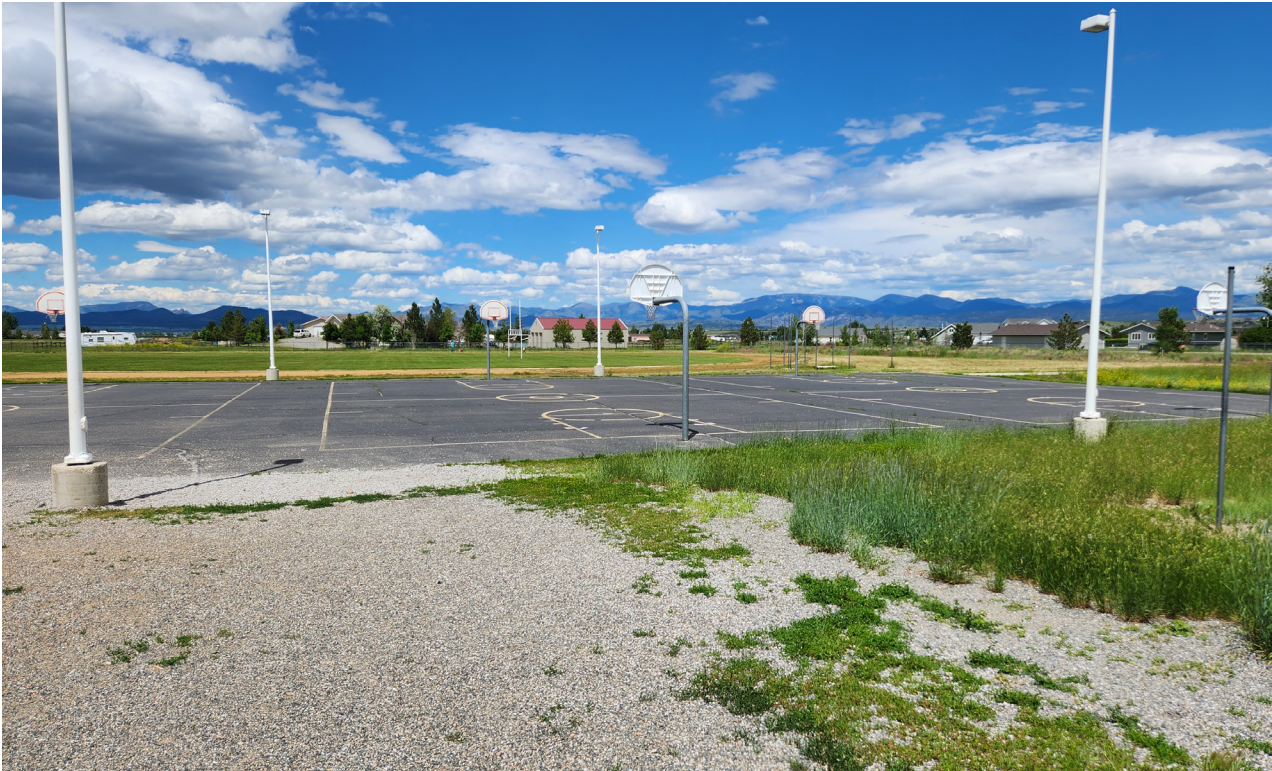
View of asphalt playground area, equipment, and lighting.

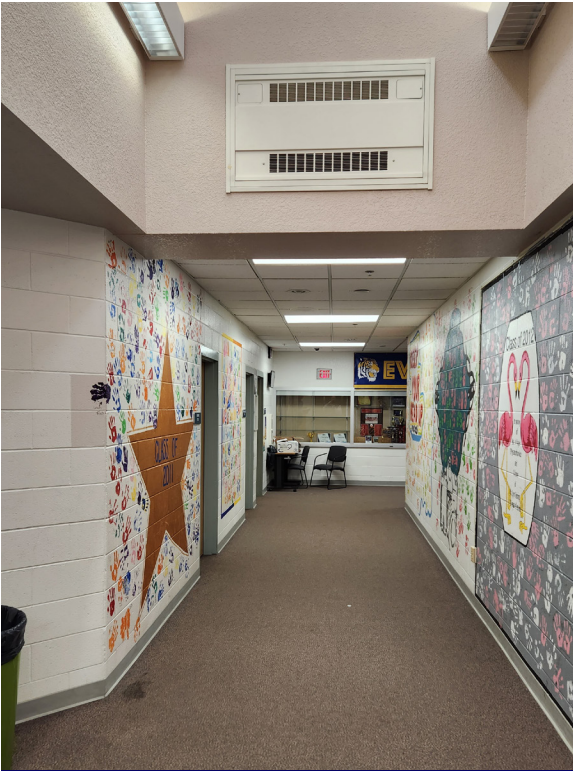
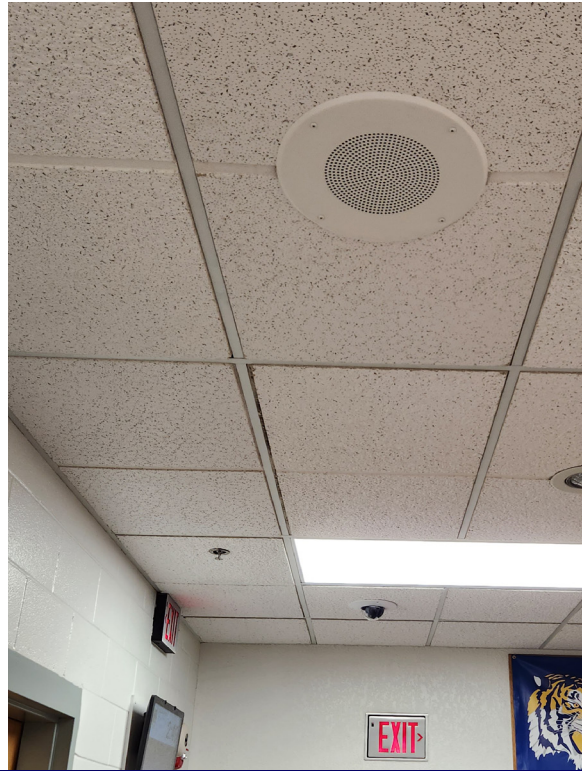
View a typical hallway and close-up view of the ceiling.

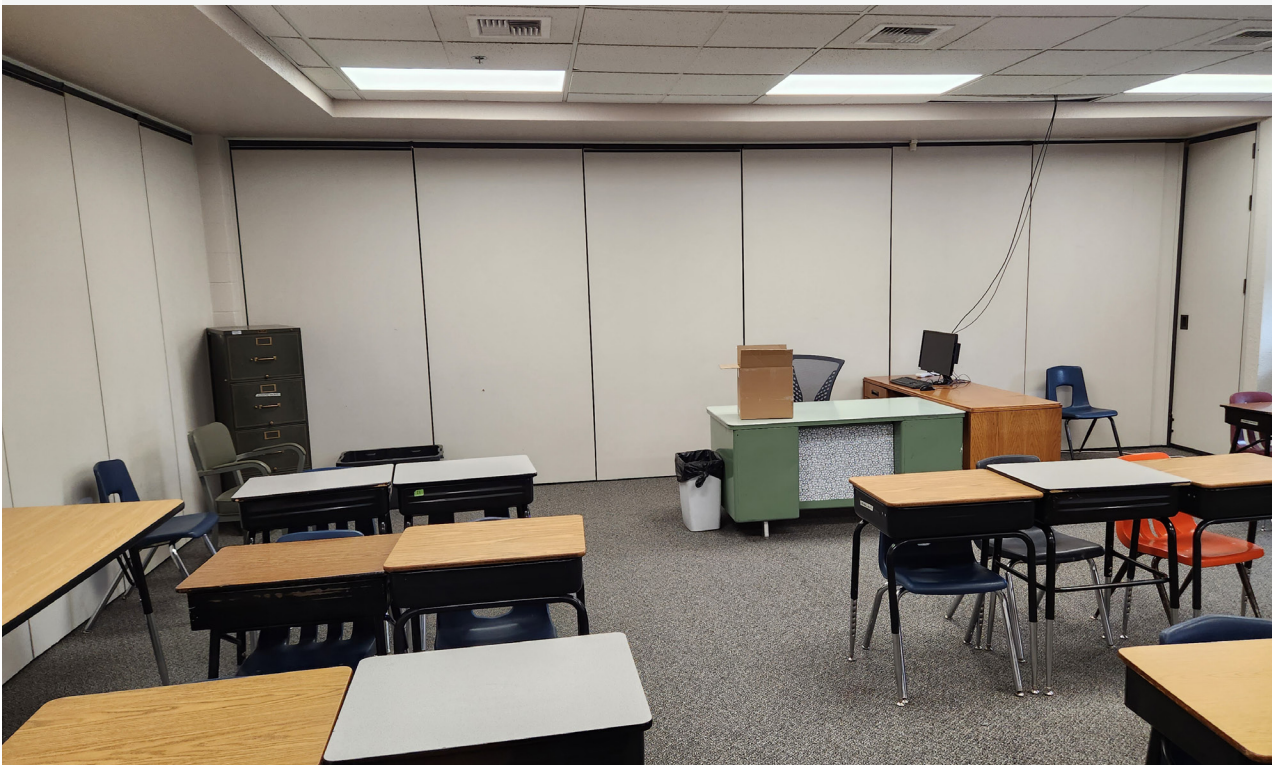
Example of damaged and missing ceiling tiles.

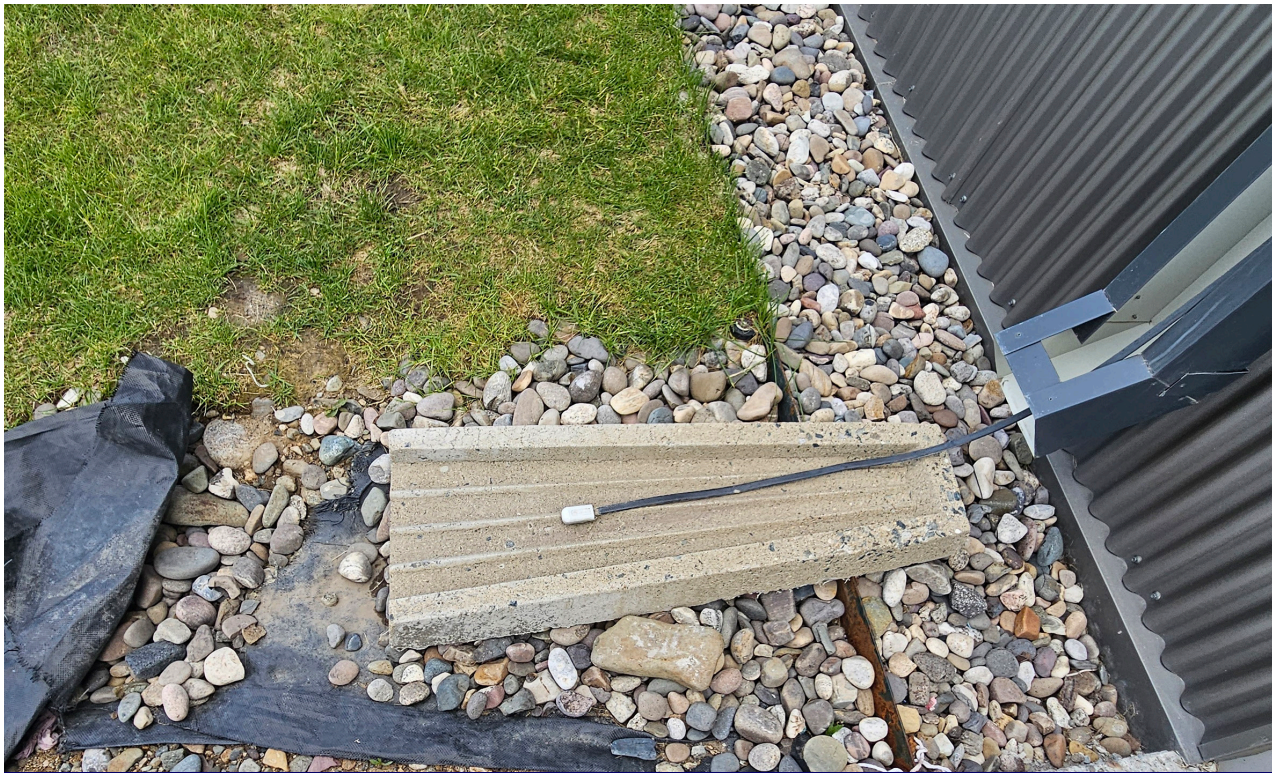
Additionally, there were minor drainage issues observed from the downspout servicing a large area of roofing on the north end of the Gymnasium.

Roof drainage damaging landscaping.

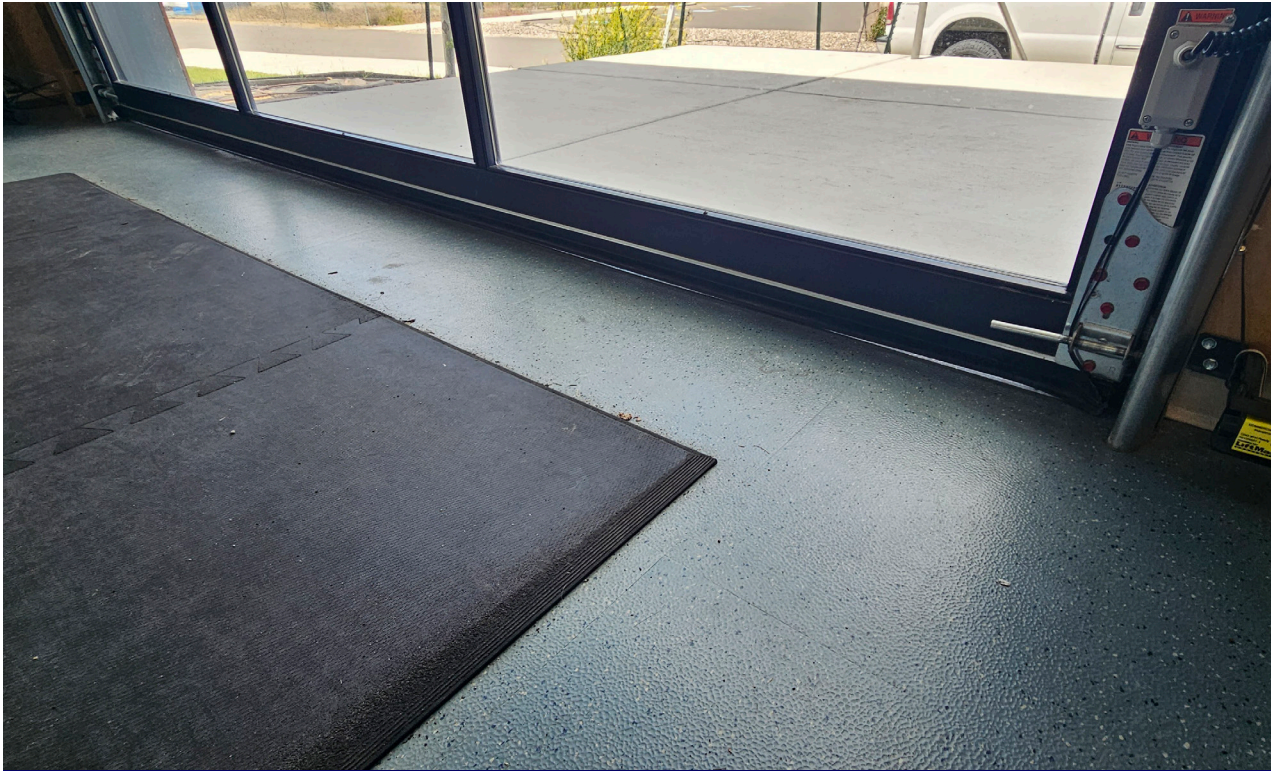
Of note, the aluminum overhead door in the weight and fitness room showed a poor seal at the floor; this seal should be adjusted or replaced.

View of overhead door sill at the fitness room.

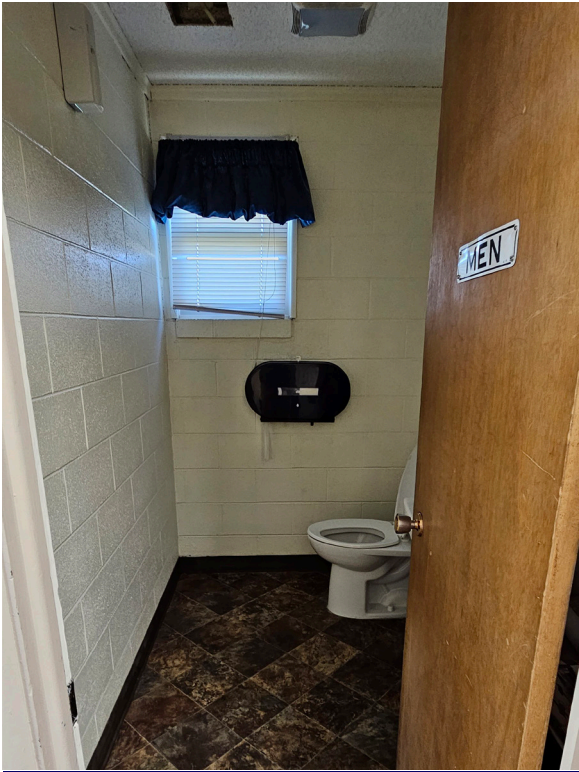
None-accessible toilet room.

Given the poor condition of the building, and although the District has made good use of this building, it is recommended to be entirely decommissioned and demolished. A new location for Administrative Offices is recommended. Removal of this building from the Radley Campus will allow improvement of the vehicular and pedestrian circulation issues at Radley Elementary. ■

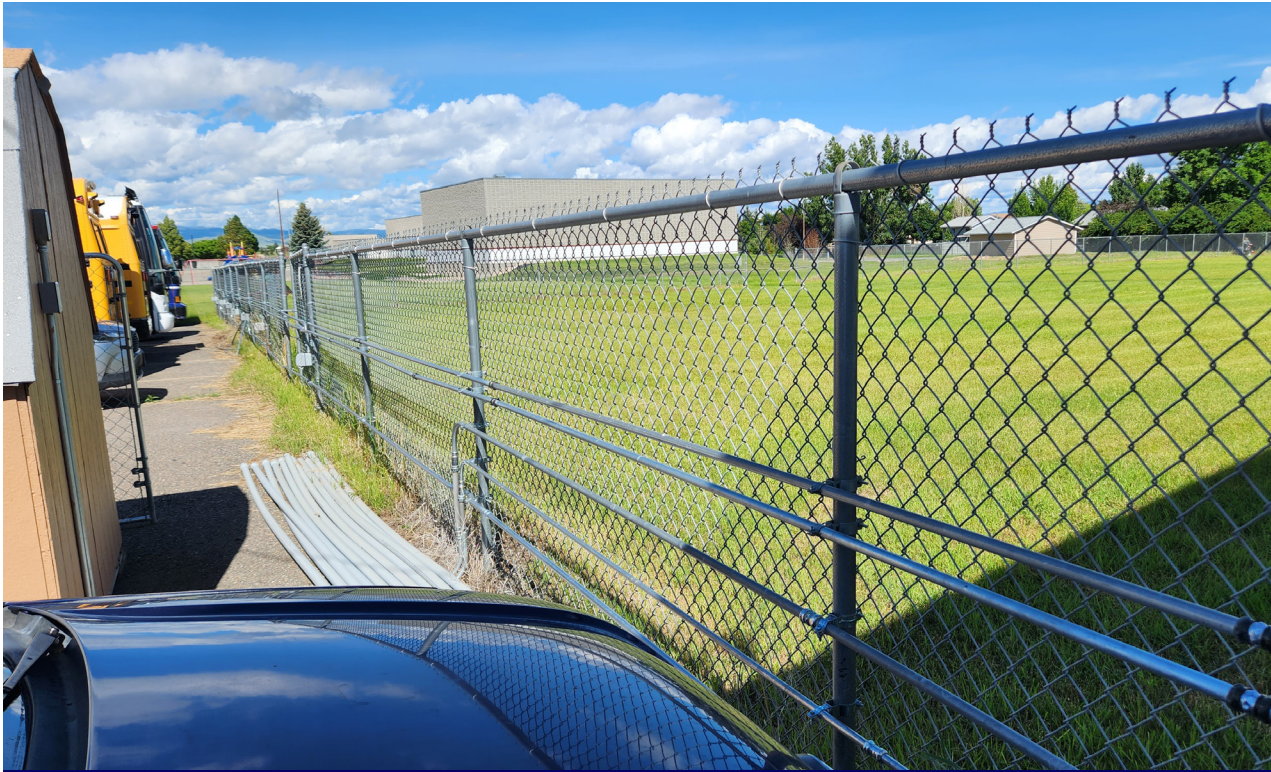
View of electrical services running to bus parking west of the Bus Barn.

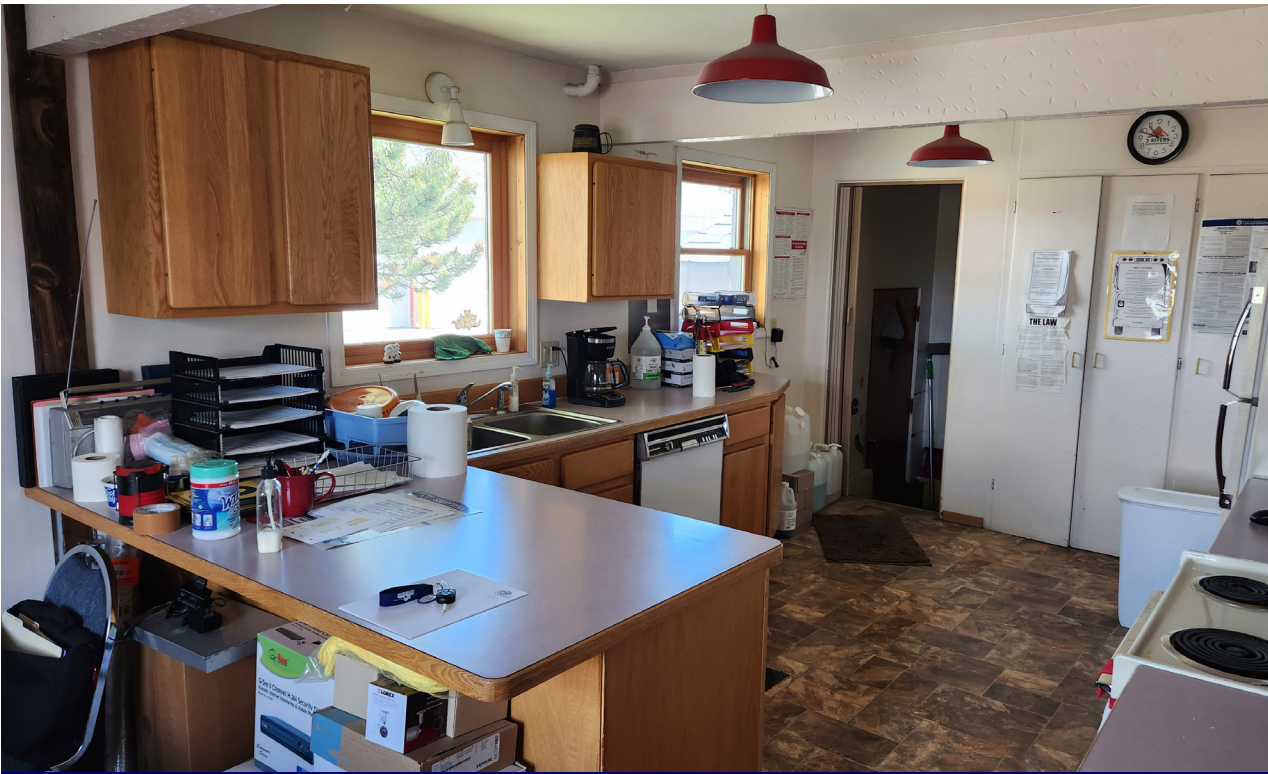
View of the kitchen area in the Miller House.

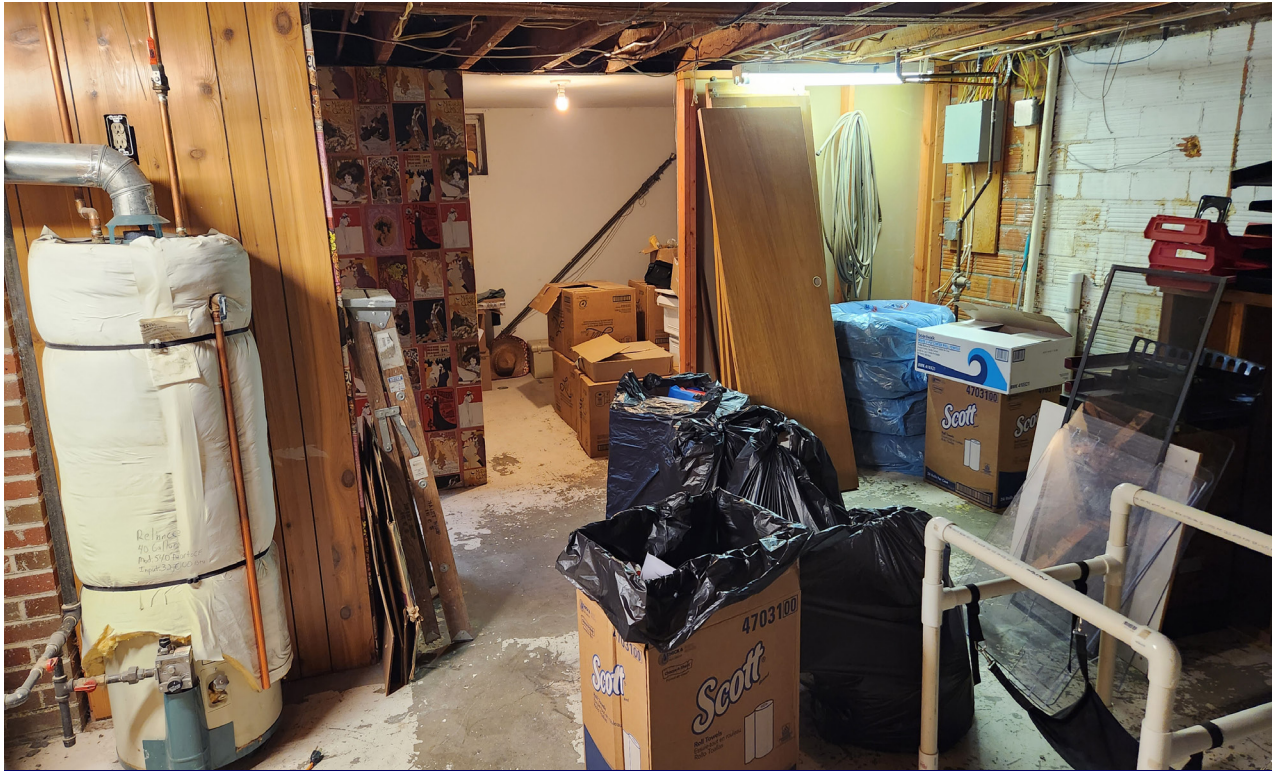
View of the basement in the Miller House.

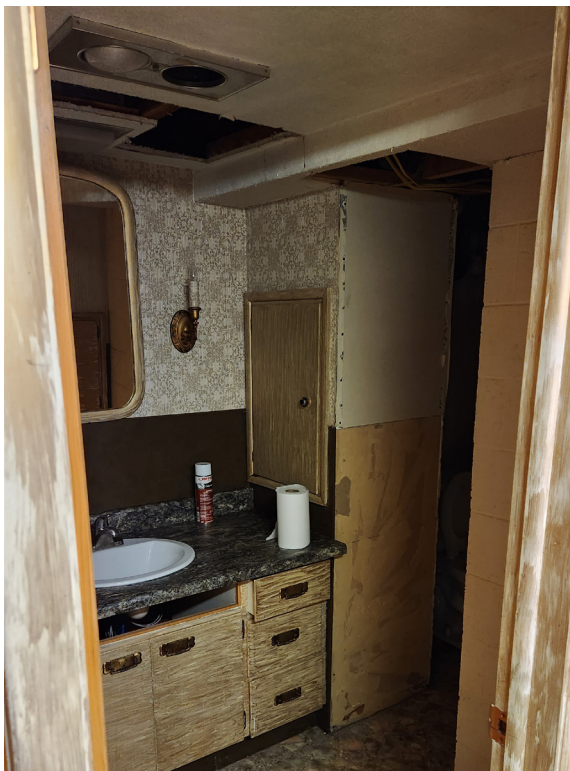
View of the restroom in the Miller House.

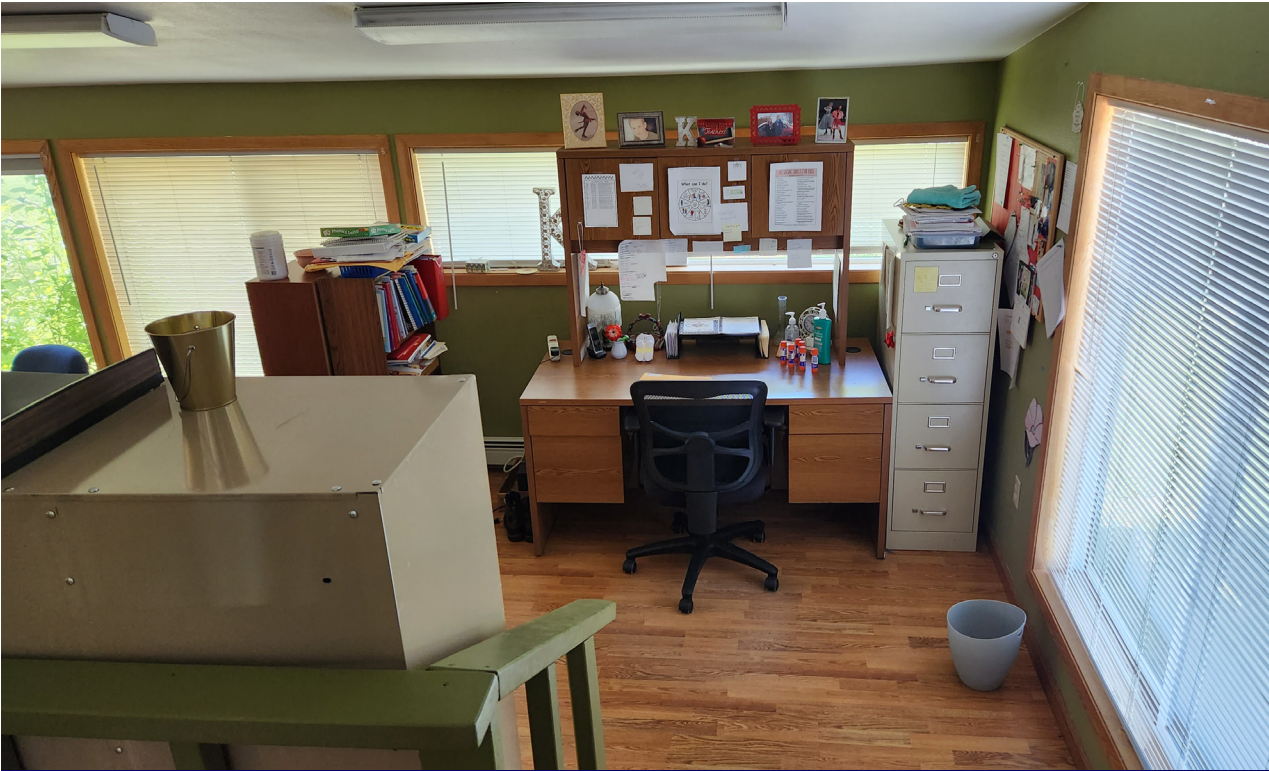
View of the lower office and conference area in the Miller House.

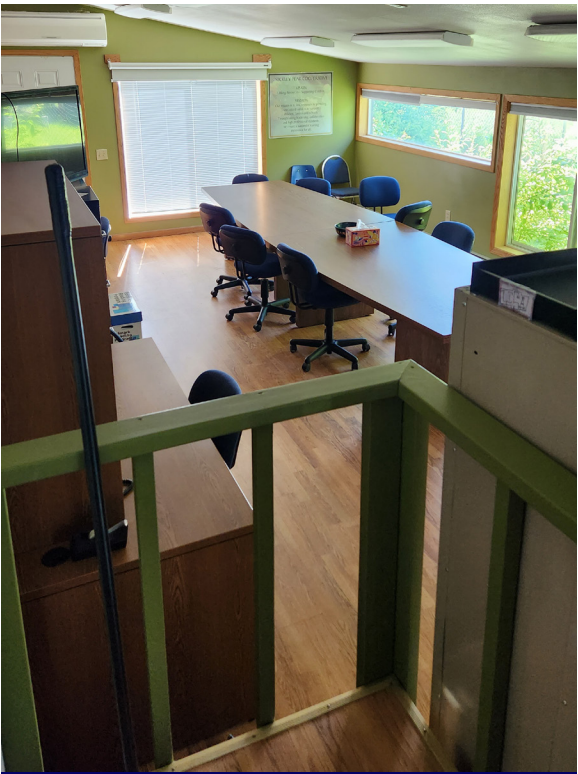
View of the lower office and conference area in the Miller House.

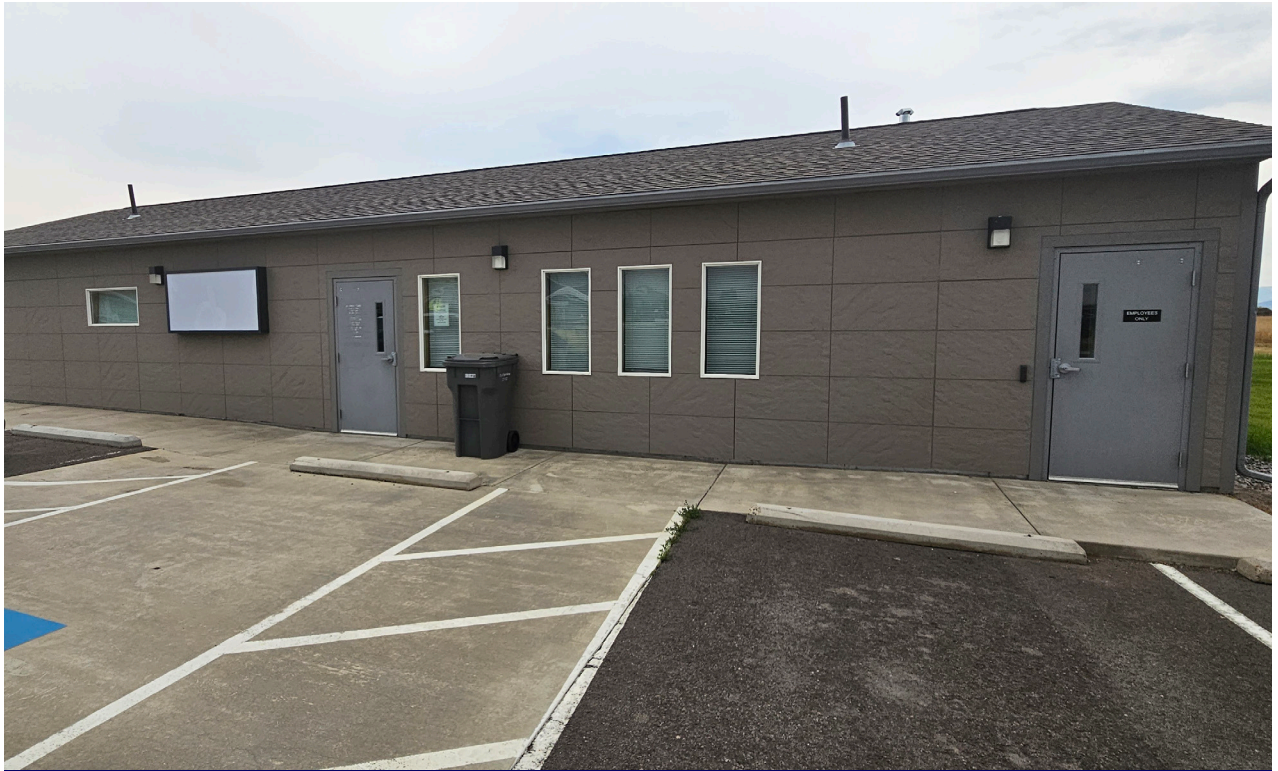
Exterior and interior finishes are only slightly worn and overall the building appears in excellent condition. Due to its relatively new age, it is compliant with current energy, building, and accessibility codes and standards for a business-type usage. The roof is a double-pitched single-ridge roof with asphalt shingles, also in good condition. There was only one minor trim piece on the exterior noted to need replacement. Windows and doors throughout were in excellent condition; with the exception of the main entry door having multiple signages applied and removed. Parking and H/C accessibility was already in place.

Exterior east-facing facade of Clinic Building.

The small building could easily remain as an outpatient clinic or be utilized for district office space; the exam spaces and offices could be converted to administrative office space with virtually no renovation or modification. An easily transferable use to this building could be as a replacement Central Administrative Office. ■

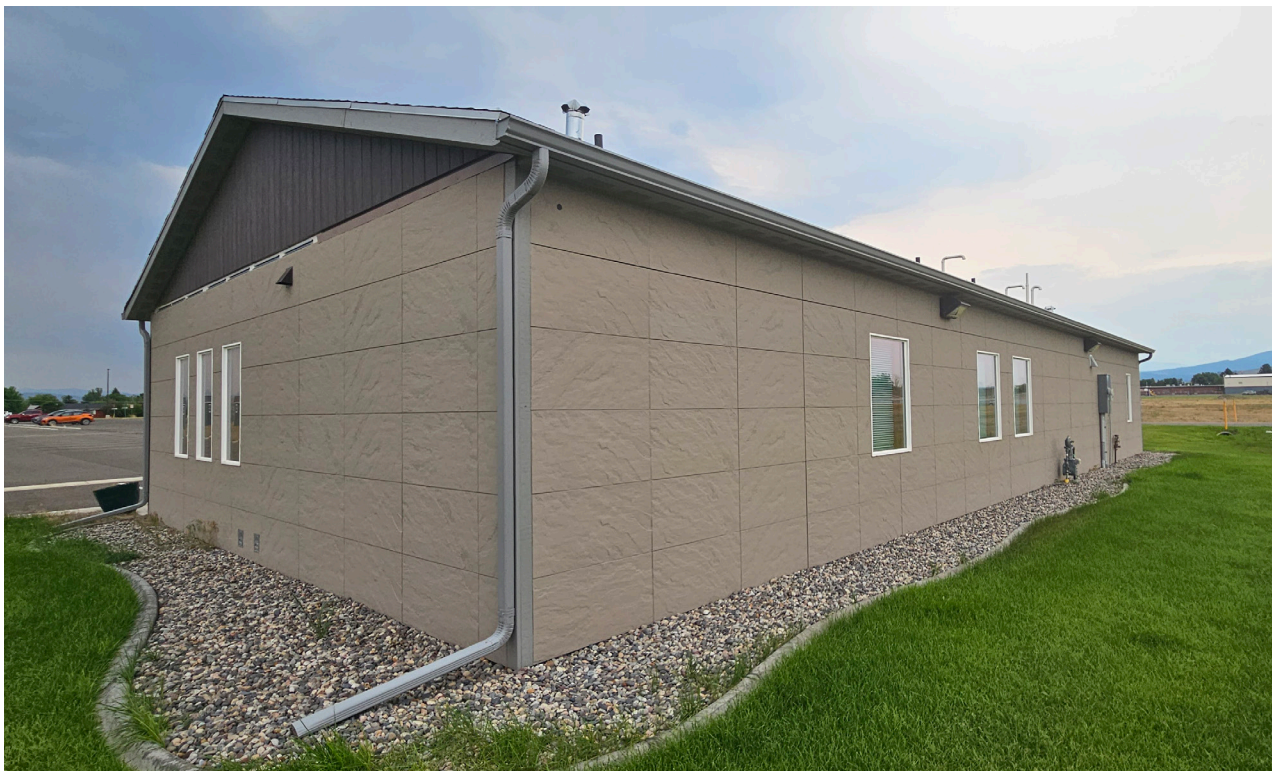
Exterior north west side.

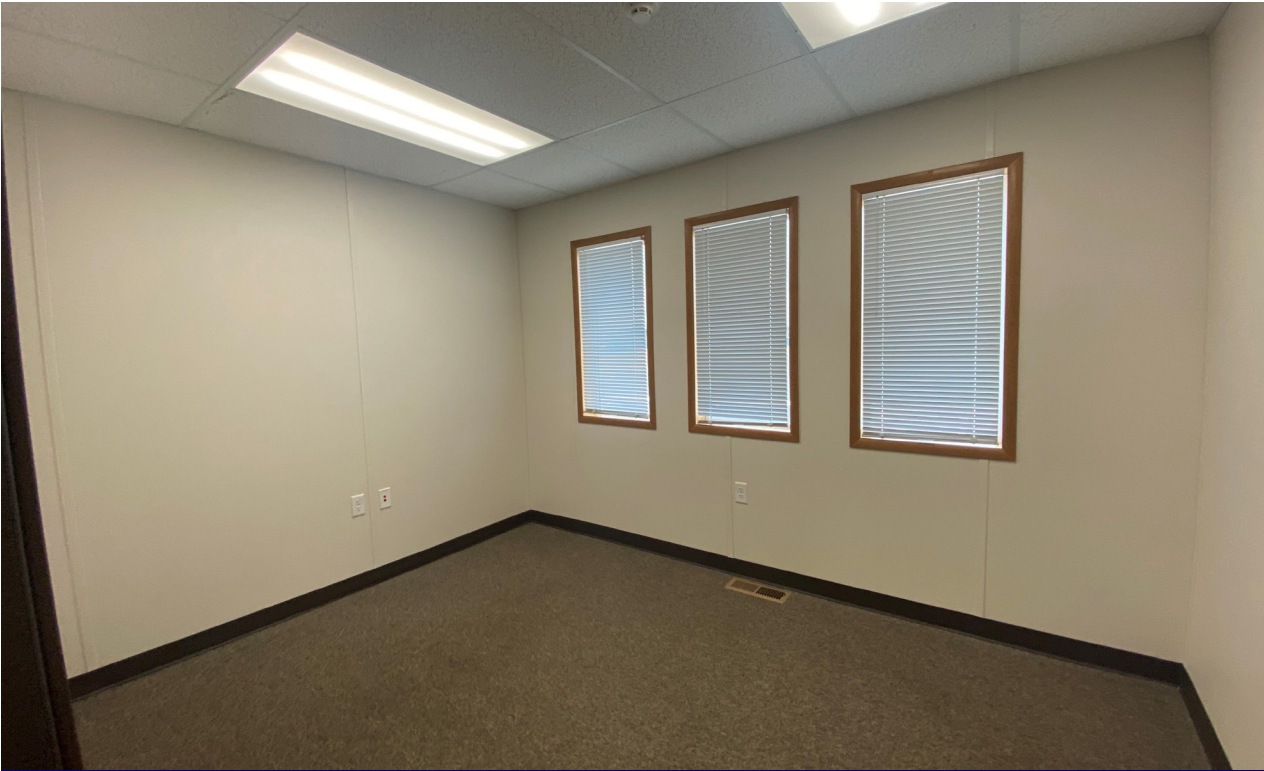
Interior office space.

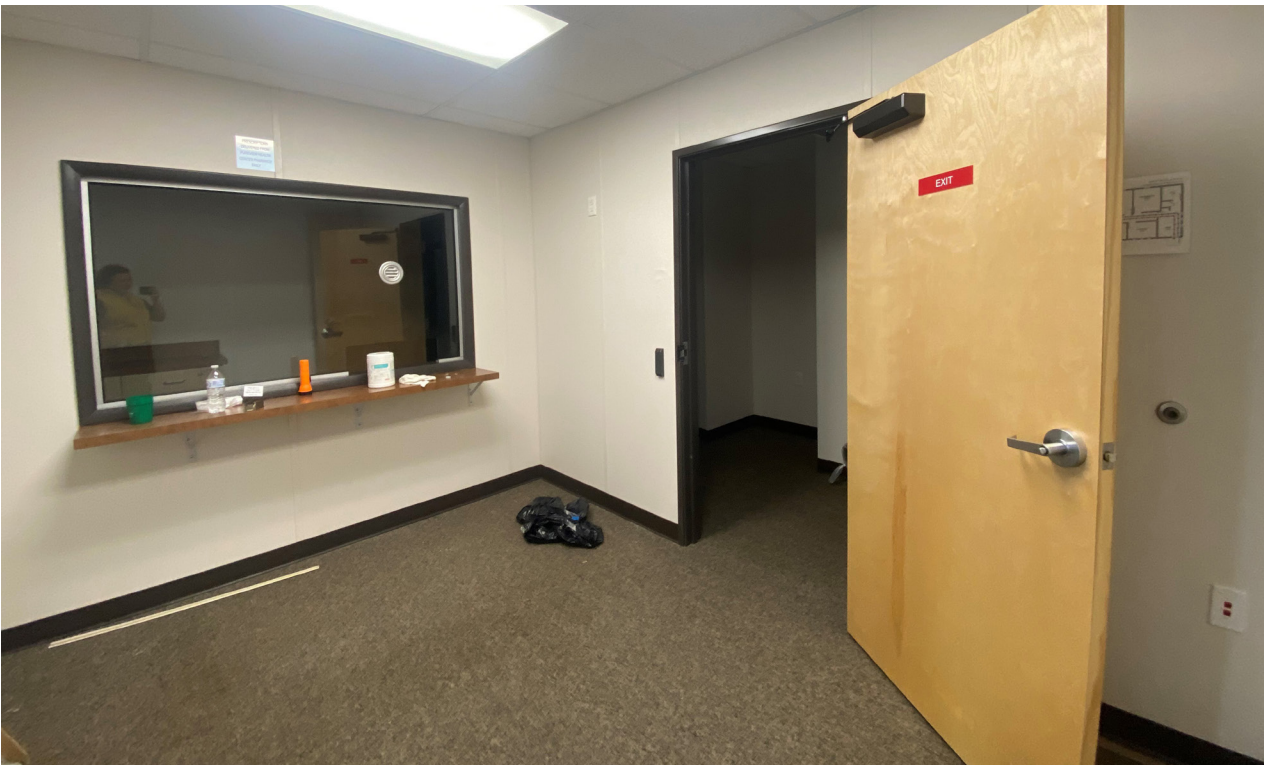
Interior Reception Area.

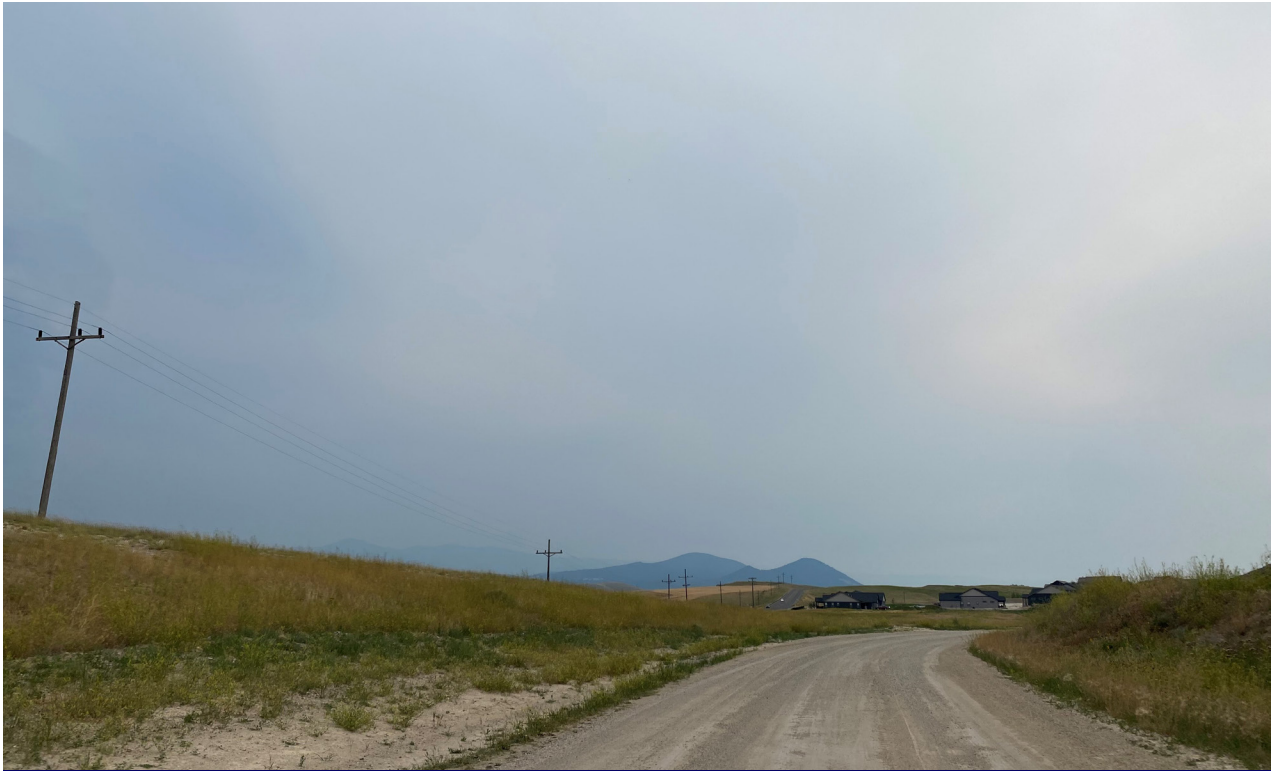
View from site looking to the South on Alpine View Road that bisects the property.

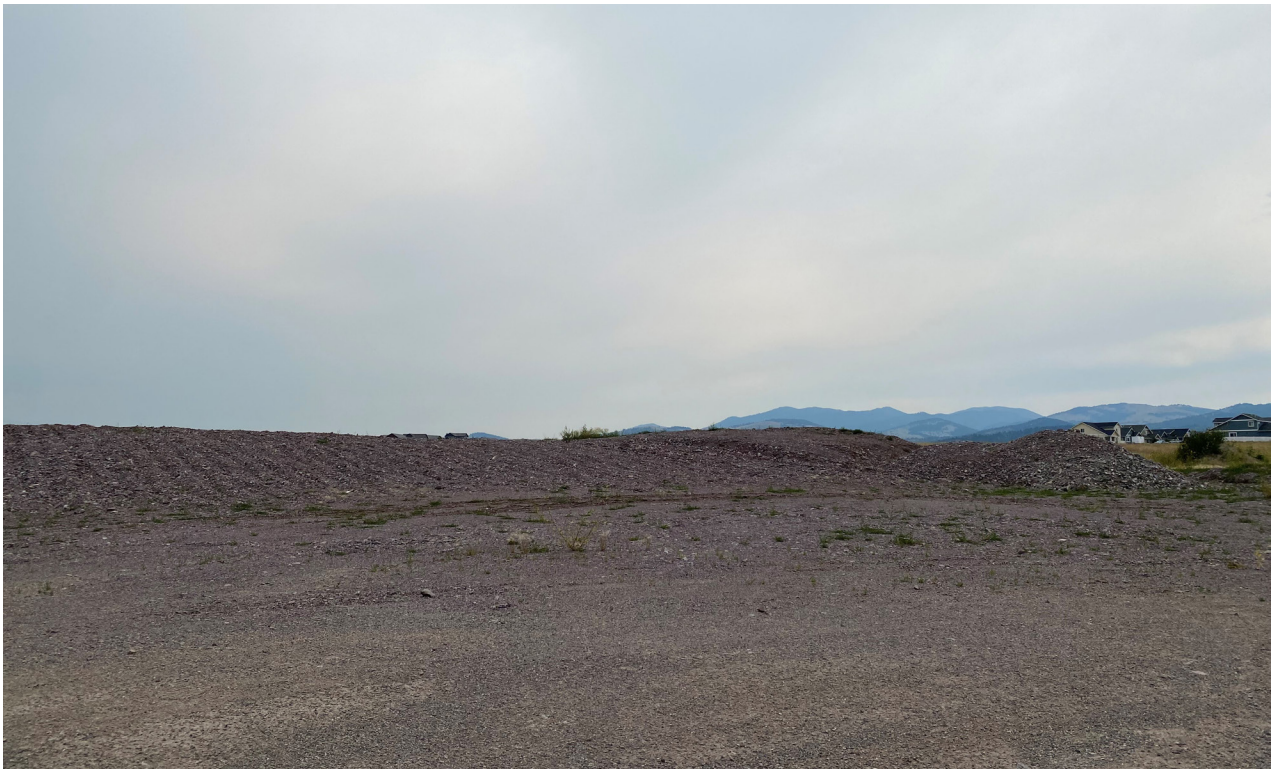
Western portion of the Mountain View Meadows site.

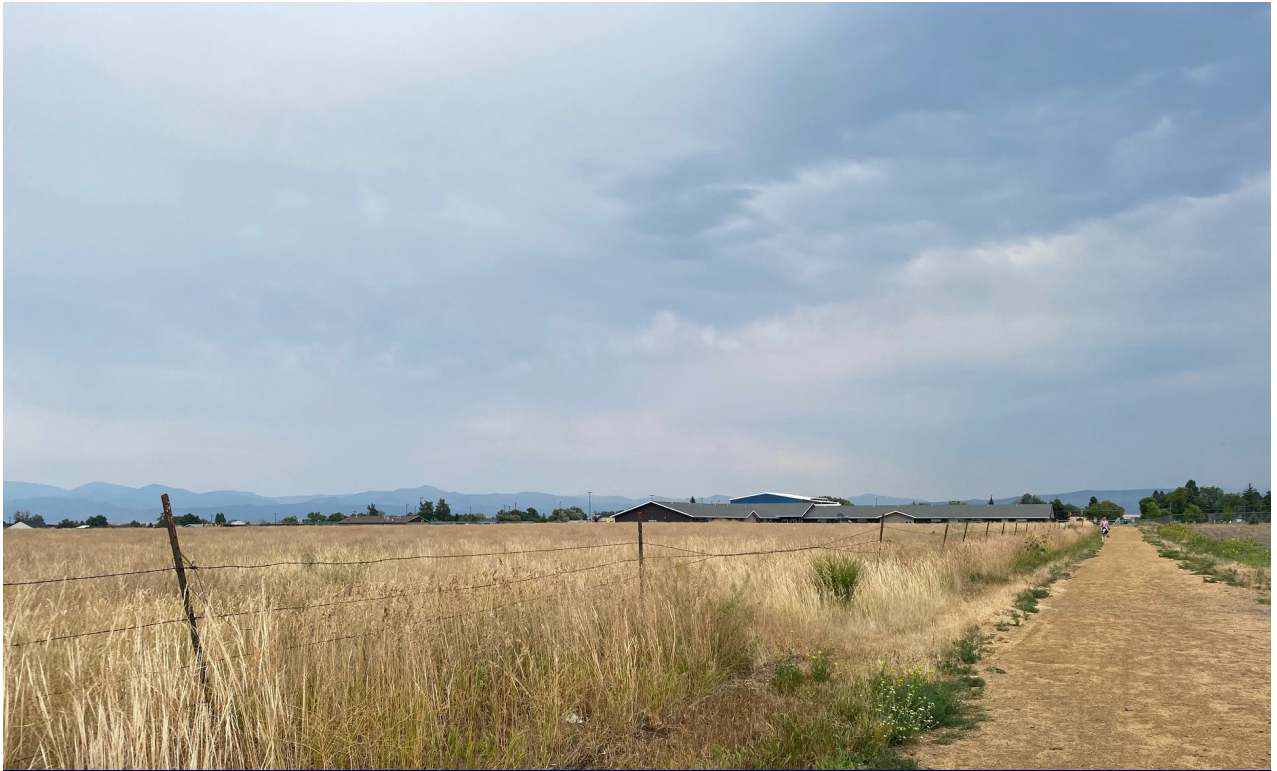
Site photographed from south edge on trail looking towards Prickly Pear Elementary to the east.

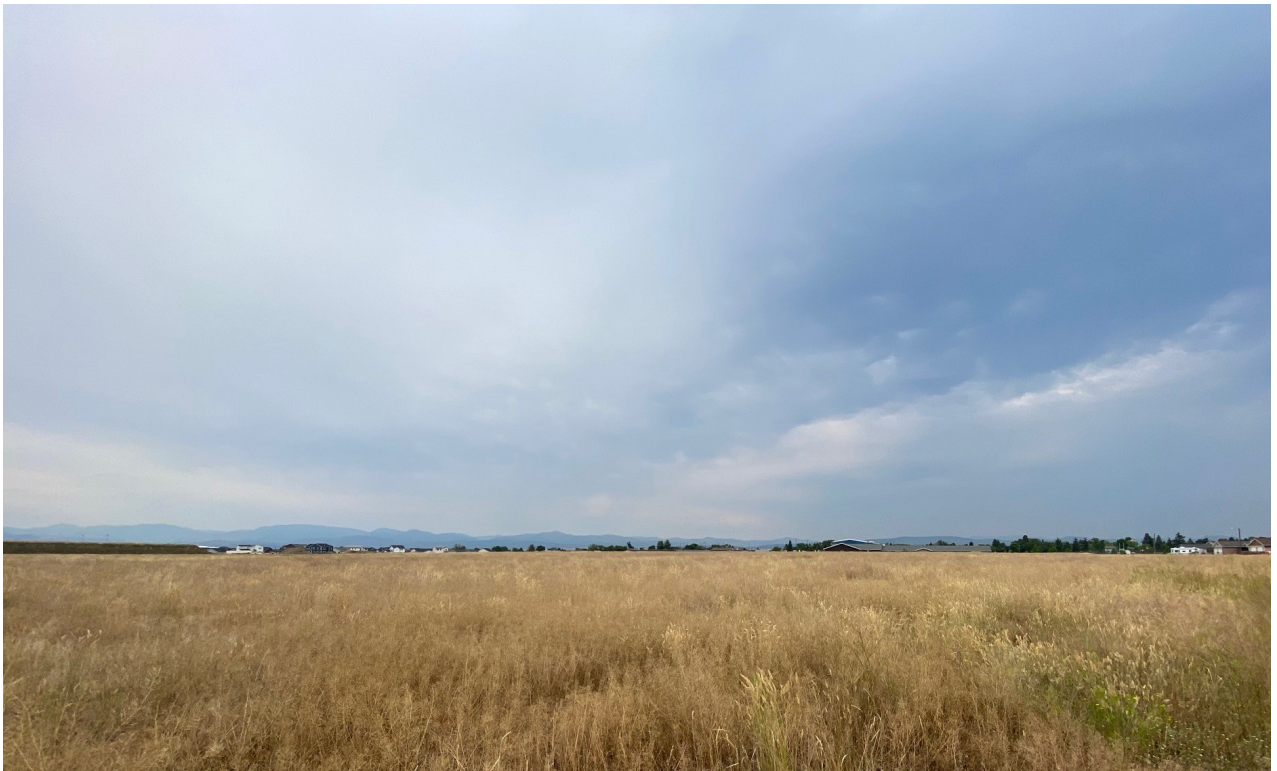
Site looking to the north.

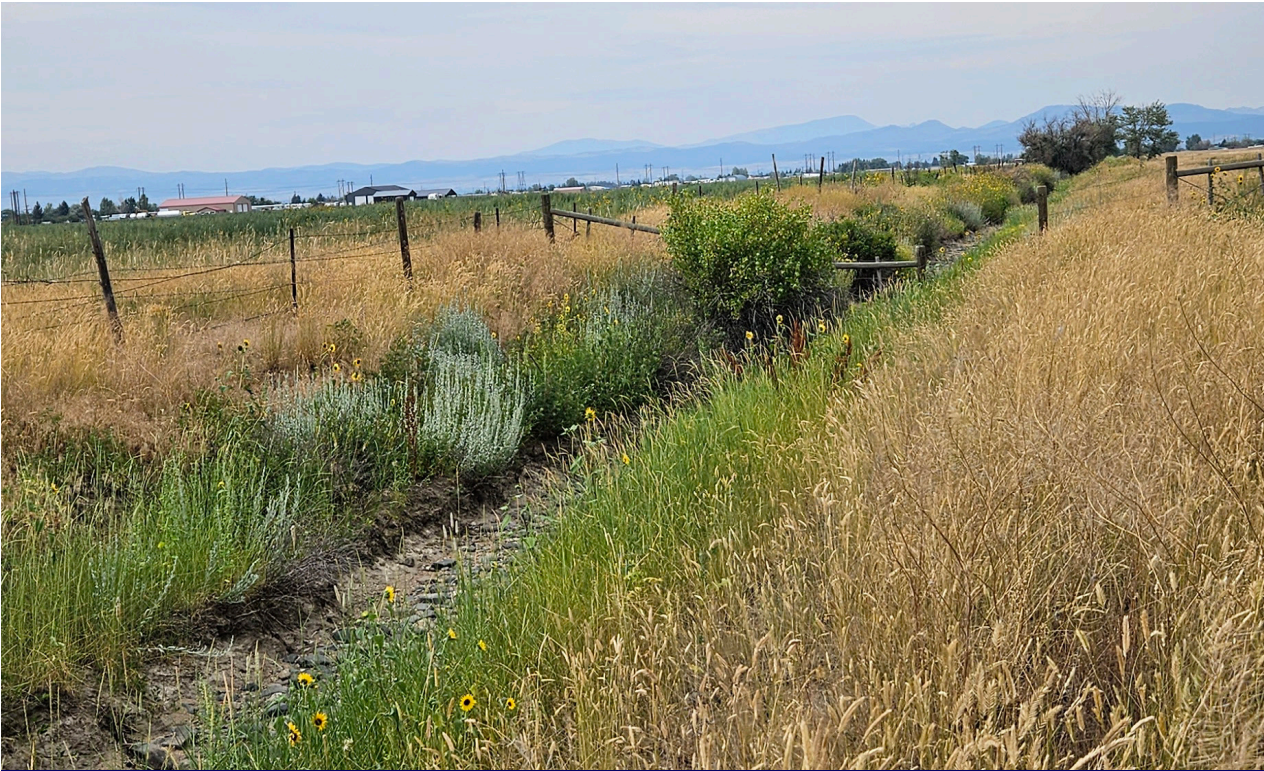
West edge of site next to irrigation canal.

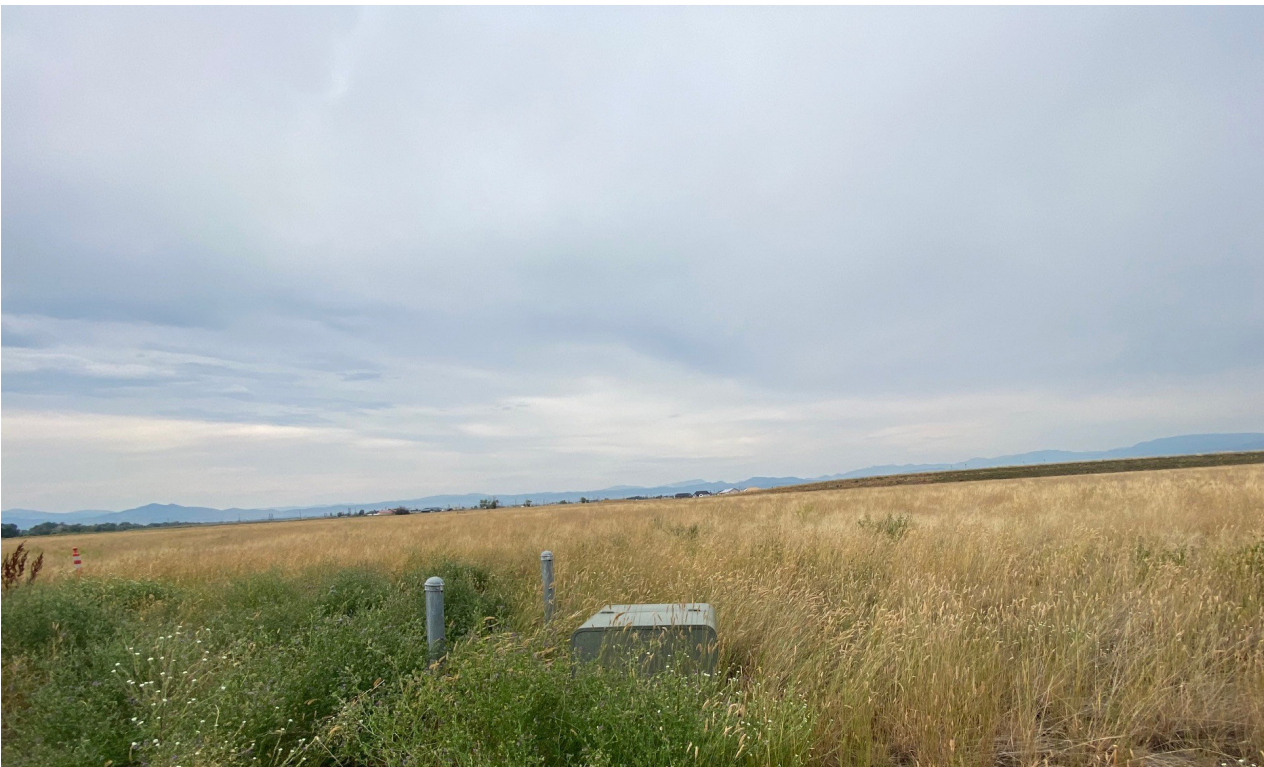
Central area of the site looking to north and east. Utilities are available.
