**LAKE OSWEGO
SCHOOL DISTRICT**

**FACILITY CONDITION
ASSESSMENT**

OCTOBER 19, 2015

OH PLANNING + DESIGN, ARCHITECTURE

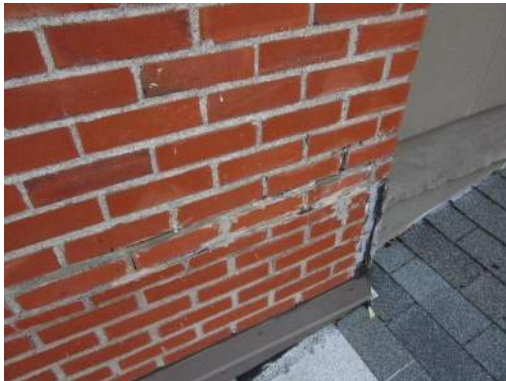
Brick Veneer Cracking

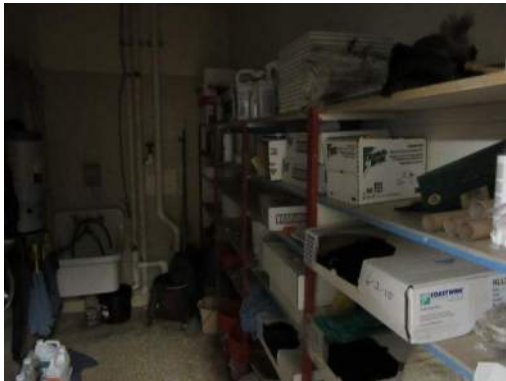
Fall Prone Contents

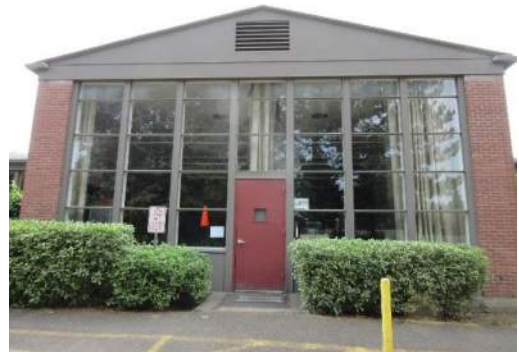
Lack of Lateral Support at Building End

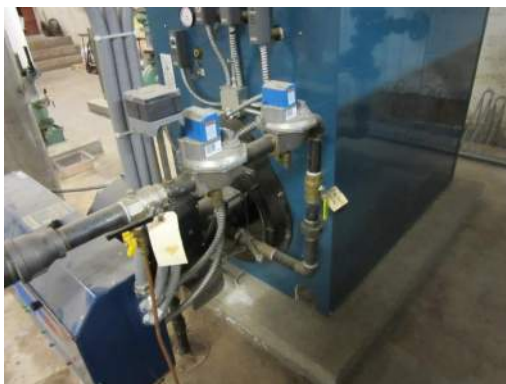
Hard Connected Gas Line

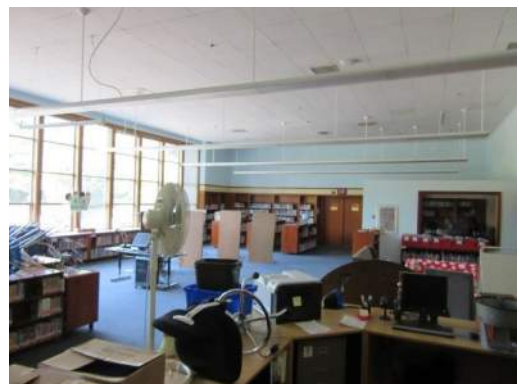
Pendant Supports

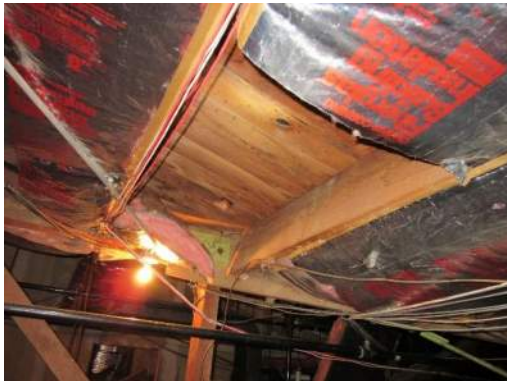
Plank Sheathing without Plywood

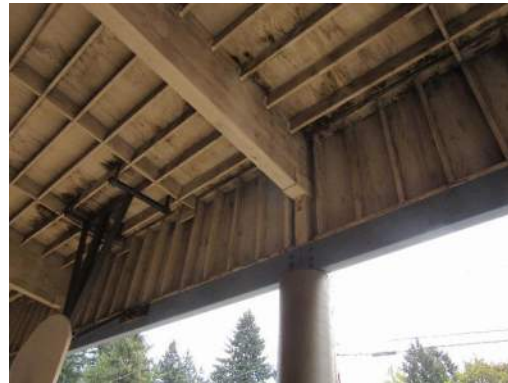
Seismically Deficient Play Canopy Adjacent to Gym

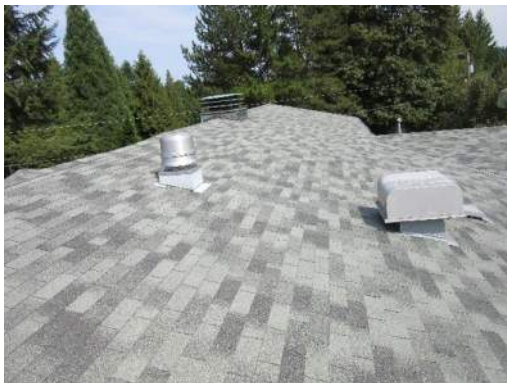
Roof Deflection at Building Joint

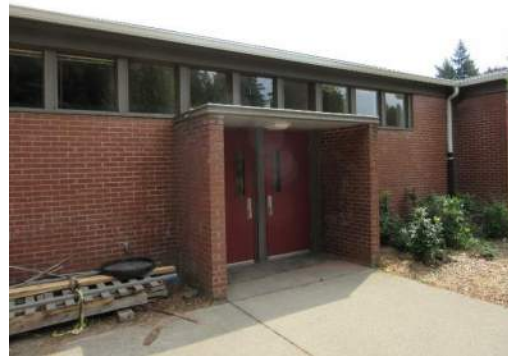
Seismically Deficient URM Side Entry with Roof

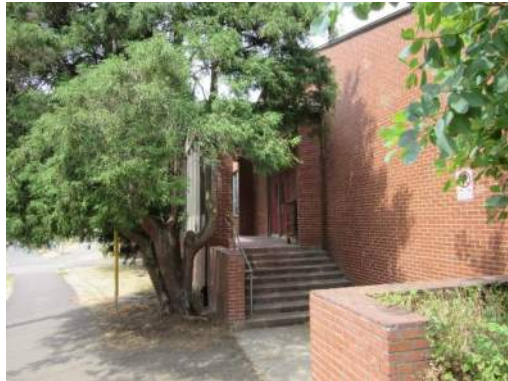
Seismically Deficient URM SW Entry

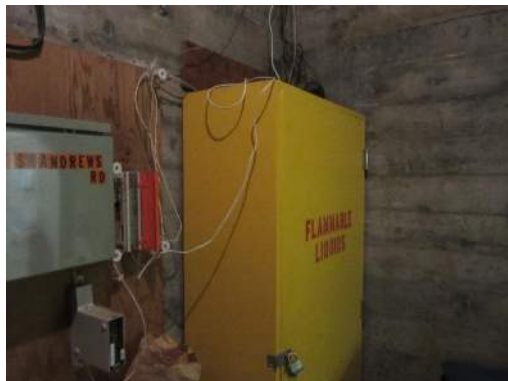
Unrestrained Flammable Cabinet

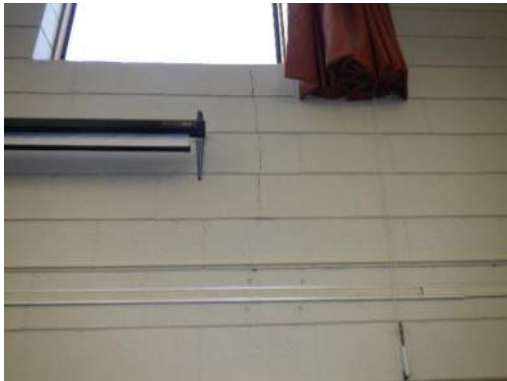
Crack in Masonry Wall

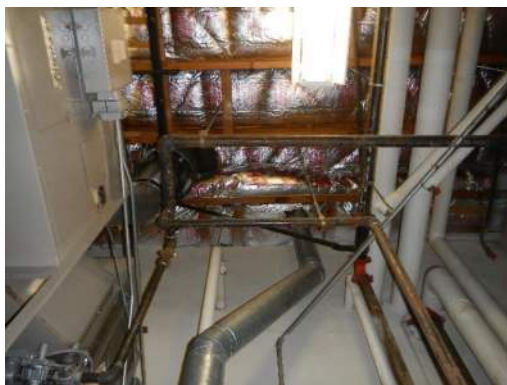
Unbraced Pipes

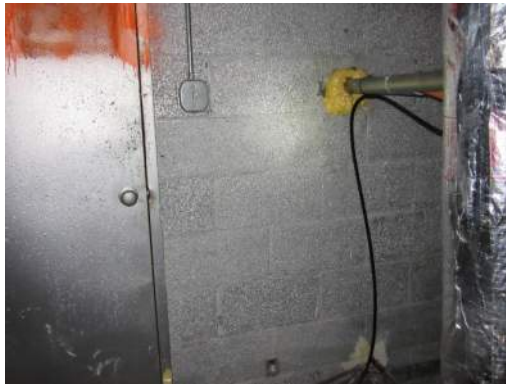
CMU Wall without Seismic Restraints

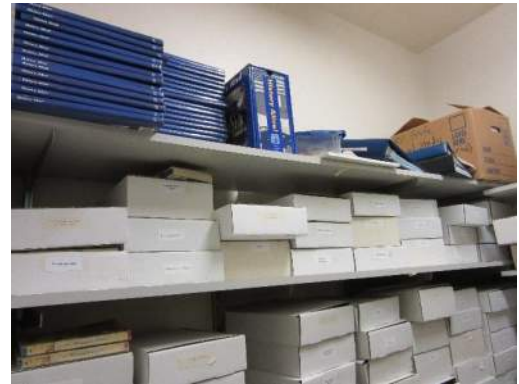
Fall Prone Contents

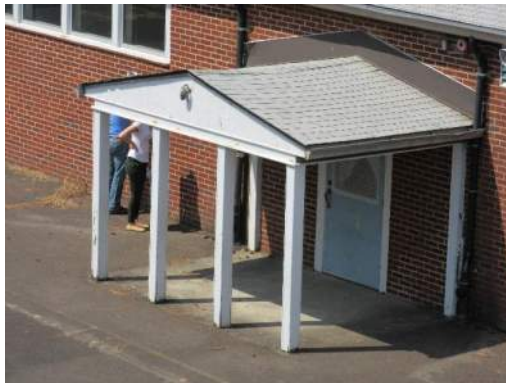
Deflecting Side Entry Canopy

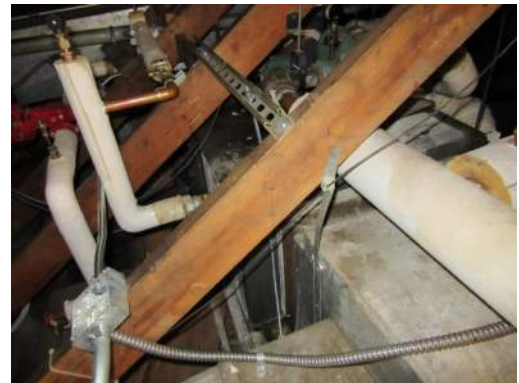
Hard Connected Gas Line & Fall Prone
Equipment

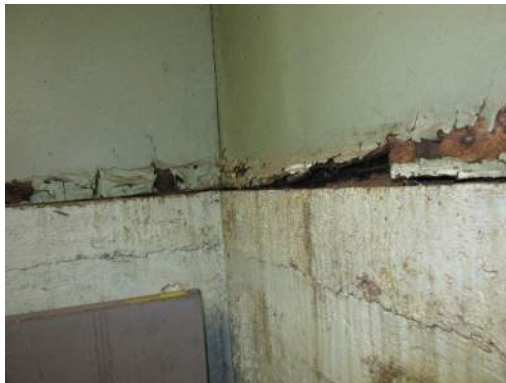
Deterioration at Base of Wall

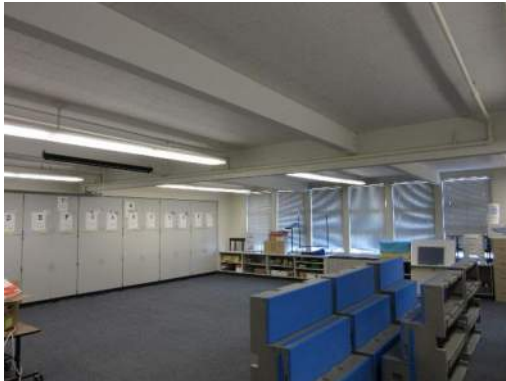
Pendant Supports

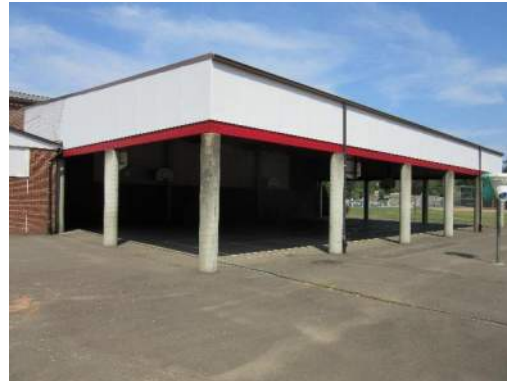
Seismically Deficient Play Canopy Adjacent

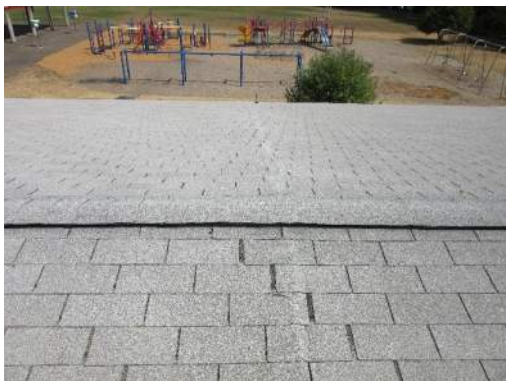
Roof Deflection at Building Joint

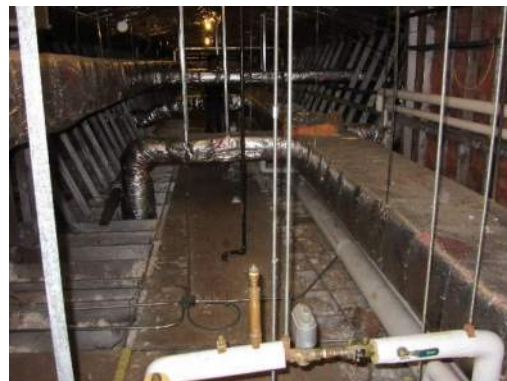
Suspended Equipment & Sprinkler Clearance

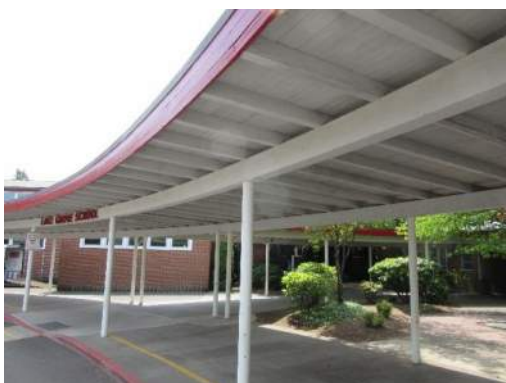
Seismically Deficient Entry Canopy

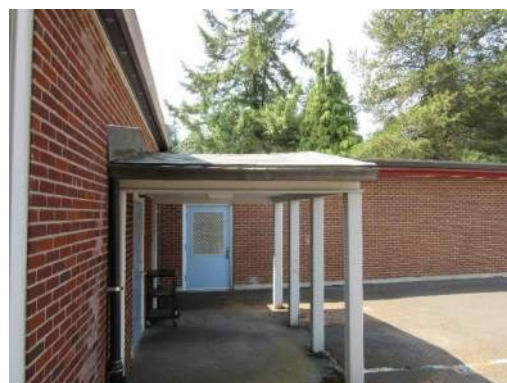
Unknown Lateral Connection Deflecting Side
Entry Canopy

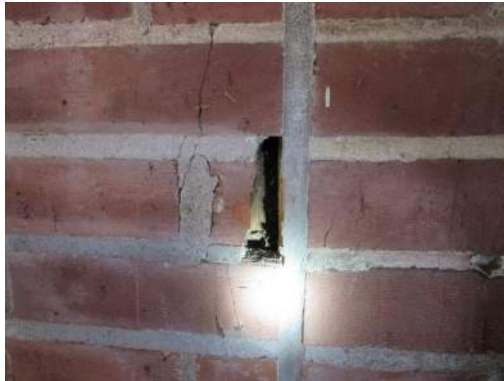
Unknown Sheathing Behind Veneer at Shear Wall

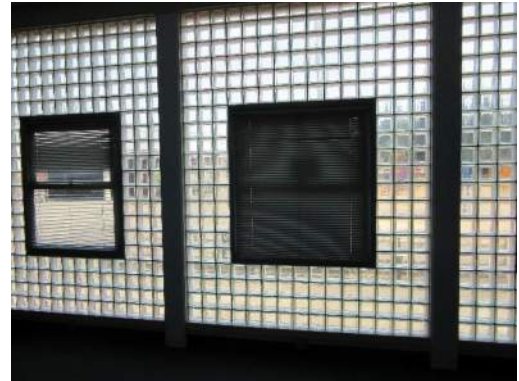
Unreinforced Glass Block Wall

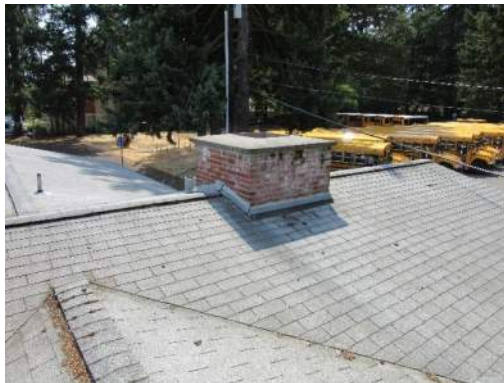
Unreinforced Brick Chimney

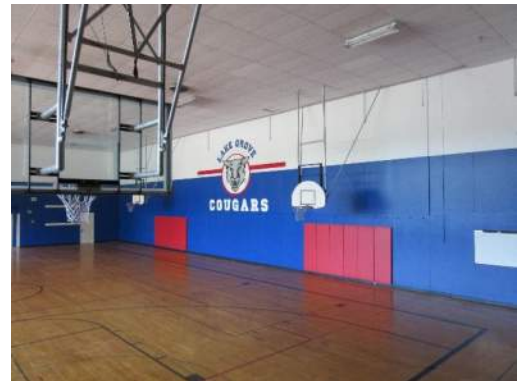
Unrestrained Gym Equipment

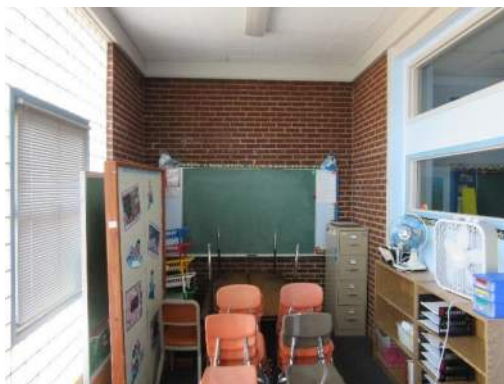
Unreinforced Brick Wall

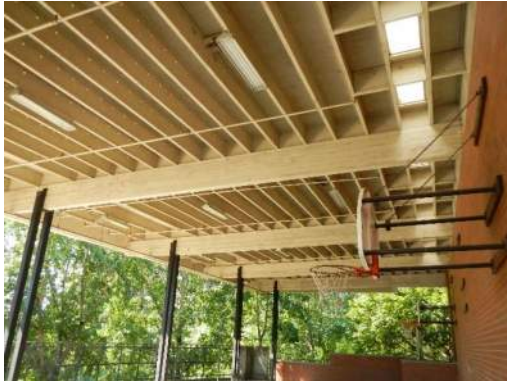
Canopy Connection to Building

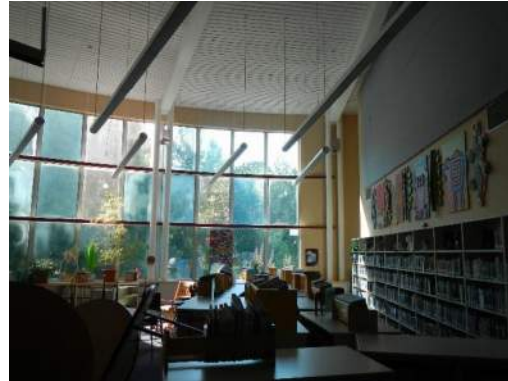
Pendulum Lights

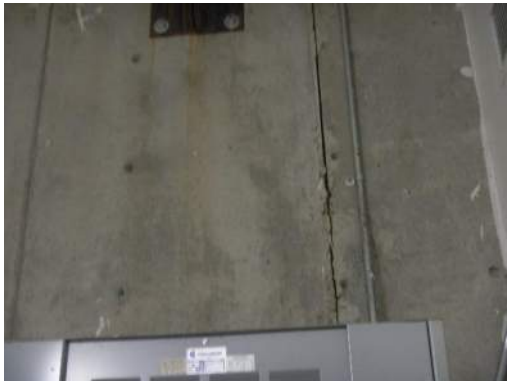
Cracks in Concrete Walls

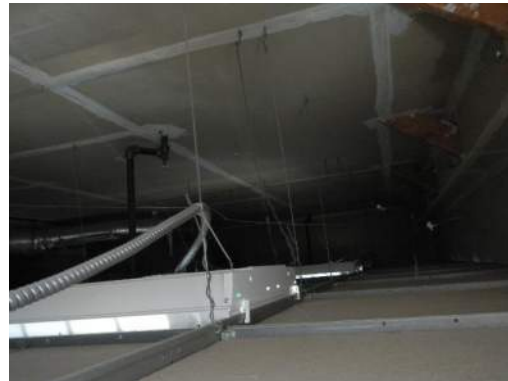
Unbraced Ceiling Tiles

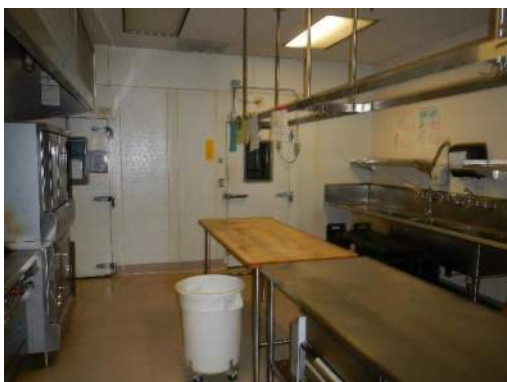
- Fall-prone contents – contents weighing more than 20 pounds whose center of mass is above four feet are not braced. (Lockers, file cabinets, etc...recommend bracing).
- Fall-prone equipment – Equipment weighing more than 20 pounds whose center of mass is above four feet is not braced.

Fall Prone Equipment

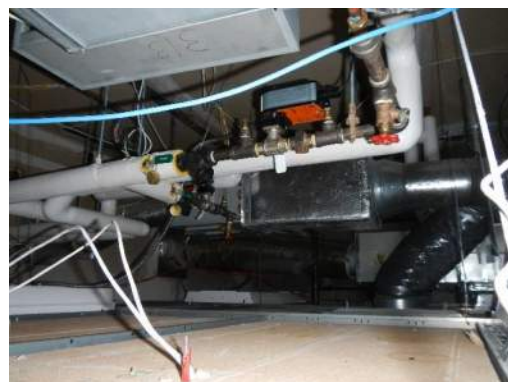
Unbraced Piping

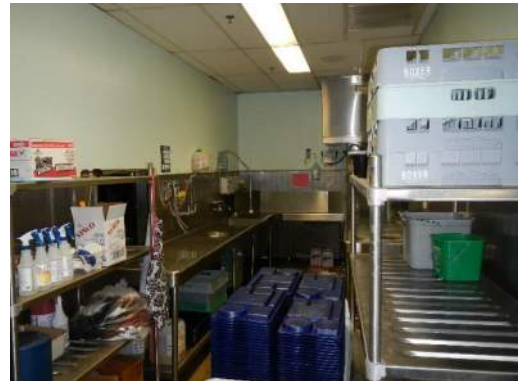
Kitchen – Fall Prone Contents

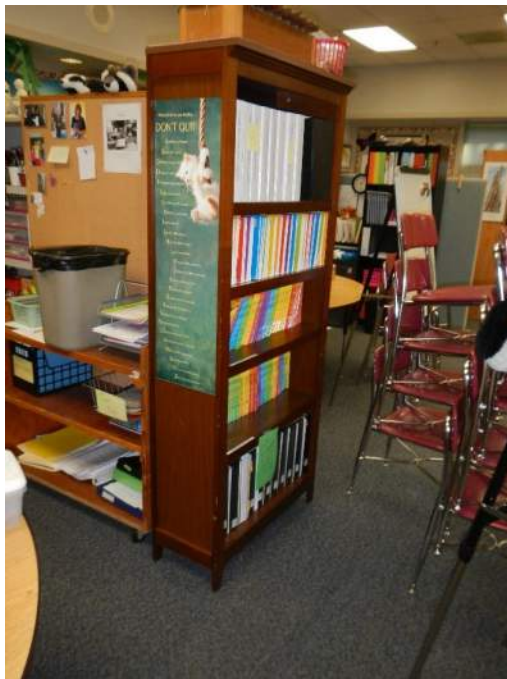
Fall Prone Shelving

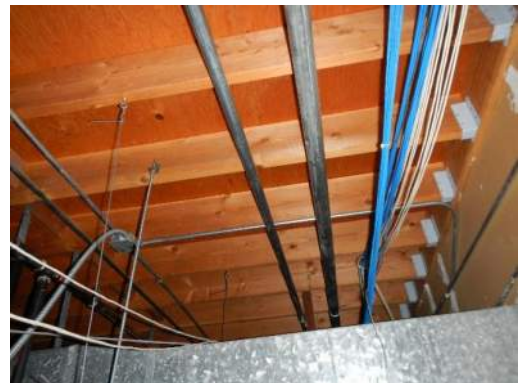
Unbraced Piping in Corridor

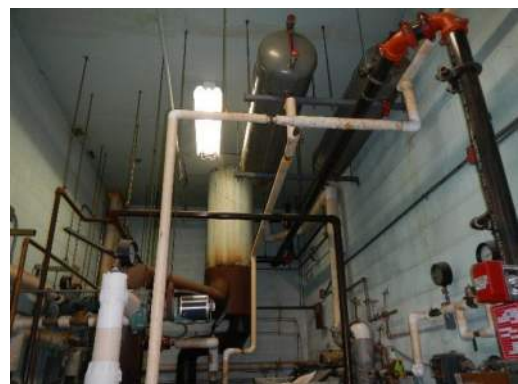
Unbraced Piping

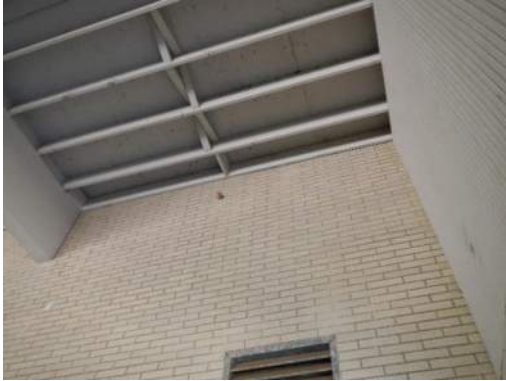
Unknown Diaphragm Connection

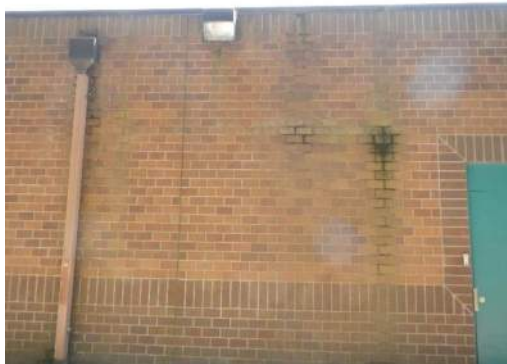
Brick Veneer Cracking

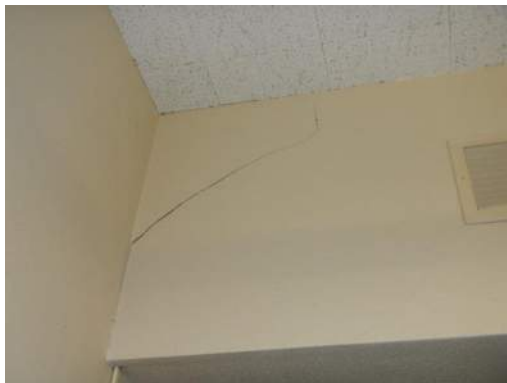
Cracked Finishes

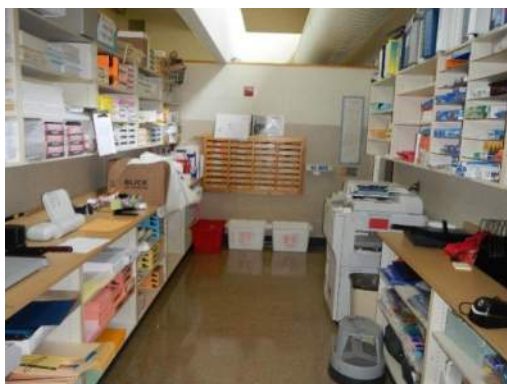
Fall Prone Contents

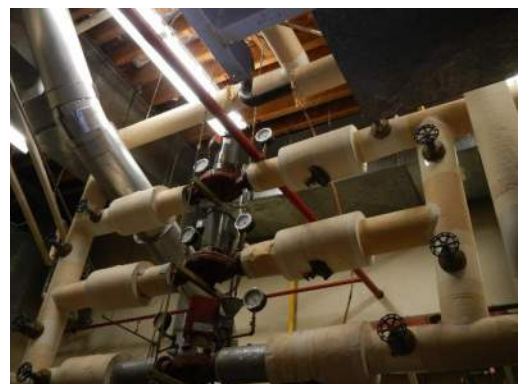
Unbraced Piping

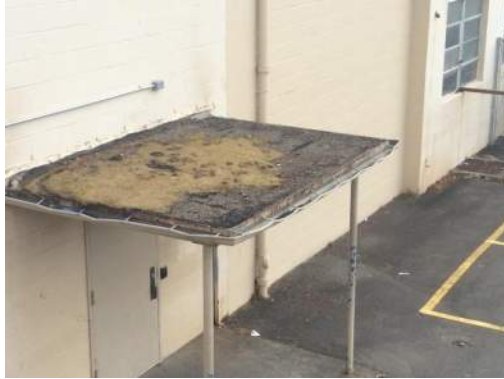
Canopy to be Removed

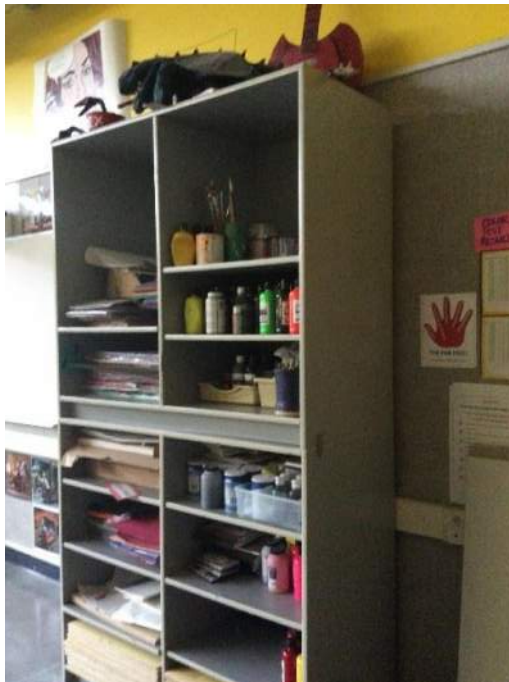
Fall Prone Contents

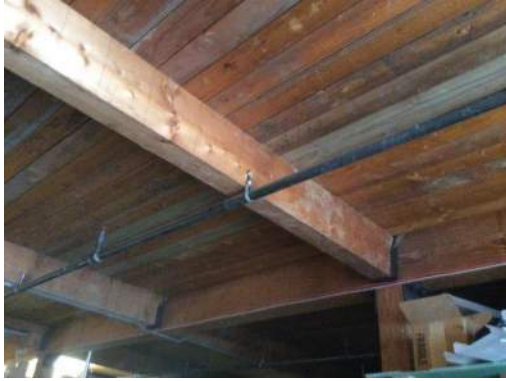
Remove Straight Sheathing

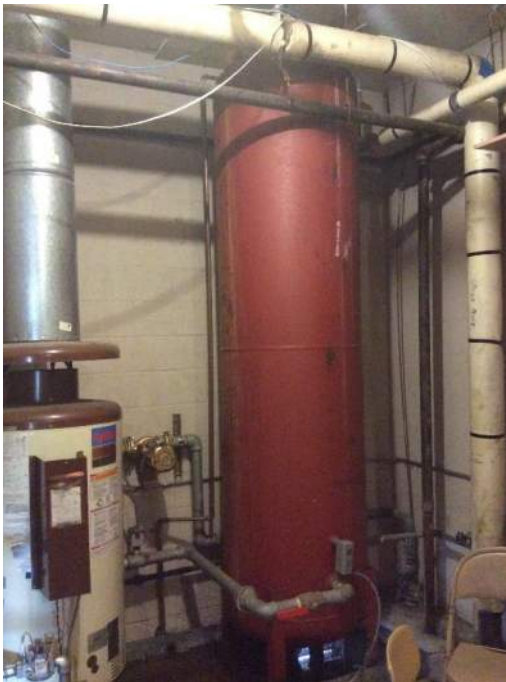
Tank to be Braced from Wall

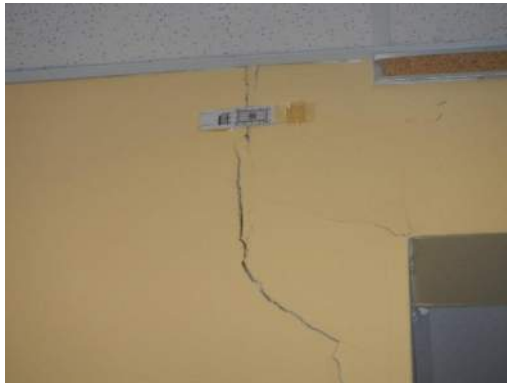
- The following applies to both the Lakeridge Jr. High building and the Bryant building: There are several cracks in the plaster and likely the masonry shear walls throughout the structure. There are also cracks in the exterior brick and brick veneer. The total crack length is approximately 200 to 250 feet throughout the structure. These are likely due to the expansive soils on site per discussions with facilities personnel and previous geotechnical and engineering reports. These cracks should be repaired. To prevent re-occurrence of cracking, foundations should be mitigated per the following:

Cracks in Masonry Walls

- Helical piles capable of resisting uplift loads should be installed at approximately 4.5 ft o.c. next to continuous footings. This equates to approximately 1500 piles. Each helical pile will likely be 20 feet long. Basis of estimate was the SS175 helical pier with 100 kips of uplift capacity (see below).

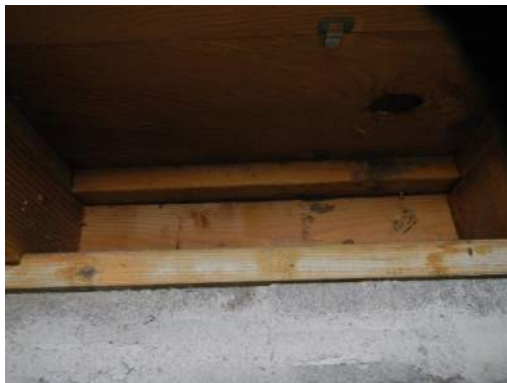
Inadequate Diaphragm to Wall Connection

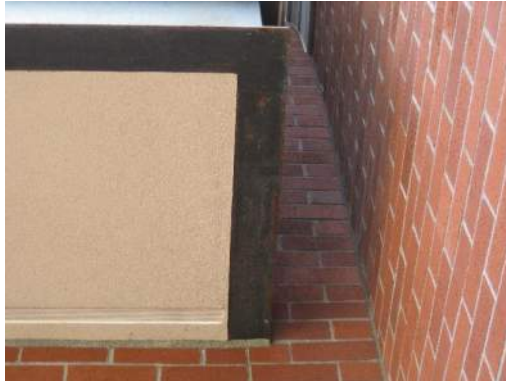
Rust on Pop-out Steel Framing

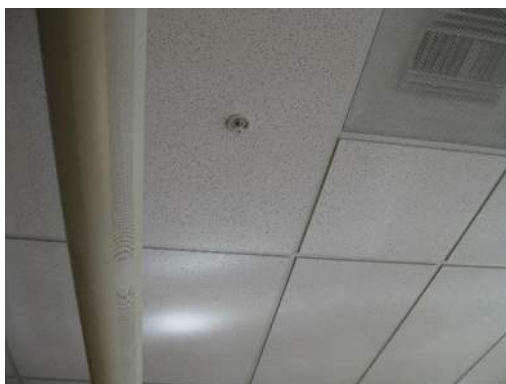
Sprinkler Head Clearance Deficient

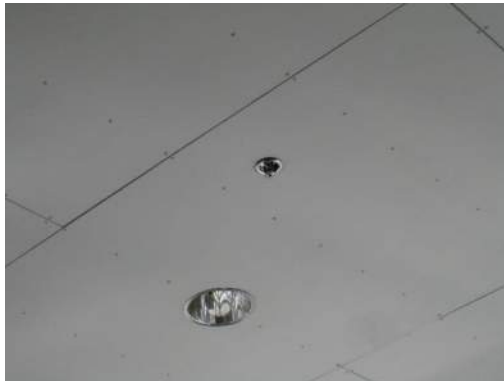
Sprinkler Head Clearance Not Adequate

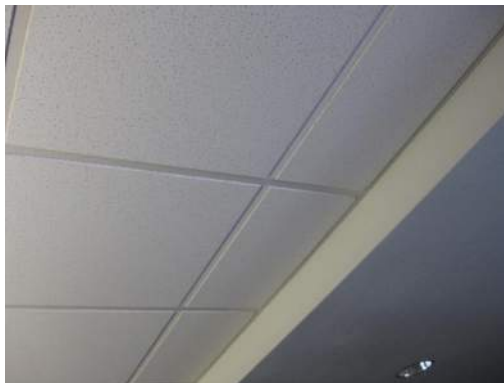
Ceiling Edge Clearance Deficient

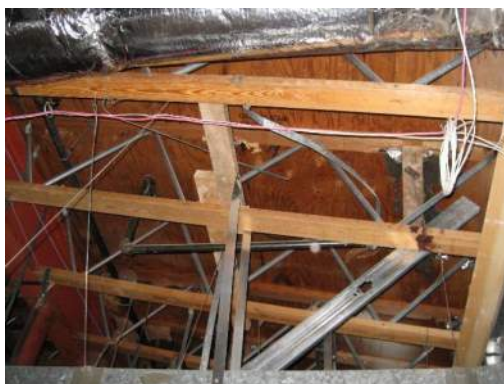
Unbraced Fire Suppression Piping

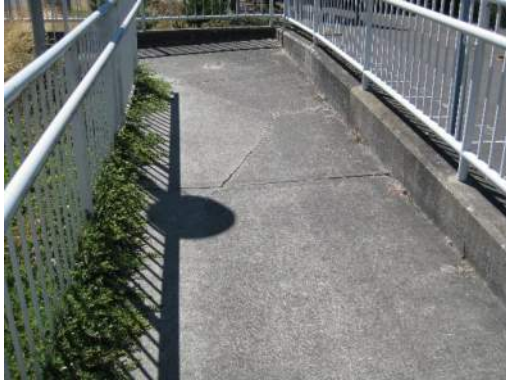
Cracking Ramp & Sidewalk

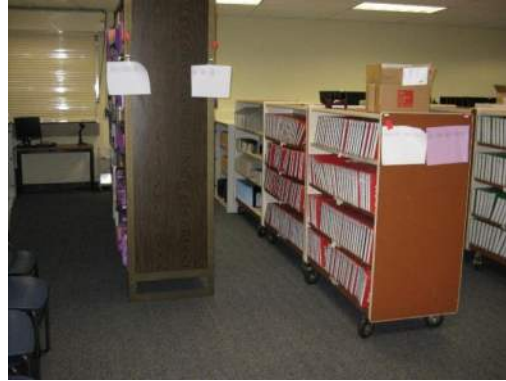
Unbraced Bookshelf

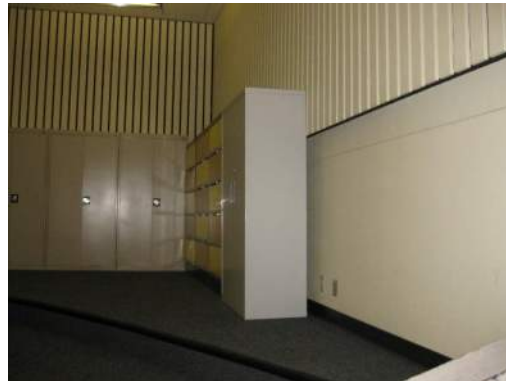
Unbraced Tall Cabinet – Falling Hazard

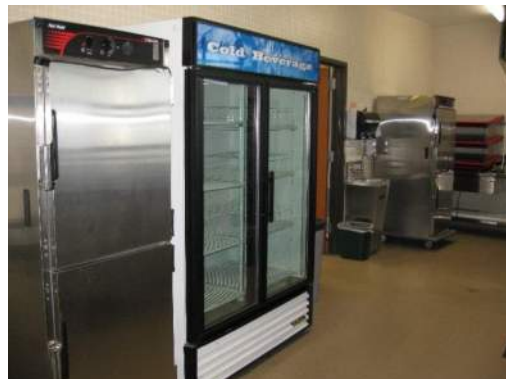
Unbraced Tall Refrigerator – Falling Hazard

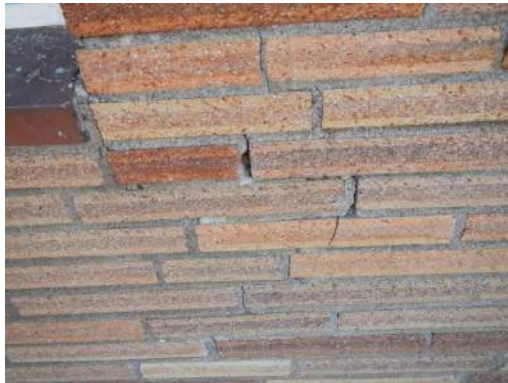
Cracking in Brick Veneer

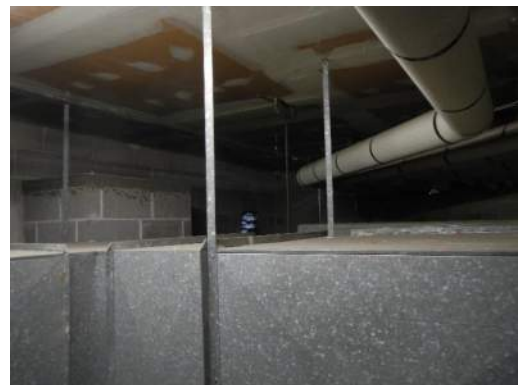
Unbraced Piping

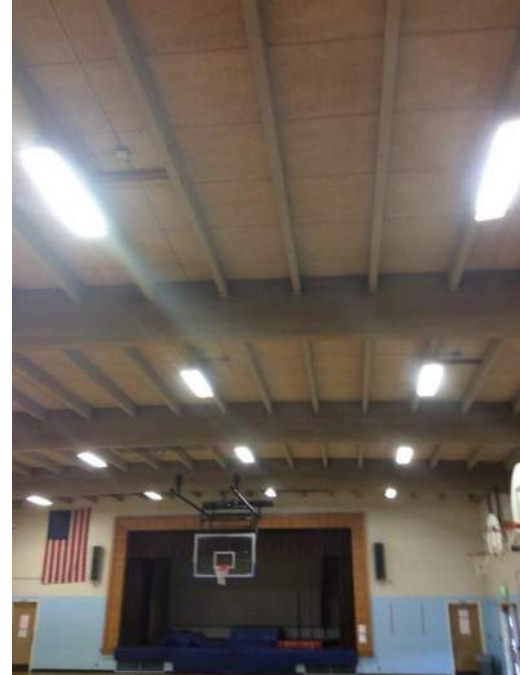
Tectum Panels in Gym

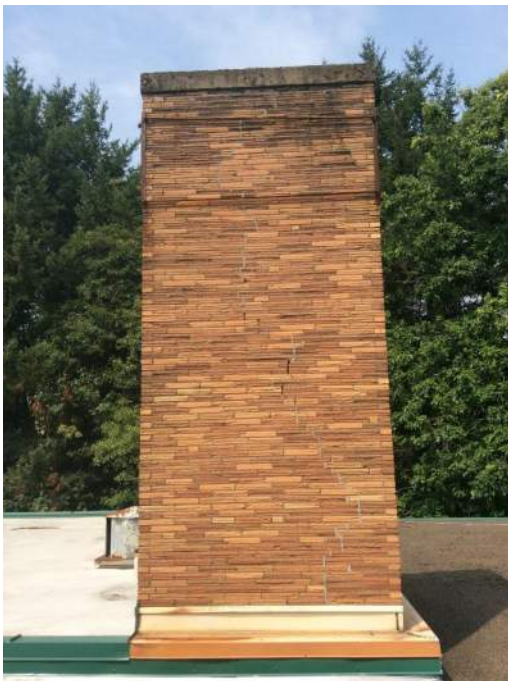
URM Chimney

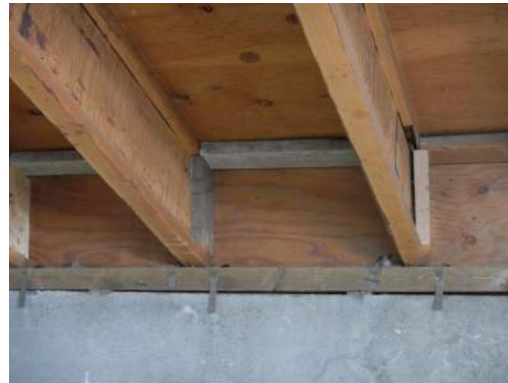
Inadequate Diaphragm Connection

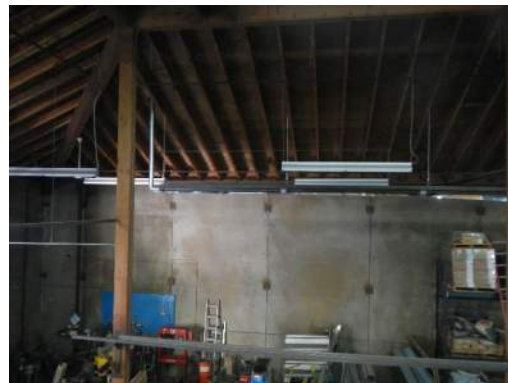
Pendulum Lighting

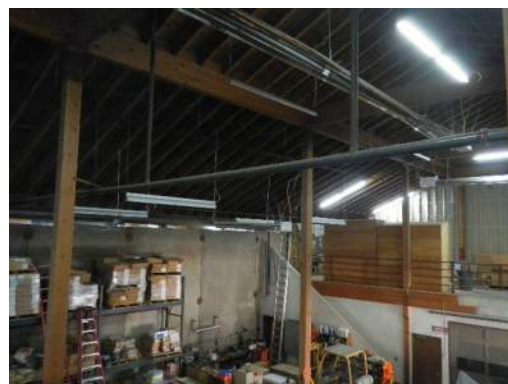
Unbraced Piping

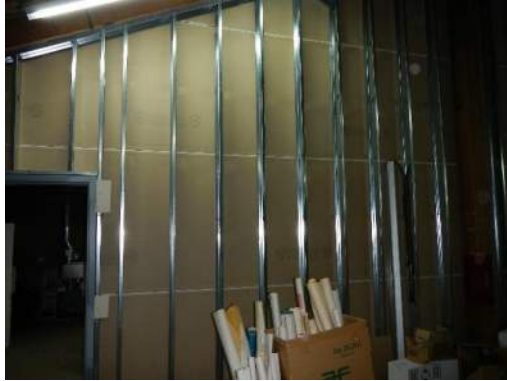
Wall Needs Blocking & Strapping

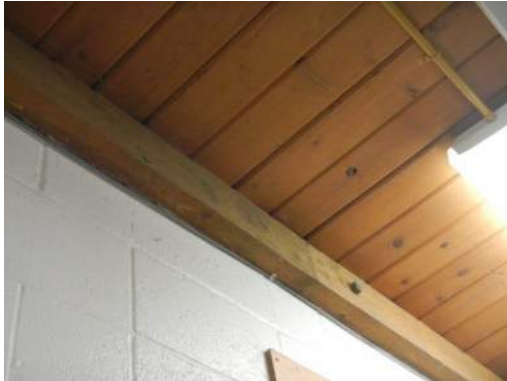
Inadequate Diaphragm Connection

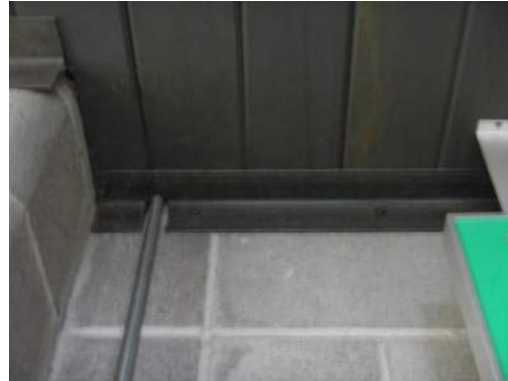
Missing Diaphragm Connection to Ledger

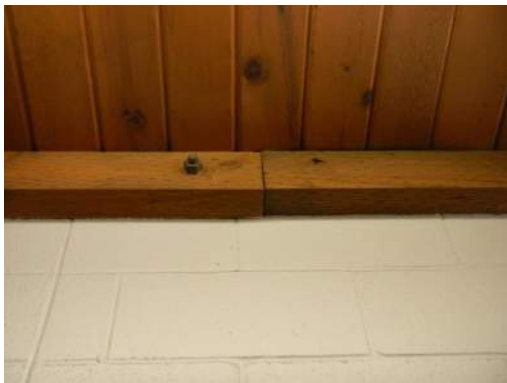
Missing Bolt in Ledger

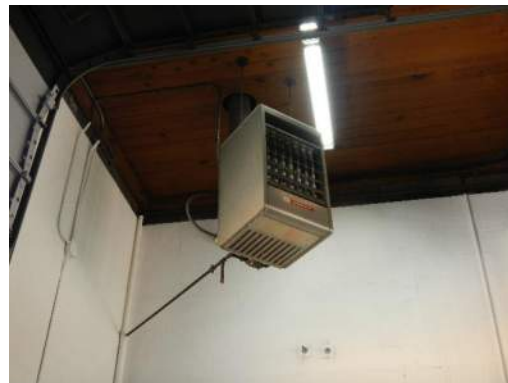
Unbraced Equipment

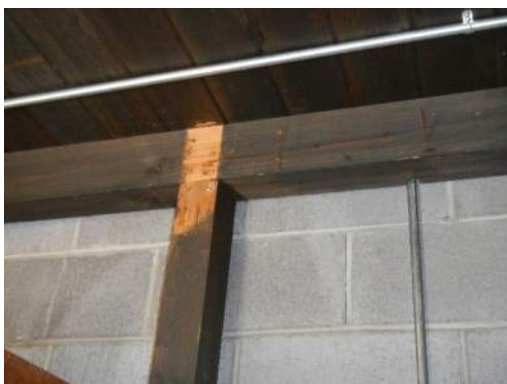
Missing Connection Hardware

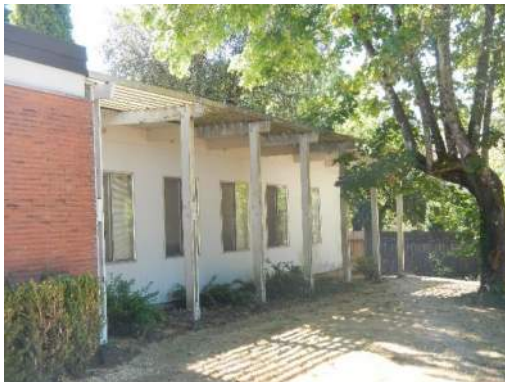
Deteriorated Trellis

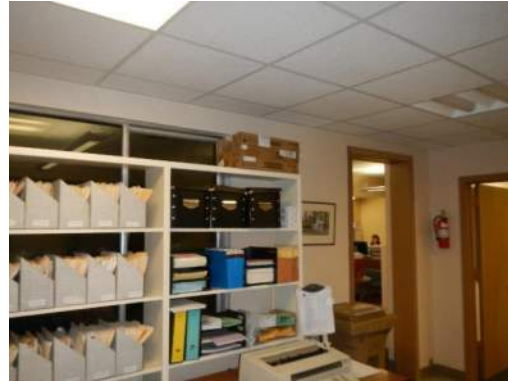
Fall Prone Contents

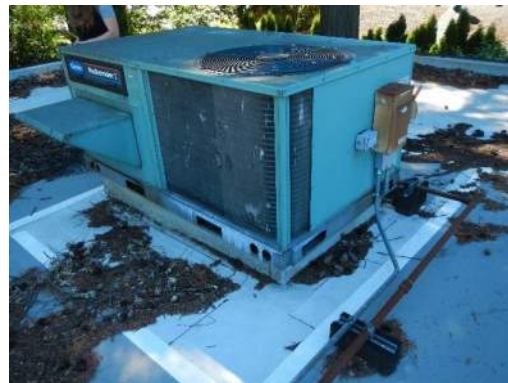
Inflexible MEP Connections

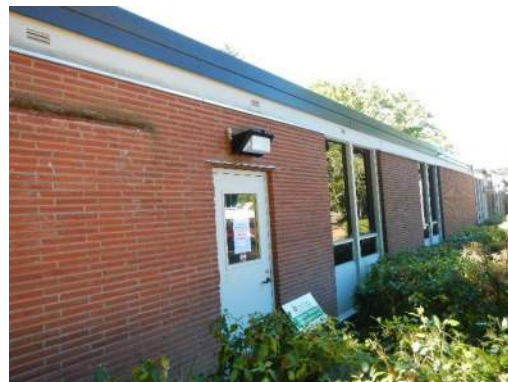
Possible Water Intrusion

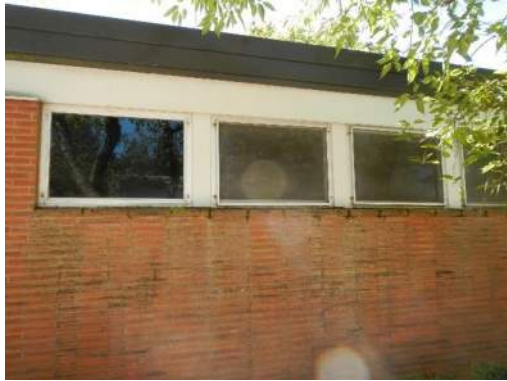
Water Damage in Brick Veneer

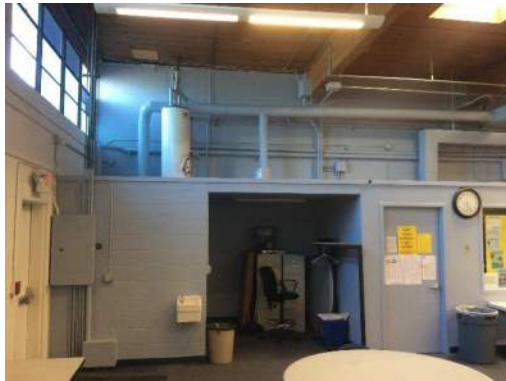
Fall Prone Equipment

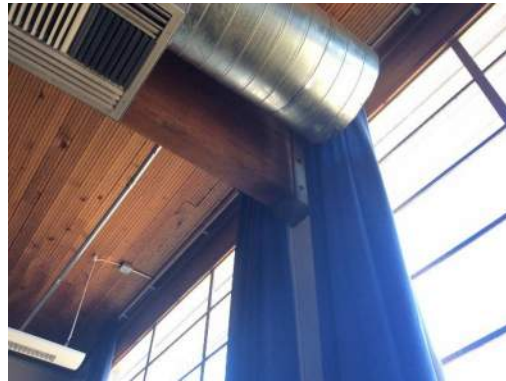
Lack of Seismic Connection & Beam Support

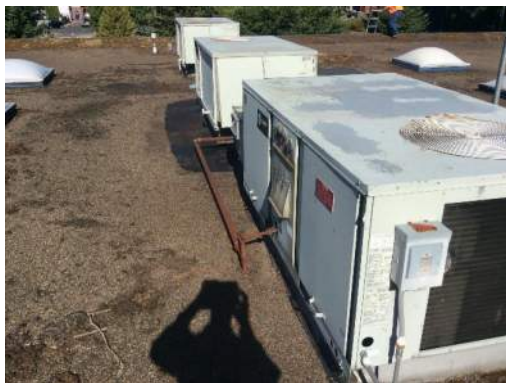
Hard Connected Gas Lines

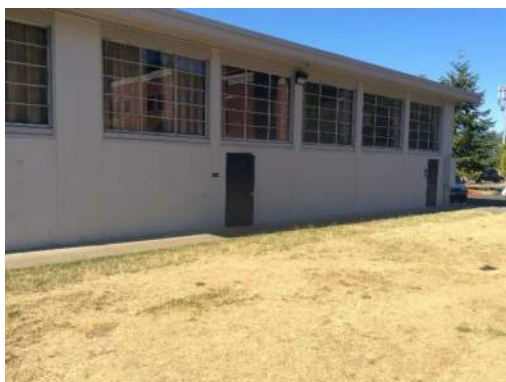
Lack of Lateral Support at Building End

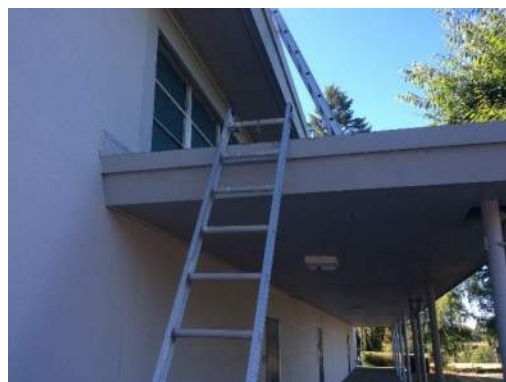
Unknown Canopy Connection

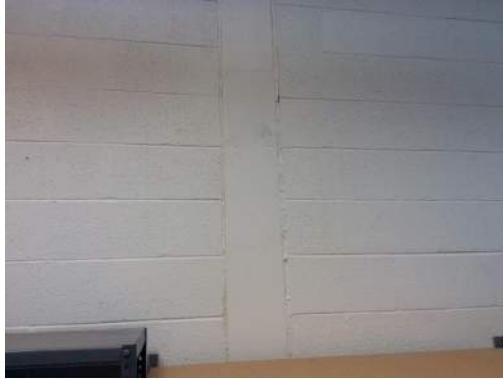
Unknown Reinforcement in Concrete Masonry
Wall

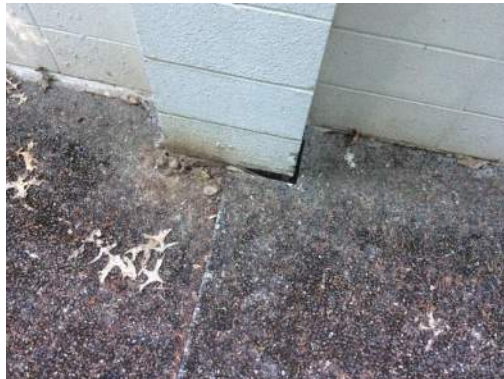
Column Undermined

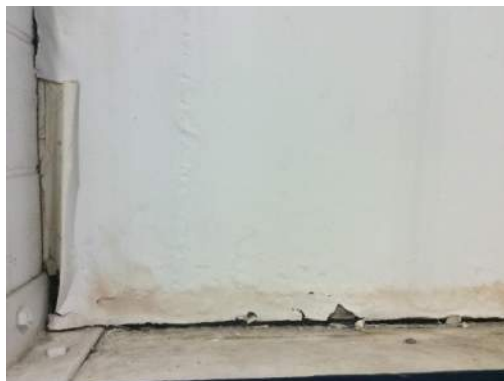
Deterioration of Wall Material

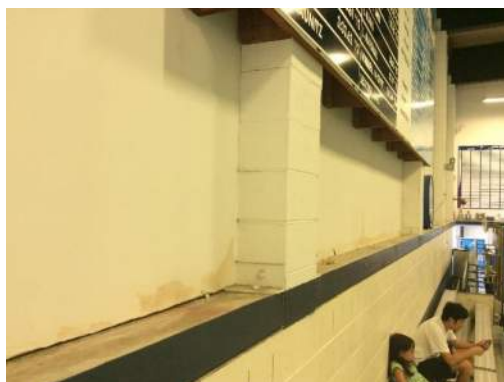
Discontinuous CMU Wall

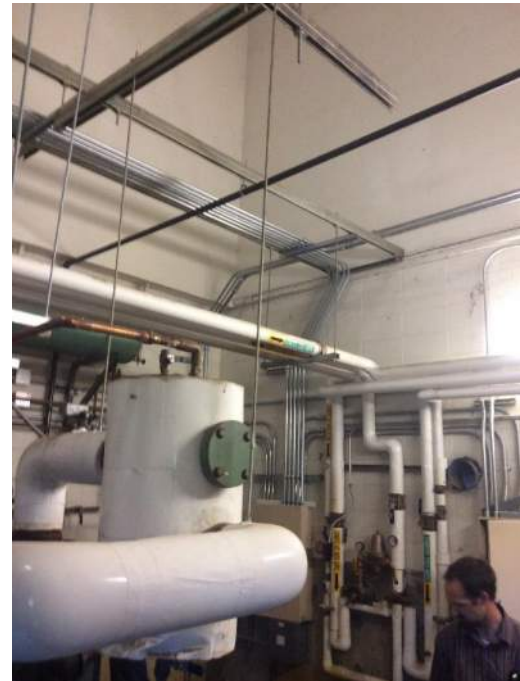
Fall Prone Equipment

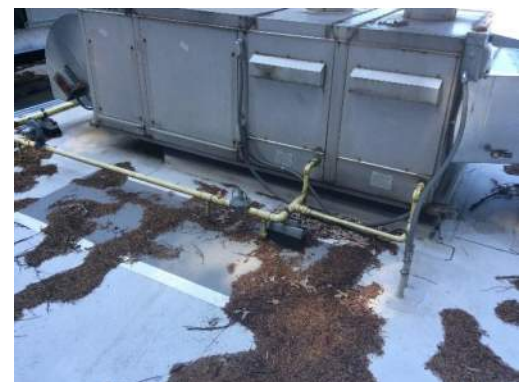
Hard Connected Gas Line

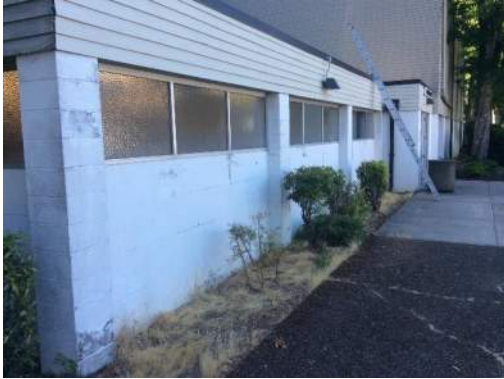
Lack of Lateral Support at Building Side

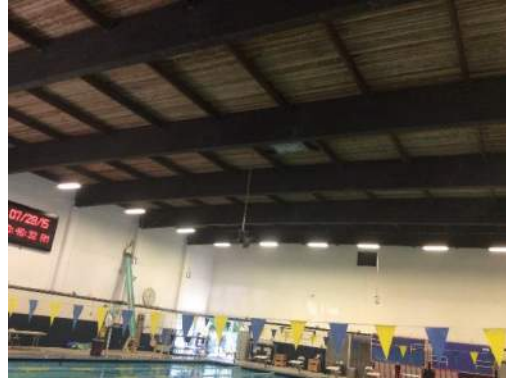
Roof Beam Connections to Columns

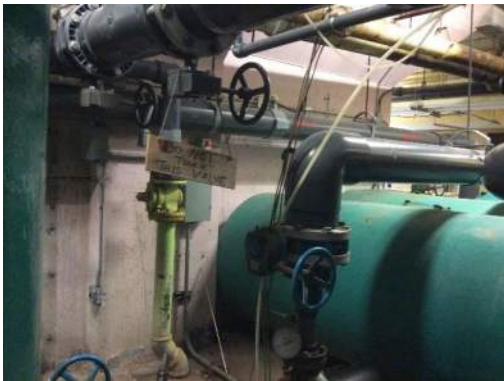
Piping Bracing

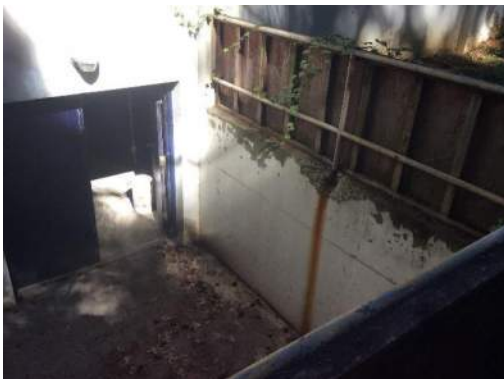
Railing Corrosion

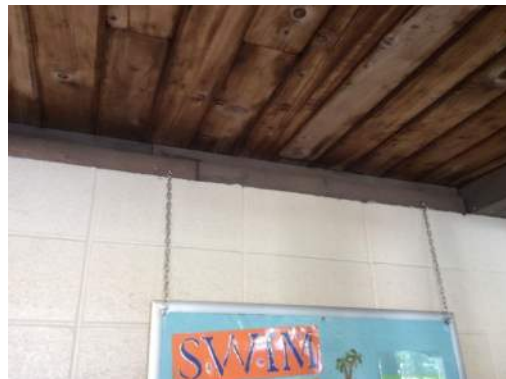
Unknown Wood Degradation & Diaphragm
Connection

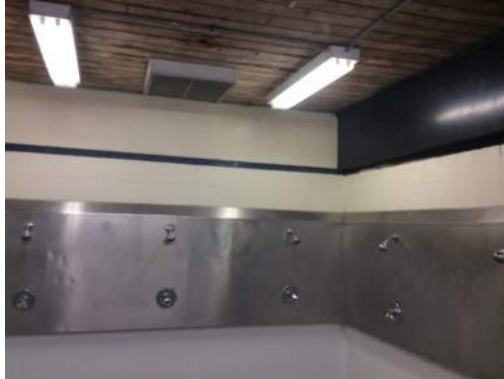
Unknown Out-of-Plane Support for CMU Wall

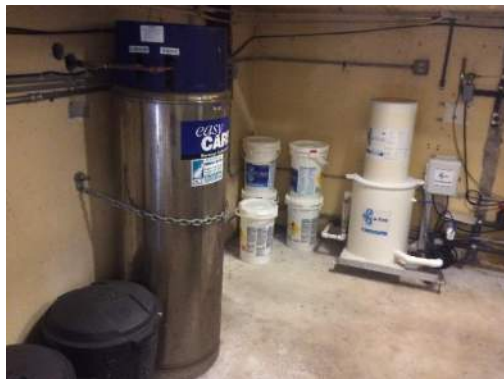
Unrestrained Hazardous Chemicals

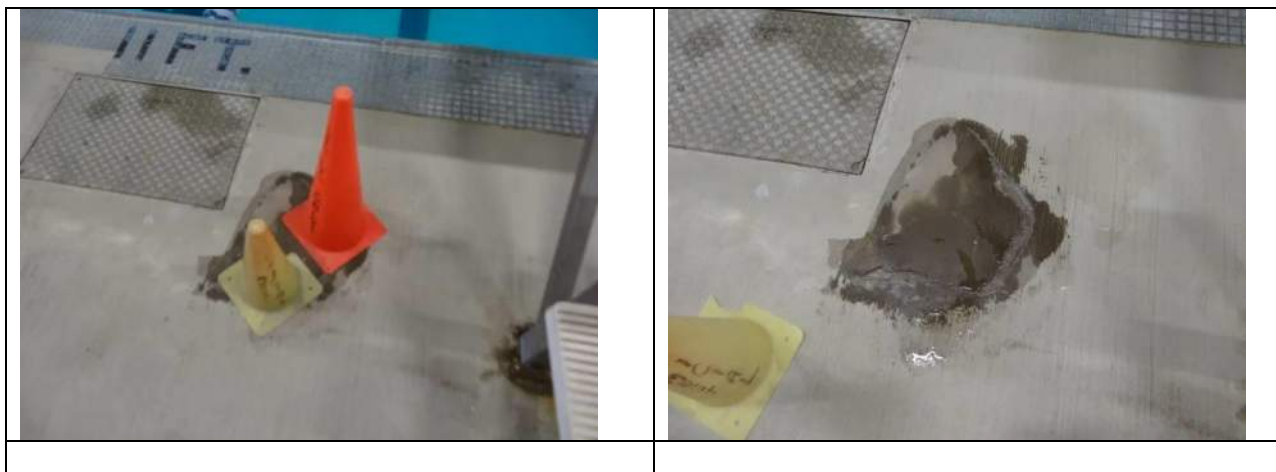
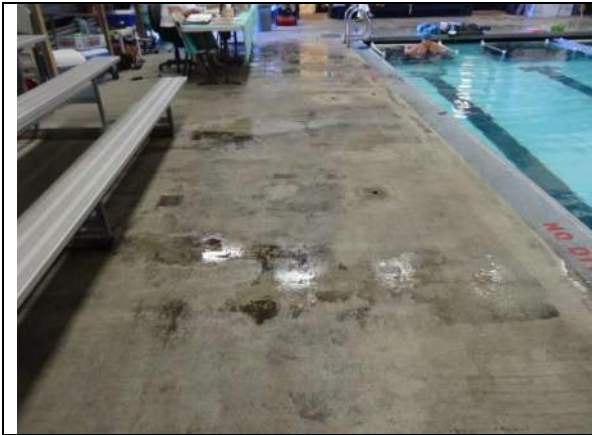
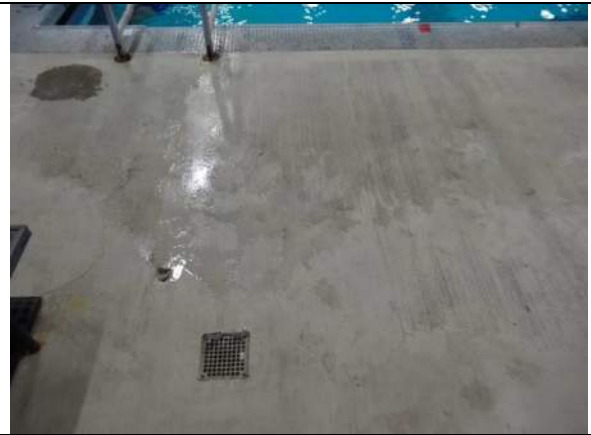
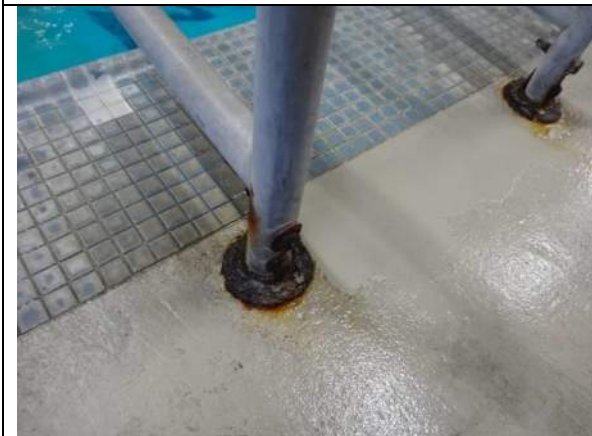
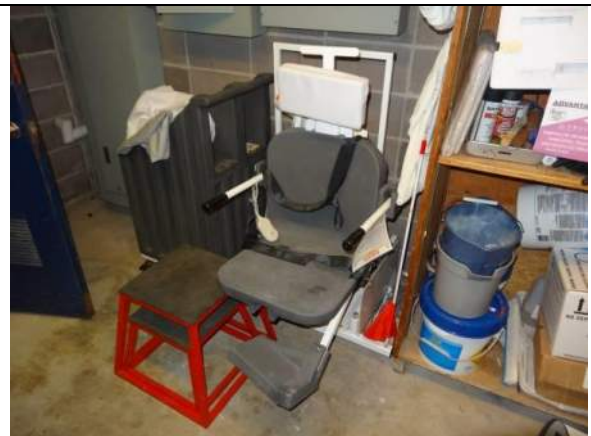
2.2 Site Photographs

8	The pool was open for lap swimming and lesson teaching at the time of observation. The starting blocks were observed to be uncovered and not blocked off.	Starting blocks should only be used for competitive swimming competition or practice by those trained to use them. The starting blocks should be covered to prevent accidents during non-competition programming.	Provide cone shaped plastic safety covers for all starting blocks when they are not in use.
Note: According to OAR 333-060-0020(5) certain exemptions are provided to pools built prior to March 1, 1979 provided that the exemption does not present a health or safety hazard. Exemptions do not apply to any alteration or replacement of affected component.
