**LAKE OSWEGO
SCHOOL DISTRICT**

**FACILITY CONDITION
ASSESSMENT**

OCTOBER 19, 2015

OH PLANNING + DESIGN, ARCHITECTURE

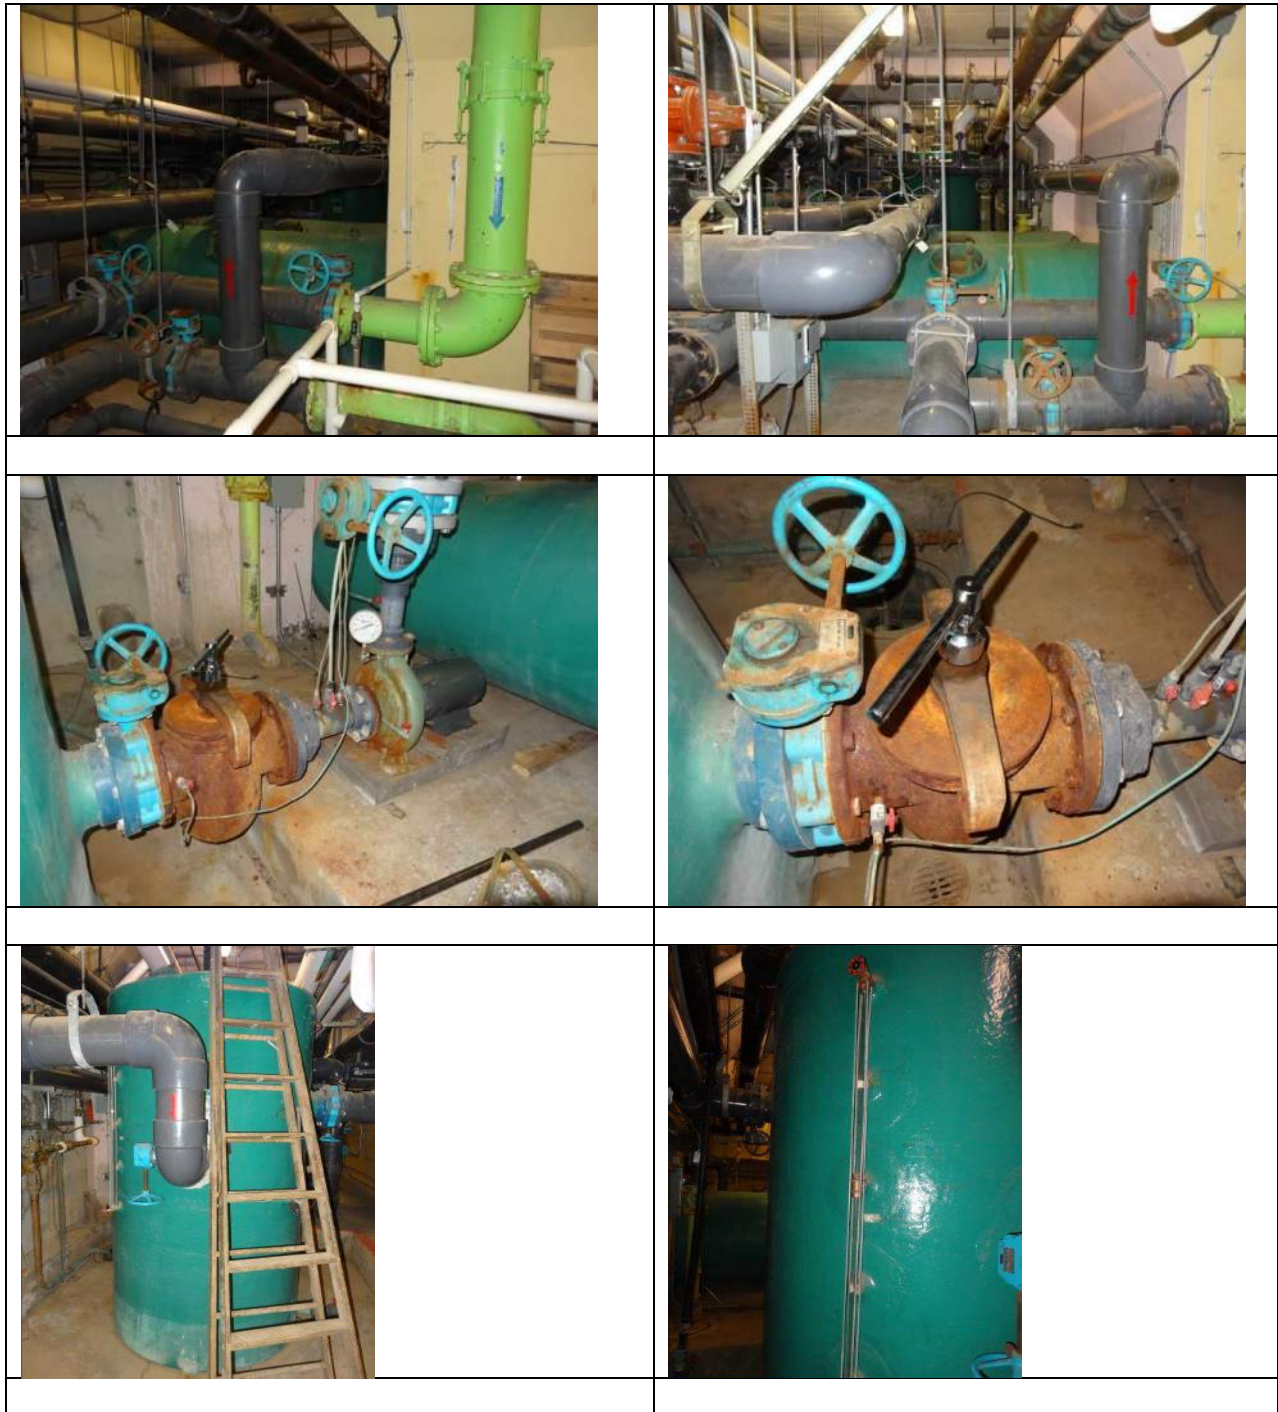
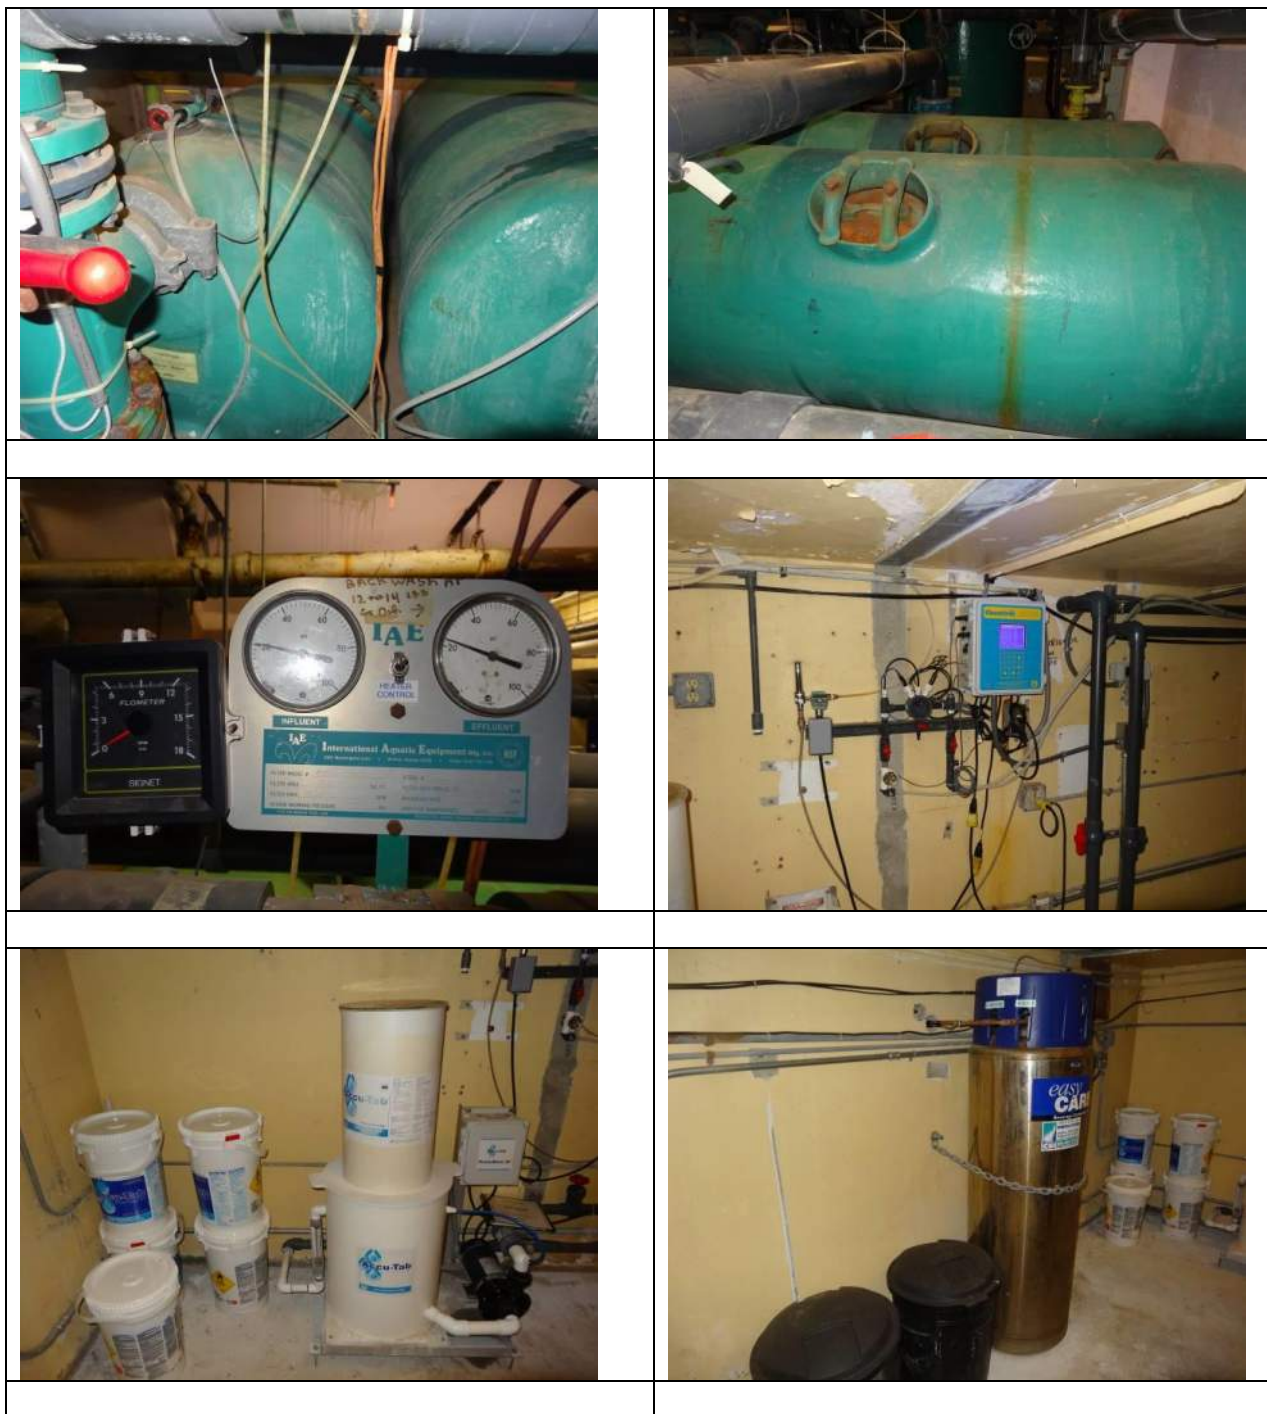
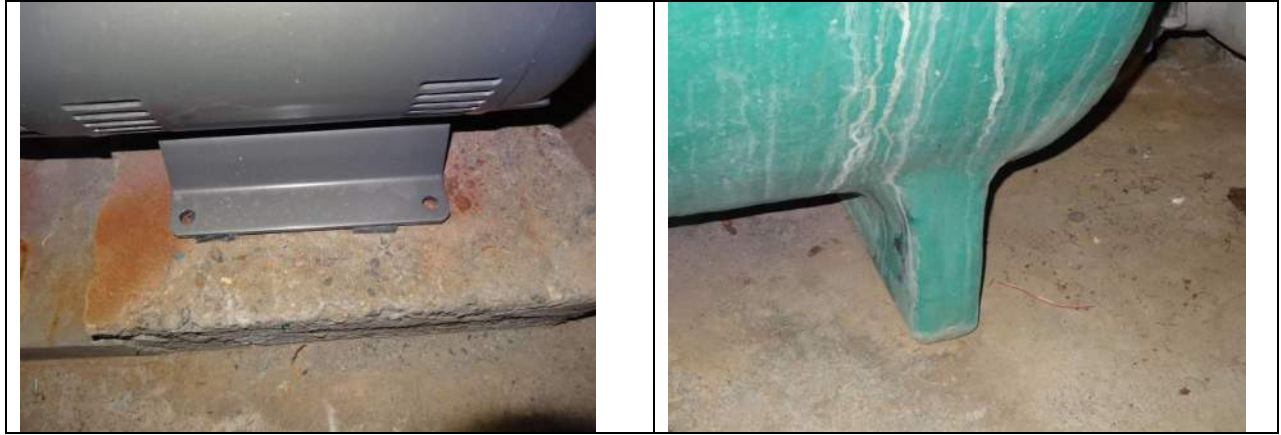
3.2 Site Photographs

12	Currently there is no way to monitor the pool water usage from the rest of the building.		Provide a water totalizer meter for the domestic fill water system for the pool with a digital readout.
13	The majority of the pool equipment was observed to not have proper housekeeping pads, anchorage, or maintenance access.	OAR 333-060-0160(1)(a) requires 3 FT of unobstructed access to all operational and maintenance portions of the equipment.	Provide housekeeping pads and proper anchorage for all pool equipment (e.g. pump, filters, etc.).
Note: According to OAR 333-060-0020(5) certain exemptions are provided to pools built prior to March 1, 1979 provided that the exemption does not present a health or safety hazard. Exemptions do not apply to any alteration or replacement of affected component.
