FACILITY CONDITION ASSESSMENT

Richmond Public Schools
301 North Ninth Street
Richmond, VA 23219

George W. Carver Elementary School
1110 West Leigh Street
Richmond, VA 23220

June 21, 2024

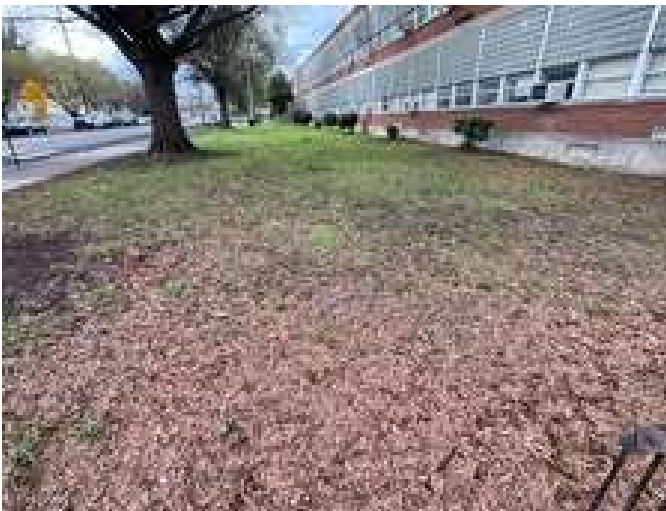
9 - LANDSCAPING

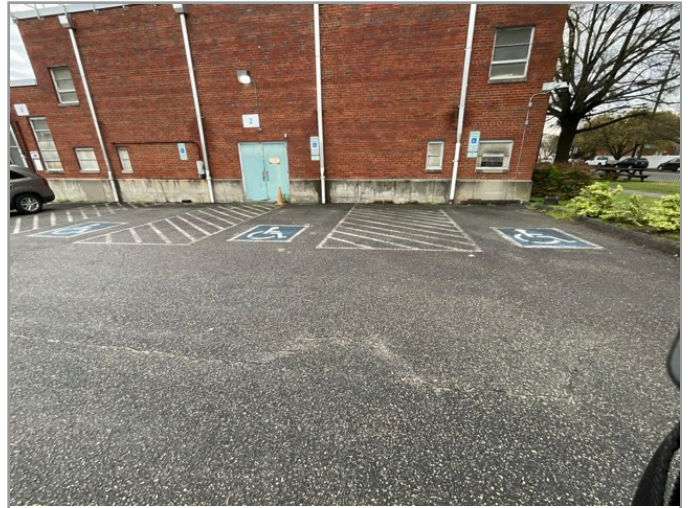
CLOSE-UP OF STALL

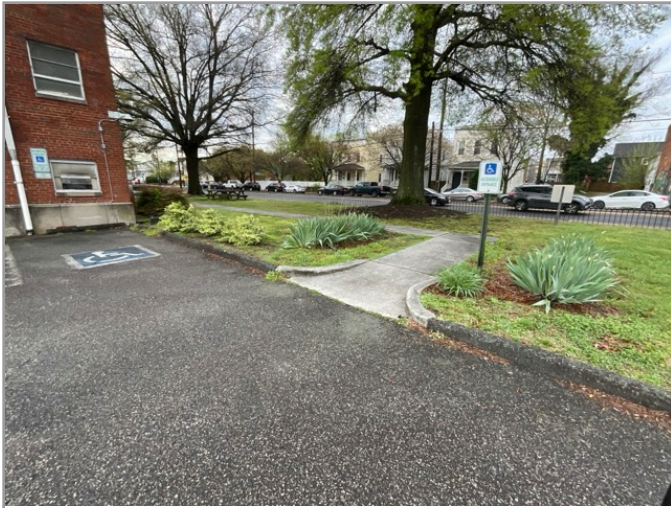
ACCESSIBLE PATH

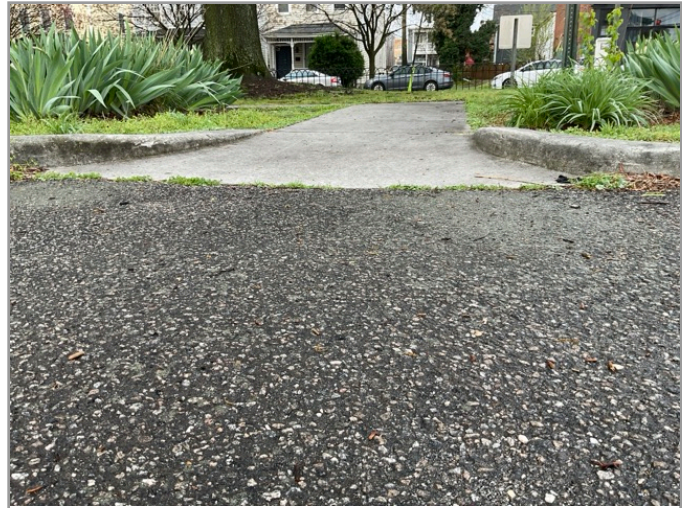
CURB CUT

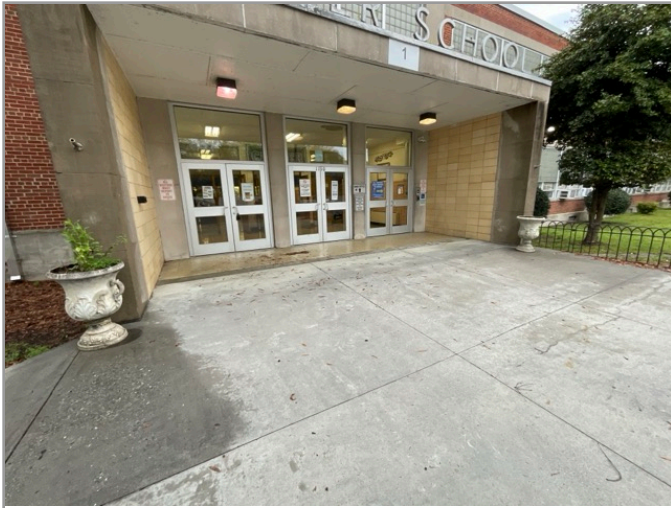
ACCESSIBLE ENTRANCE

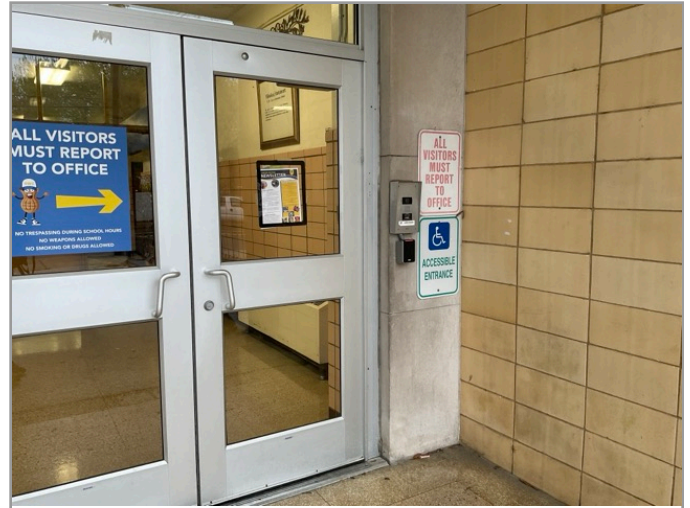
SIGNAGE

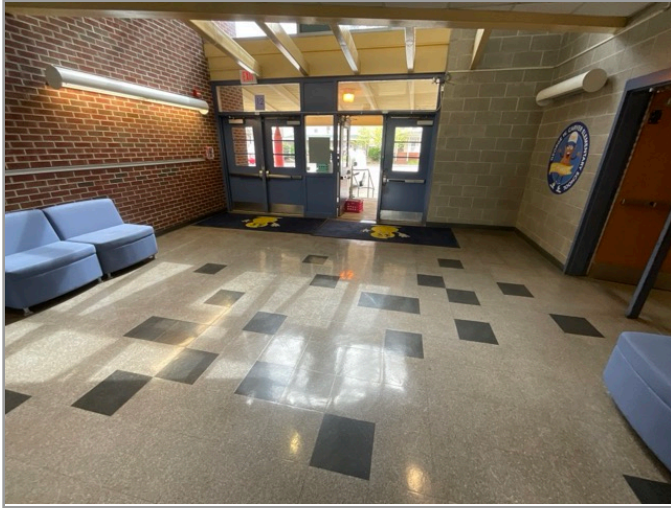
ACCESSIBLE INTERIOR PATH

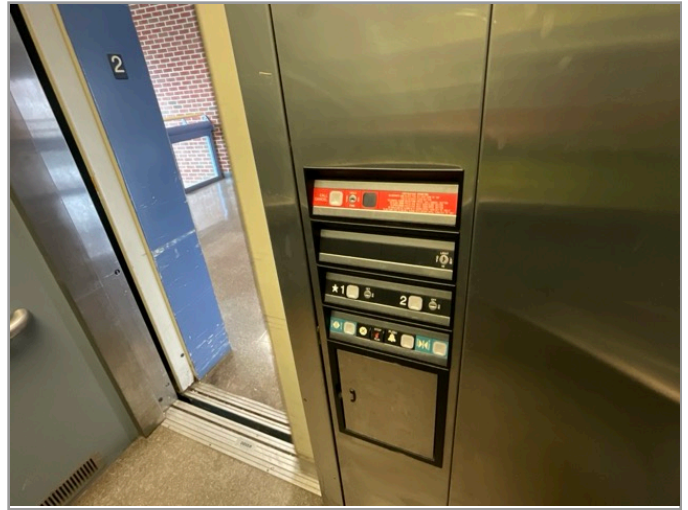
IN-CAB CONTROLS

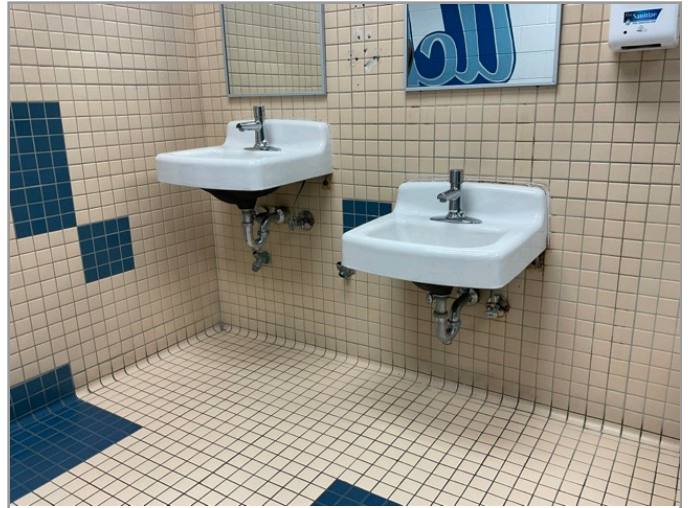
SINK, FAUCET HANDLES AND ACCESSORIES

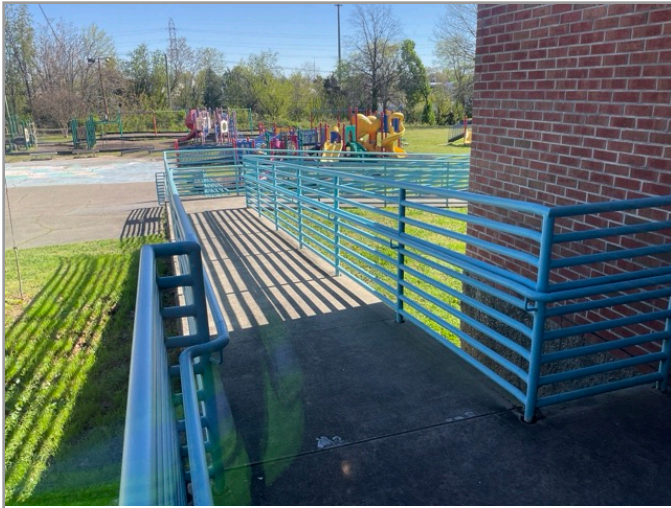
ACCESSIBLE ROUTE TO PLAYGROUND

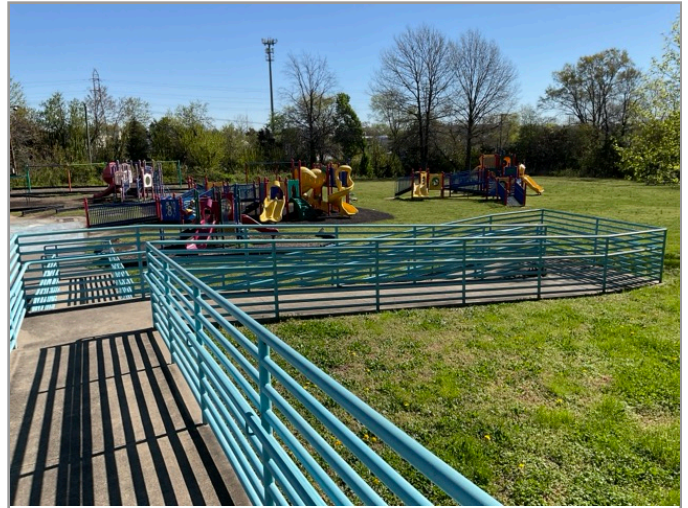
OVERVIEW OF PLAYGROUND
