FACILITY CONDITION ASSESSMENT

Richmond Public Schools
301 North Ninth Street
Richmond, VA 23219

Elizabeth D. Redd Elementary School
5601 Jahkne Road
Richmond, VA 23225

May 15, 2024

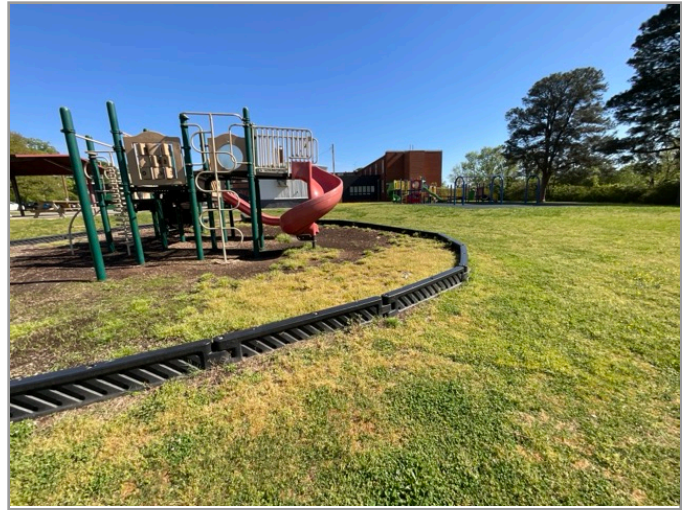
OVERVIEW OF PLAYGROUND
