FACILITY CONDITION ASSESSMENT

Richmond Public Schools
301 North Ninth Street
Richmond, VA 23219

Oak Grove-Bellemeade Elementary School
2409 Webber Avenue
Richmond, Virginia, 23224

October 9, 2024

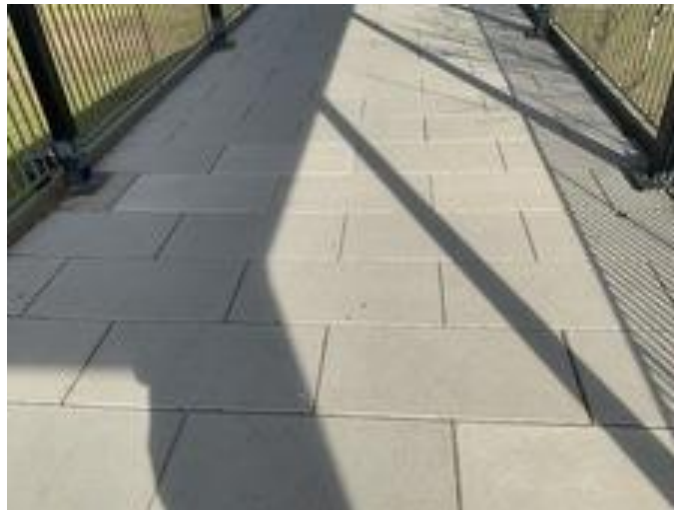
4 - CONCRETE PAVERS

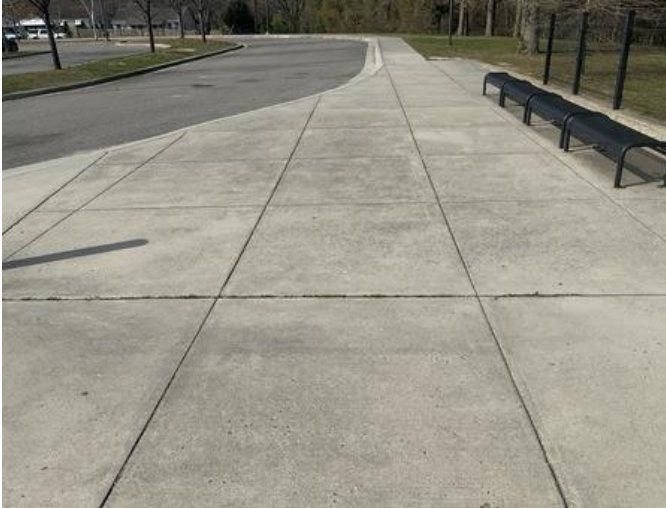
5 - CONCRETE SIDEWALK

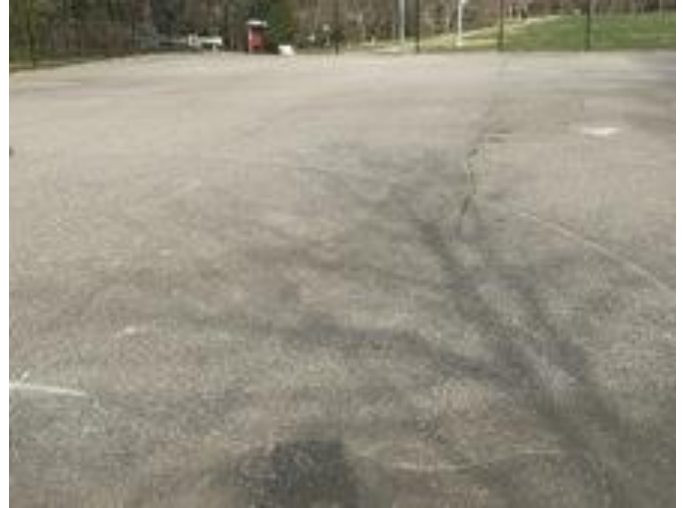
6 - BASKETBALL COURT

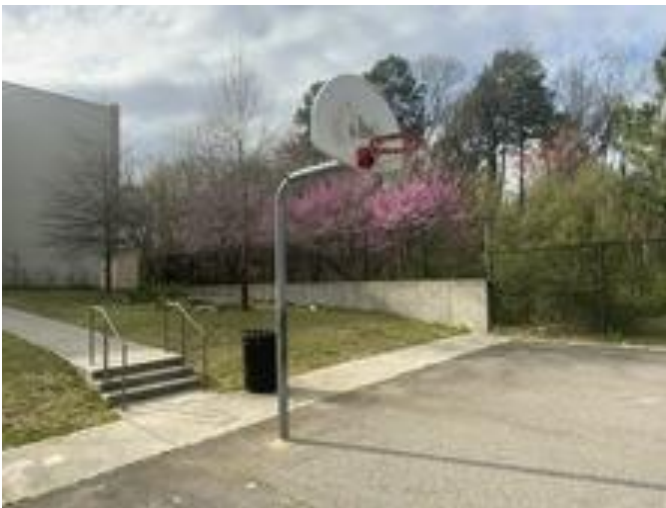
7 - BASKETBALL HOOP AND BACKBOARD

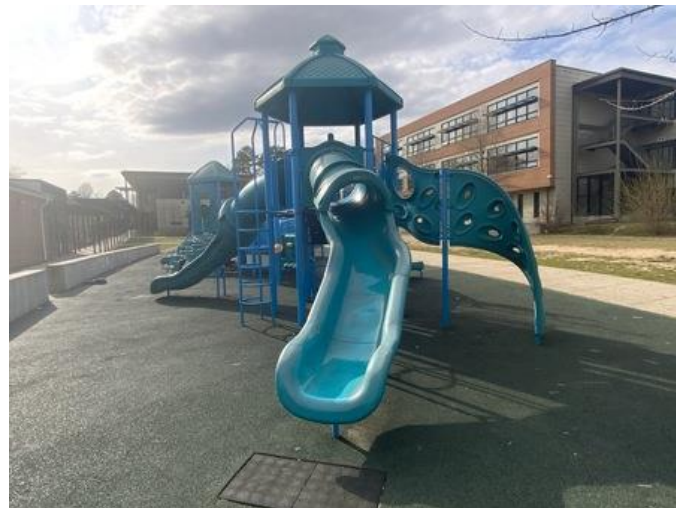
8 - PLAY STRUCTURE

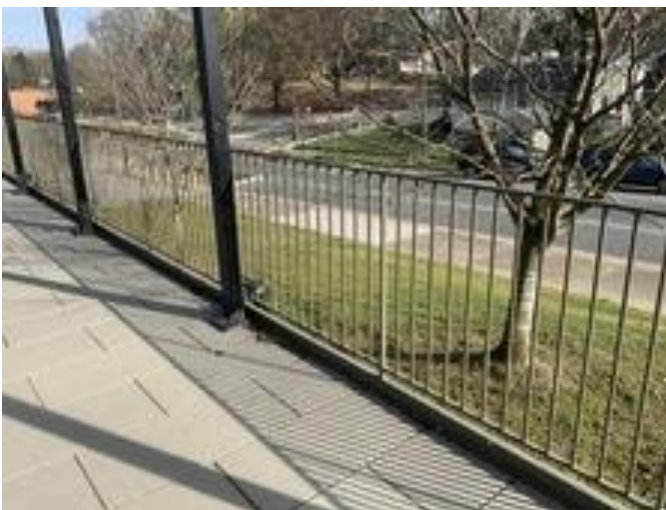
9 - WROUGHT IRON FENCE

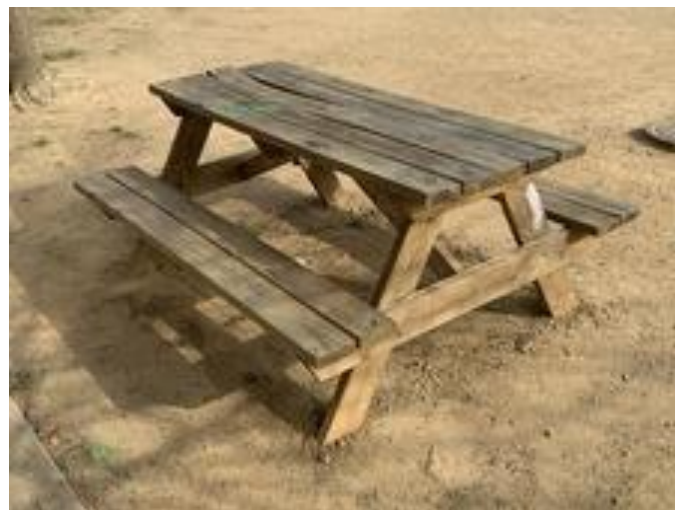
10 - PICNIC TABLE

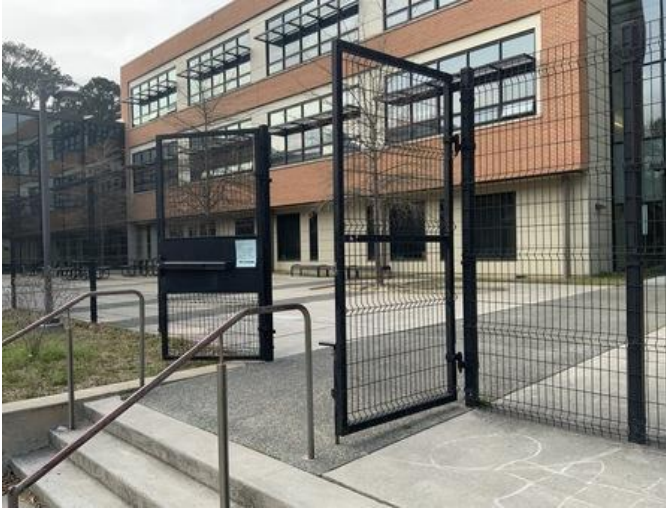
11 - HOLLOW TUBE FENCE

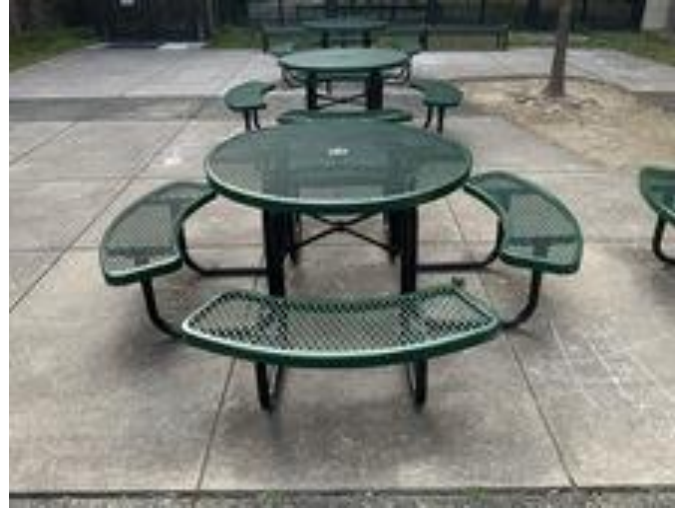
12 - METAL PICNIC TABLE
