HOPE-PAGE PUBLIC SCHOOLS FACILITIES ASSESSMENT REPORT

HIGH SCHOOL

ELEMENTARY SCHOOL

February 2019

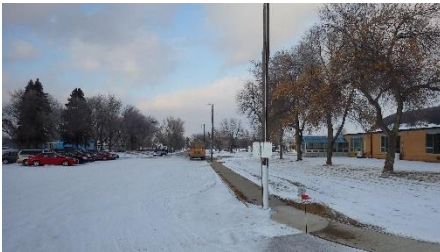
Site parking, drive, sidewalks

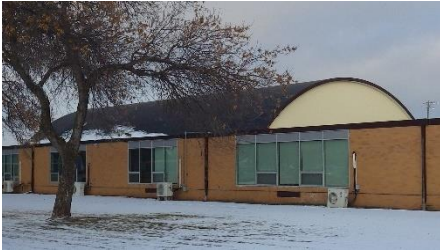
EPDM Roof membrane over the Gymnasium

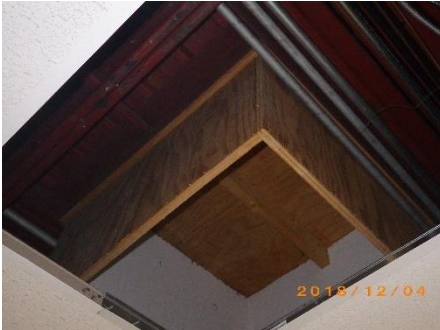
Steel roof deck / abandoned skylight

- There are active roof leaks throughout.
- There is no roof access from inside the building.
- Several skylights were originally located on the roof above the hallways but have since been removed and infilled.

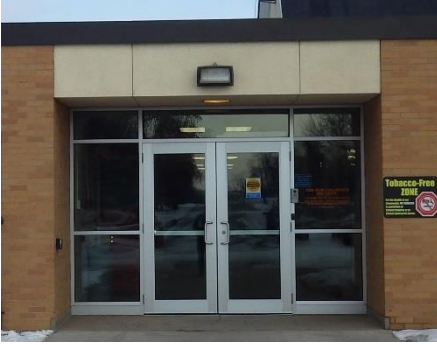
- Stucco soffits above the entrances are in average condition. Some hairline cracking was observed.
- The original louvers providing fresh air to the building are blanked off with metal covers.

Aluminum entrance door with plaster soffit

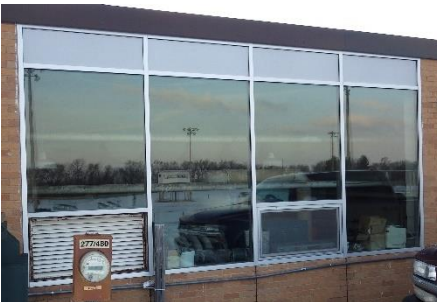
Aluminum window with insulated glazing

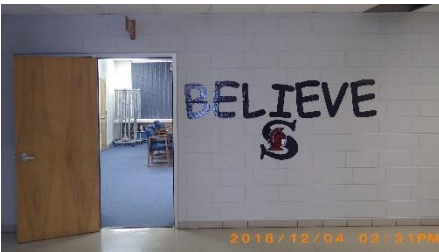
Example of painted CMU walls

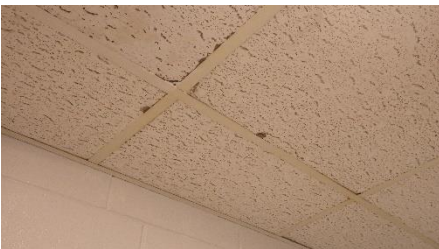
Discolored 2x4 ATC ceiling tile and grid

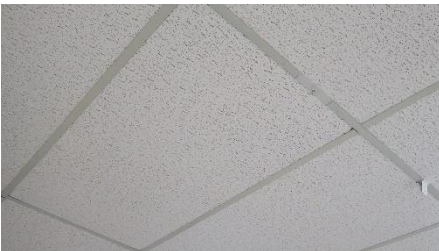
2x4 ATC ceiling tile and grid at classroom.

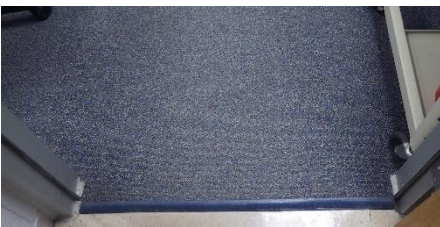
Broadloom (roll) carpet

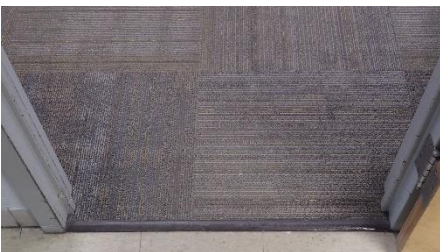
Square tile carpet

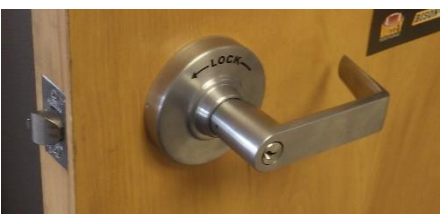
Lever style door hardware on original wood door

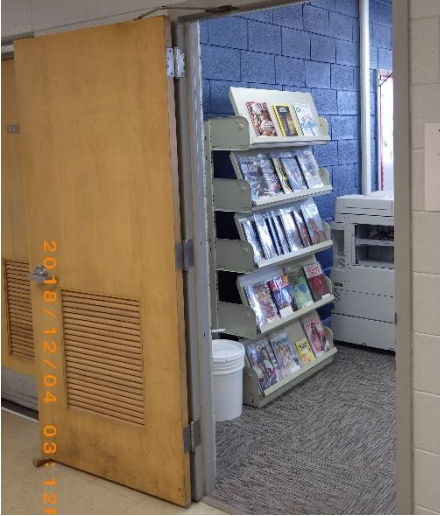
Original wood door with louver

- The solid-core wood doors appear to be original and are in average condition. Various types of wear/tear and damage was observed.
- Many of the doors also contain louvers, which are not allowed under current building codes. Replacement of the doors should be considered with an upgrade project.
- Most of the door hardware throughout the building has lever style door handles, which is ADA compliant.
- Several doors throughout the building are less than 3'-0" wide, which may be an issue with ADA guidelines.
- Potential code deficiencies include corridor doors with louvers, non-rated corridor doors, corridor doors without closers, and doors that open entirely into the corridor. These items are typically not allowed by code and may require improvements with future building improvements.

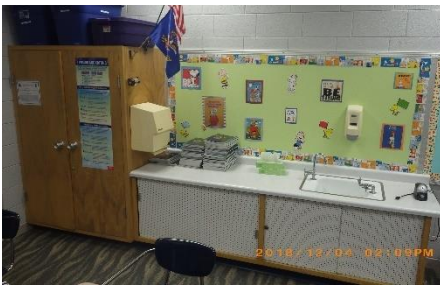
Original casework with pegboard doors and items stored above tall cabinets

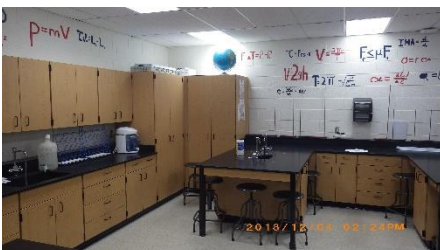
New casework at science.

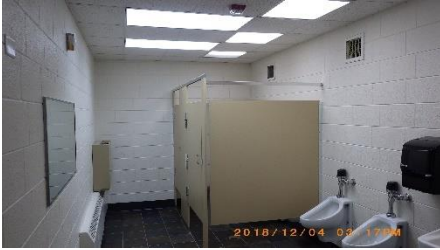
Typical restroom

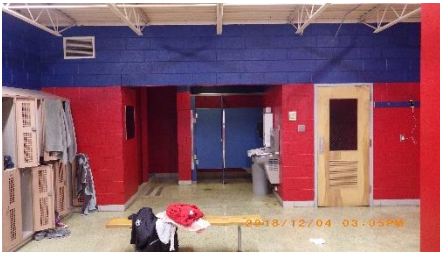
Locker room

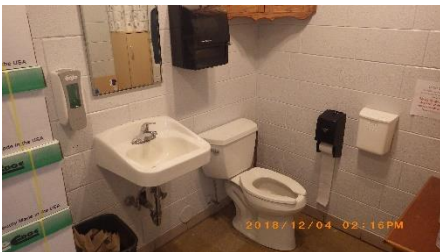
Staff restroom is not ADA compliant

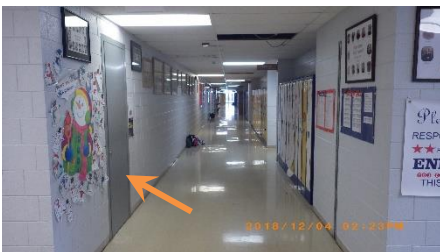
Corridor with folding gate

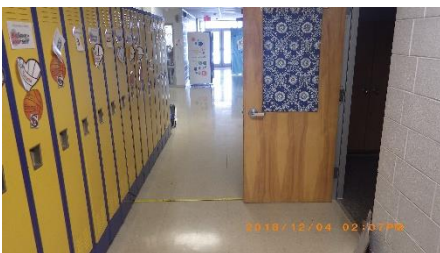
Corridor width restricted to 46"

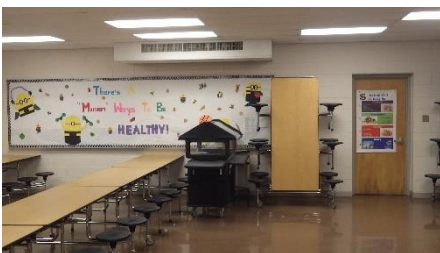
No panic hardware at cafeteria

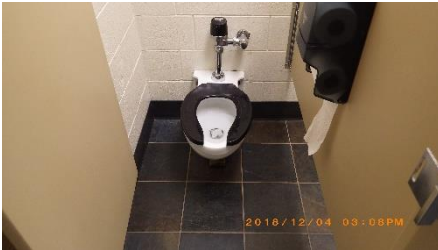
Toilet and stall is not ADA compliant

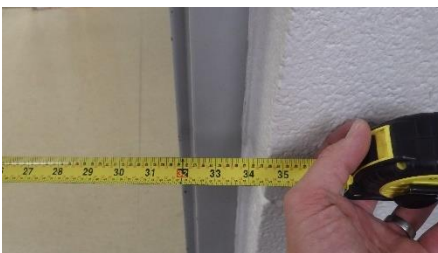
Door widths less than 36" wide

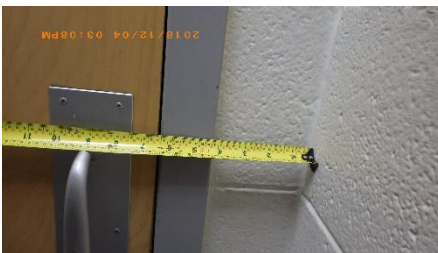
Clear area / pull space at door less than 12"

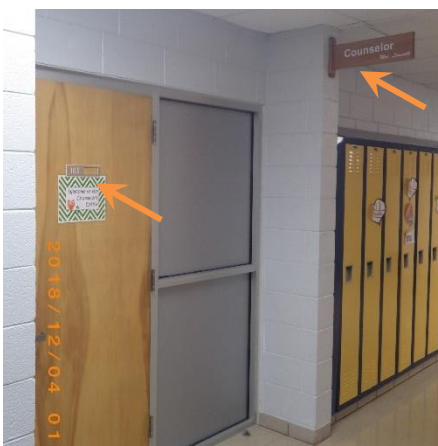
Room signage is not ADA compliant

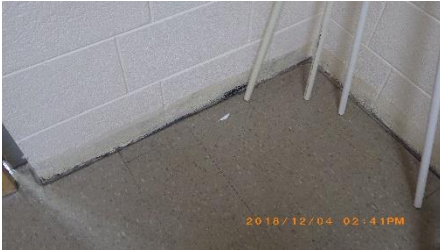
Vinyl Asbestos Tile

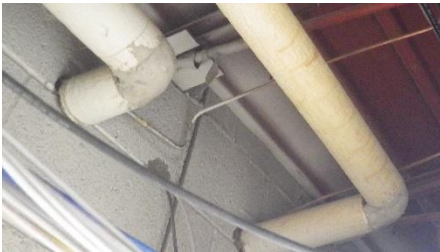
Asbestos Pipe Elbows

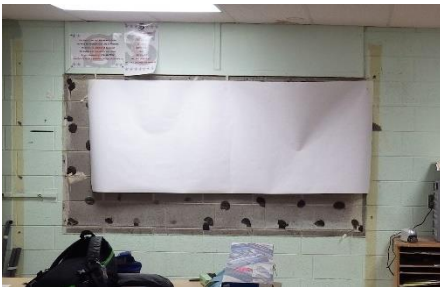
Glue pucks on wall may have asbestos

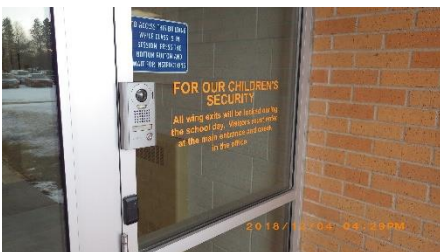
Signage & video-intercom at main entry

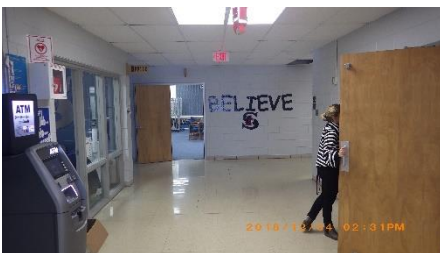
Main office is not near main entrance

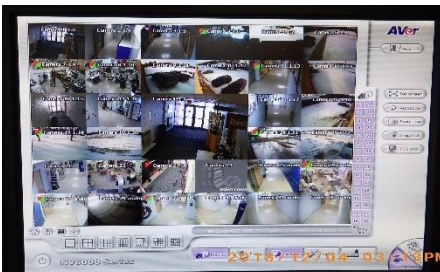
Video surveillance

- A digital surveillance system with recording capabilities was observed. Adding a large TV screen near the main office that actively displays the various cameras is another way to reinforce security in action.

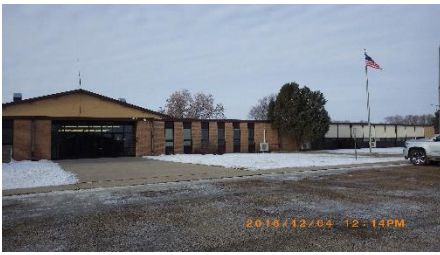
Main entrance, no accessible parking

- Deteriorated surfaces and cracked panels were observed.
 - Vertical and horizontal shifting of the concrete sidewalks was observed.
- There are no accessible parking spaces.

- Provide accessible parking that complies with ADA requirements.
- Repair/replace deteriorated concrete walks from street to main entrance.
- Address grading issues at parking lot.

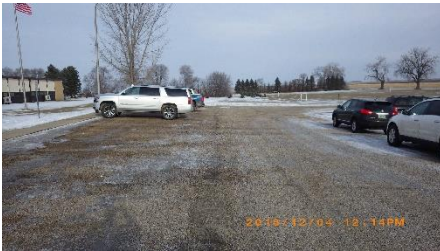
Overlap of parking, drop-off areas

- Bus drop-off and visitor parking on May Avenue overlap the same area.
 - Segregating these activities are ideal.
- In general, the sidewalks are in average-poor overall condition.

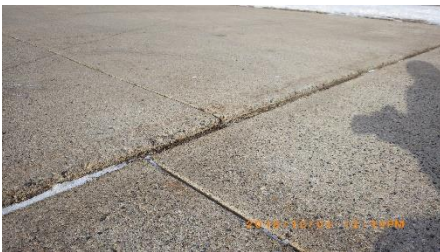
Uneven pavement at main entrance

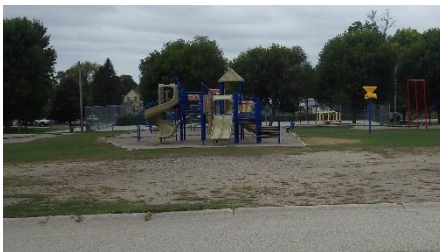
Playground across the street from school

- 6th Street to the south is closed (via gates) during the school day to allow safe access to the playground across the street.
 - There is no accessible path to the playground.

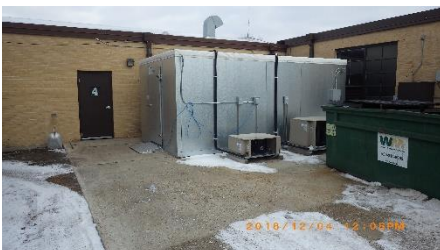
Walk-in freezer outside kitchen

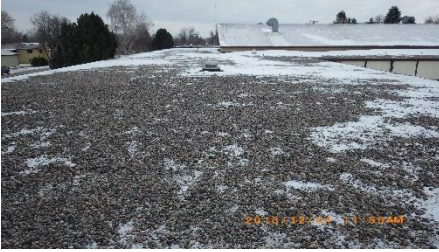
Ballasted EPDM roof

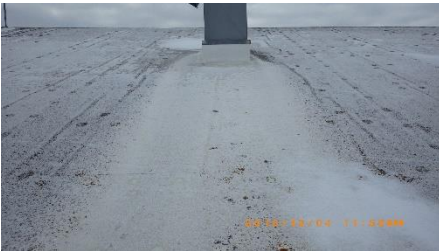
Plastic singly-ply roof membrane over gym

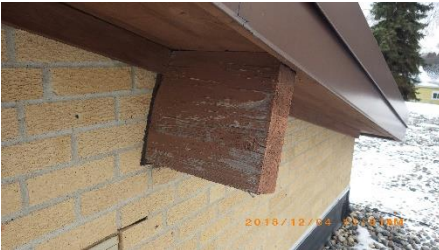
Peeling paint at wood beams and deck

- The exposed, painted wood beams and trim under the gymnasium overhang is peeling and deteriorated. There are a few pieces of wood trim that are loose and or missing.

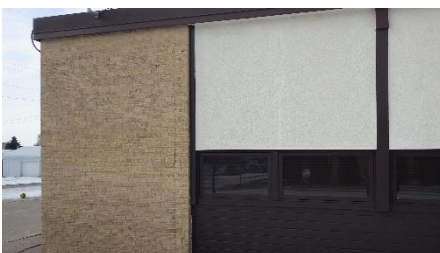
Fiber board above windows

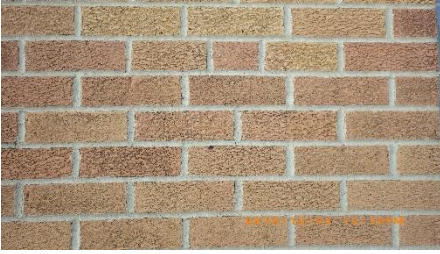
Typical condition of brick and mortar

- Staining/discoloration of mortar was observed on the north exposure. It was also observed around the downspouts on all sides.
- Selective tuck-pointing at the exterior walls is needed. Some mortar joints need repaired as a result of expansion/contraction, lack of control joints, and deterioration from moisture/normal wearing.
 - In general, the life-span of mortar varies due to exposure conditions, and mortar materials, but can typically be expected to last over 25 years to upwards of 50 years or more.

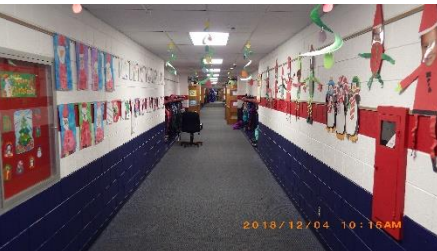
CMU walls and 2x4 ATC ceiling at 1954 corridor

- A general review of the building structure was performed, and no significant deficiencies or concerns were observed.
- The building consists of a concrete foundations and masonry walls.
- The floor system is slab-on-grade with a perimeter tunnel system.
- The 1954 and 1960 buildings have wood glue-laminated trusses a 2" thick tongue and groove (T&G) structural wood deck.

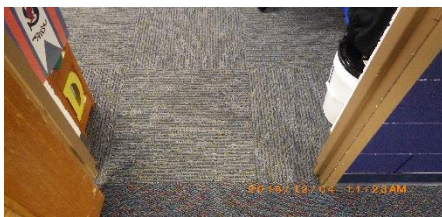
Square tile in classroom abutting broadloom carpet (roll) carpet at the corridor

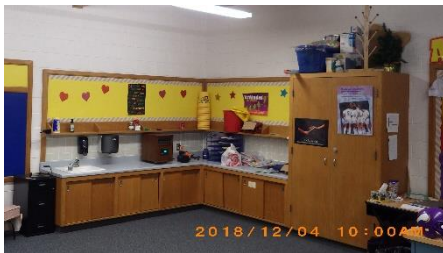
Original casework at classroom

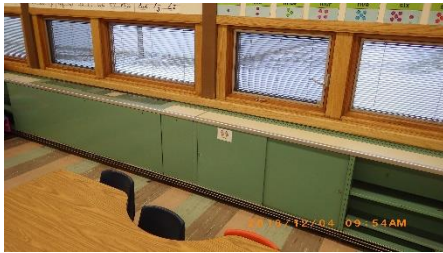
Original casework at exterior wall that is part of the cabinet unit ventilator (CUV)

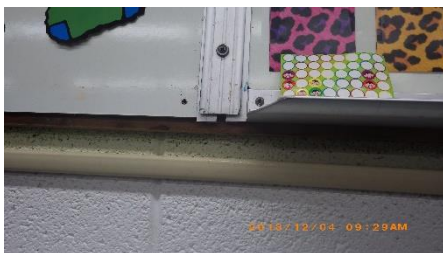
Markerboard laminated over chalkboard

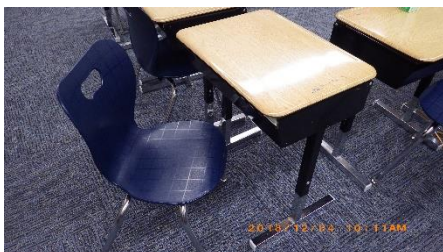
New student chairs with older desk.

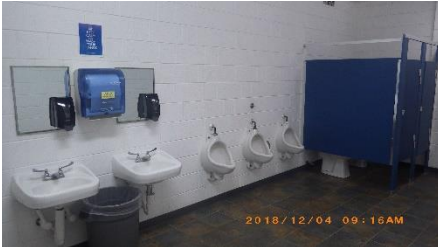
Stall is not ADA compliant

- Repaint HM doors/frames.
- Remodel restrooms and locker rooms
 - For compliance with ADA requirements and to replace plumbing.
- Review extent of kitchen equipment.

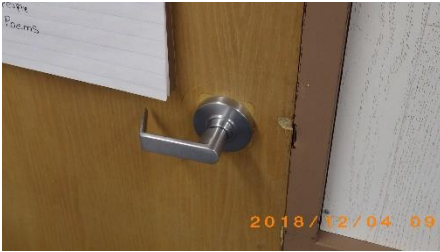
ADA compliant lever style door hardware

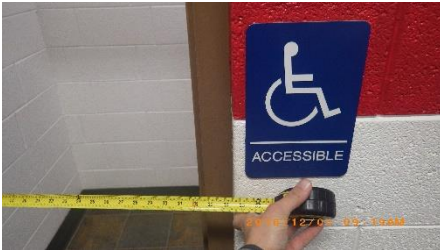
Door opening to restroom is not ADA compliant

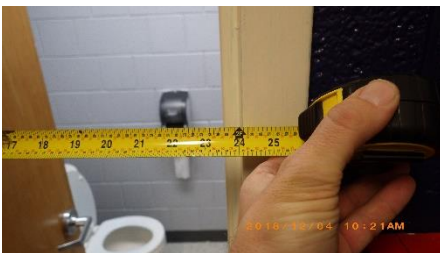
Door opening is not ADA compliant

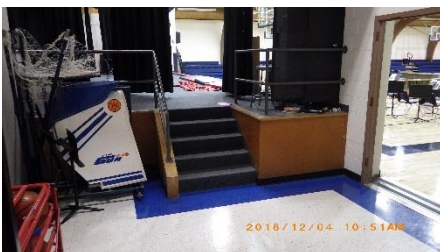
- Step at shower areas
 - Element 7 – Stairs and Lifts
 - Lift / Ramp access to the stage and weight room
 - Element 8 – Communication Elements
 - Room signage

Stairs to stage level

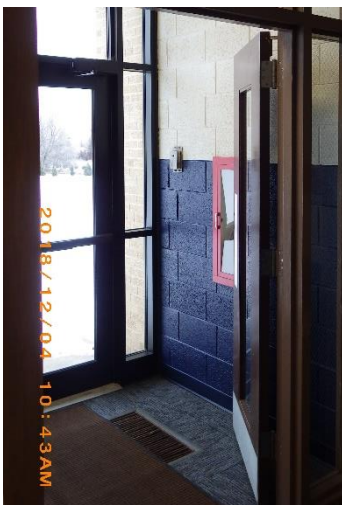
Vestibule doors do have proper floor clearance and not ADA compliant

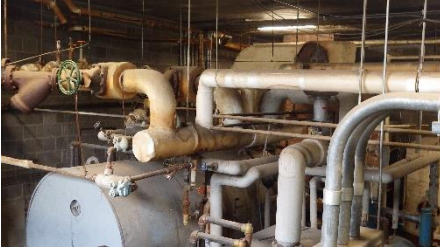
Pipe elbows, boiler insulation with asbestos

- Replacement of storage, equipment. Consider enclosing walk-in cooler/freezer.
- Provide new room signage / wayfinding signage.
- Asbestos abatement throughout the building.

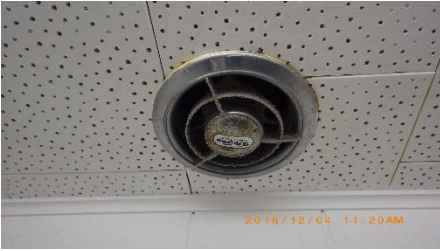
Adhesives holding various finishes in place

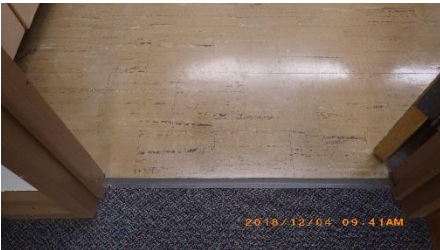
Vinyl asbestos tile (VAT)

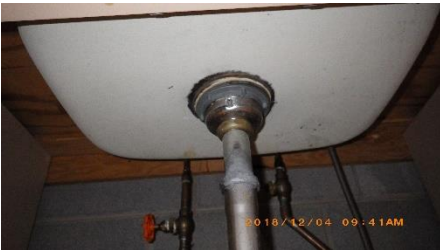
Coating on underside of sink

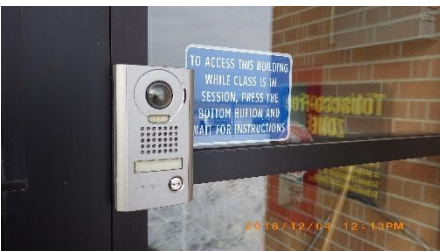
Signage & video-intercom at main entry

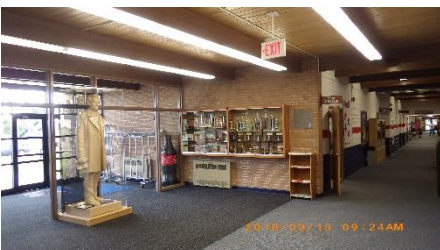
Opportunity exists for secure entrance with main office near the main entrance
