## FACILITY NEEDS ASSESSMENT

### ESSEX ELEMENTARY SCHOOL AND MANCHESTER ESSEX MIDDLE-HIGH SCHOOL

#### Manchester Essex Regional School District

DRAFT REPORT: January 27, 2023  
H&A JN 2217.01

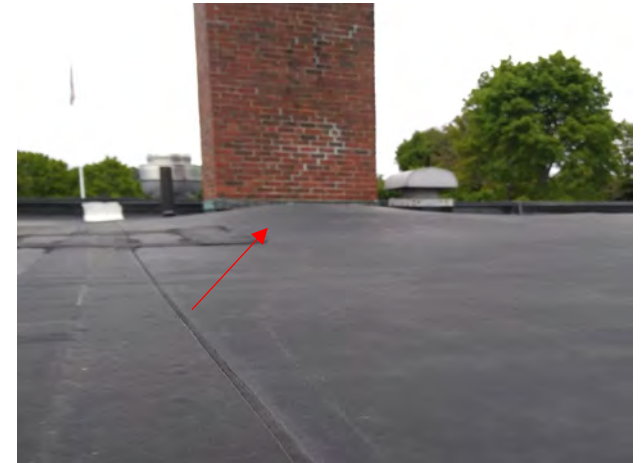
12. There are areas where the roof has bubbled and the membrane is no longer adhered.

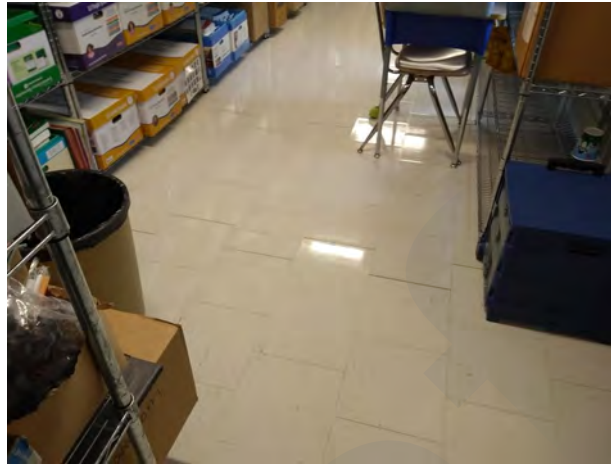
14. Vinyl floor tiles in Modular addition show signs which may indicate issues with subfloor.

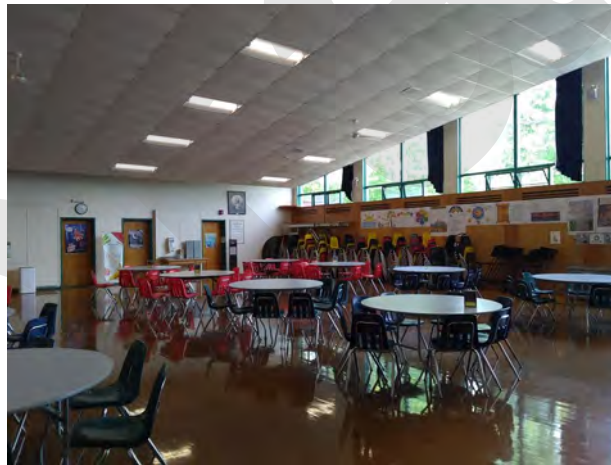
17. Existing 2x4 ceiling tiles have sagged and are cupped.

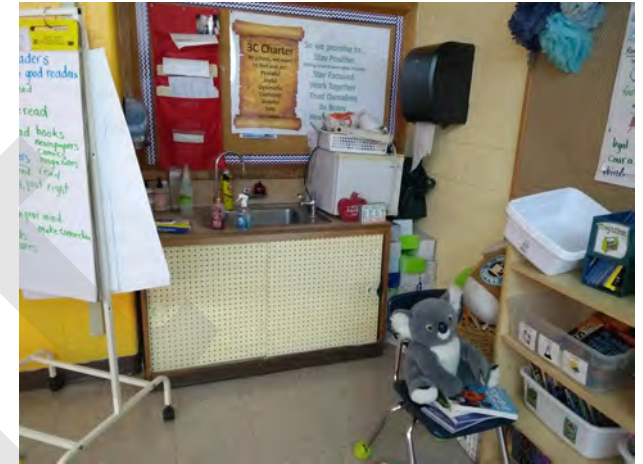
21. Classrooms have outdated sinks that do not meet AAB accessibility requirements.

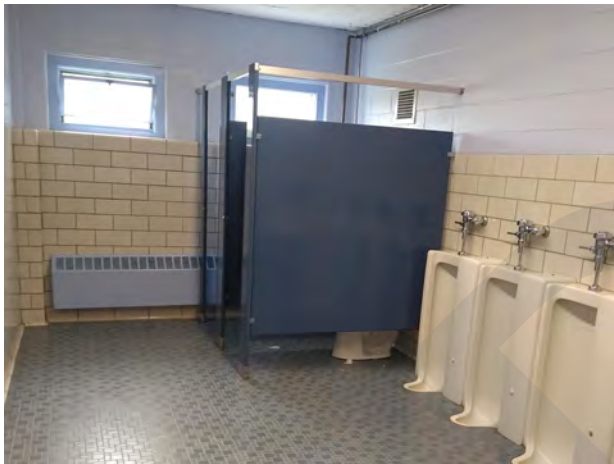
22. Multi-user toilet rooms have original, outdated fixtures and several have no AAB updates.

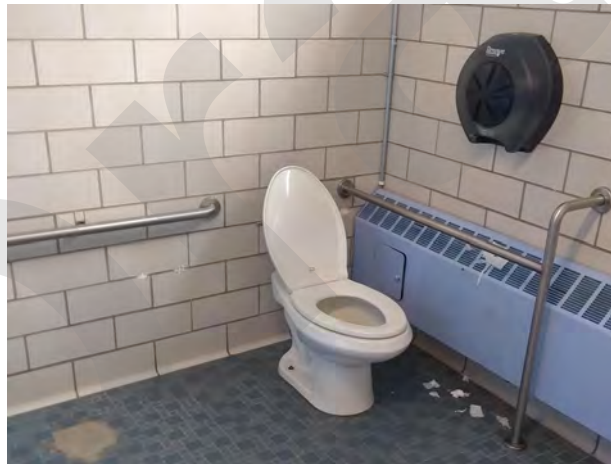
23. Grab bars/accessories are non-compliant and original tile floor is patched.

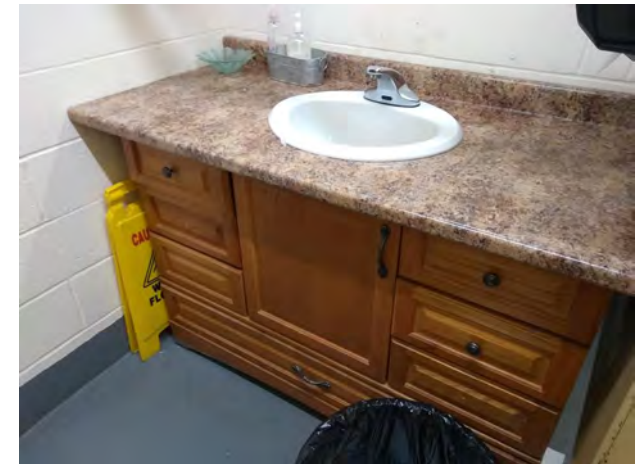
24. Single-user toilet rooms do not meet AAB requirements.

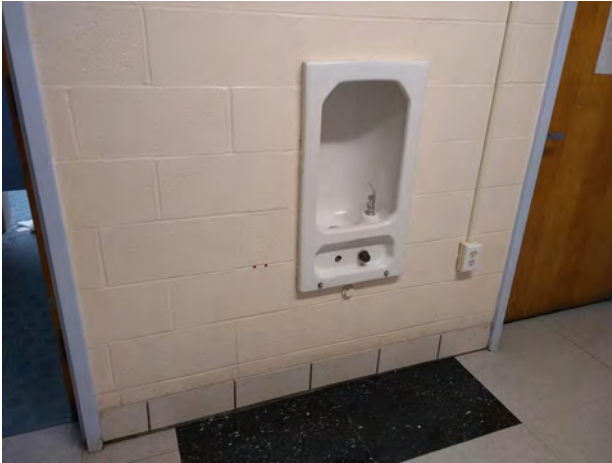
25. All drinking fountains are original and are not AAB compliant.

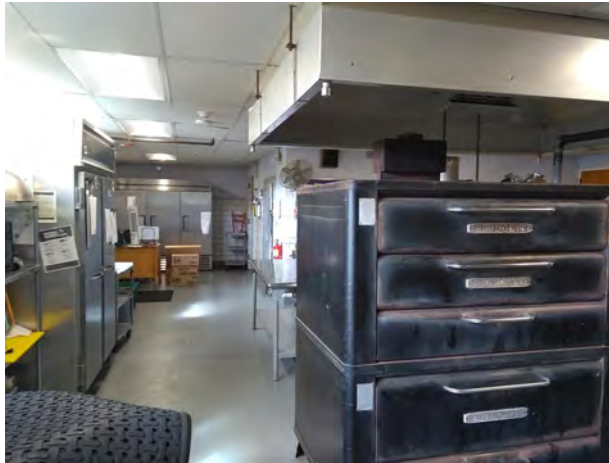
26. Kitchen equipment is very old and inefficient.

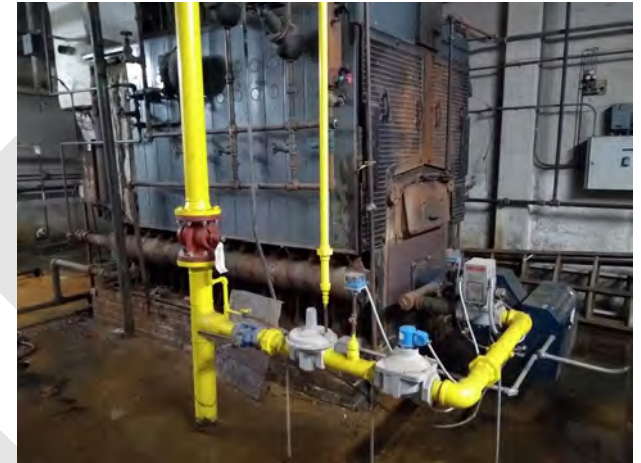
27. This 1975 era boiler is no longer being used.

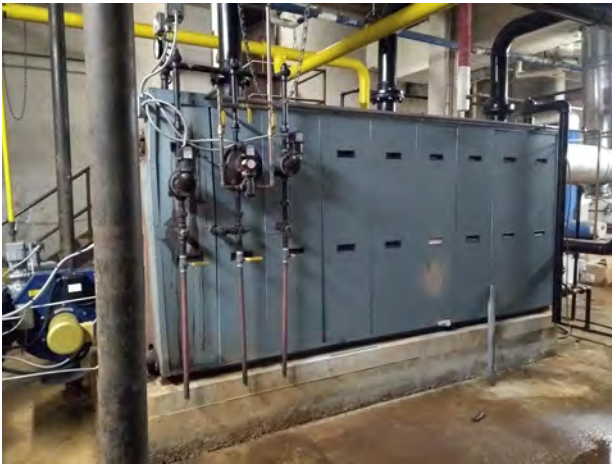
28. This boiler was installed in 2008 and still functions.

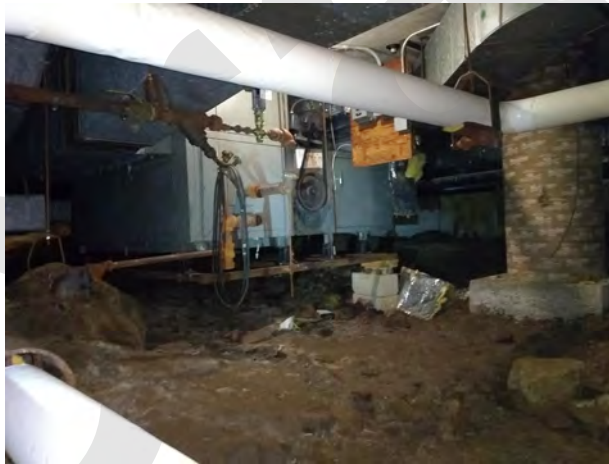
29. This Air Handling Unit in the crawl space is obsolete.

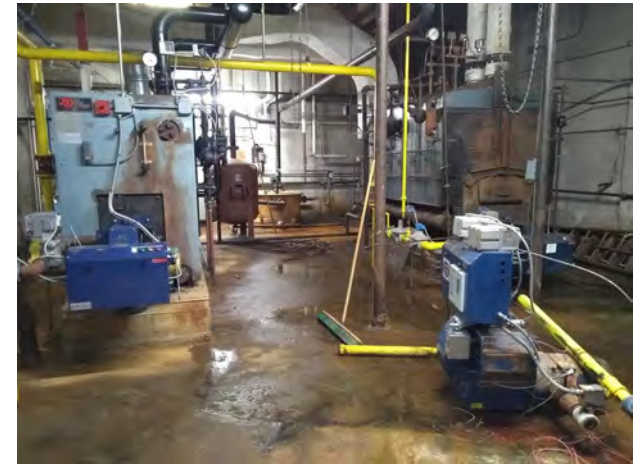
30. Boiler room shows signs of chronic flooding, equipment is obsolete and inefficient.

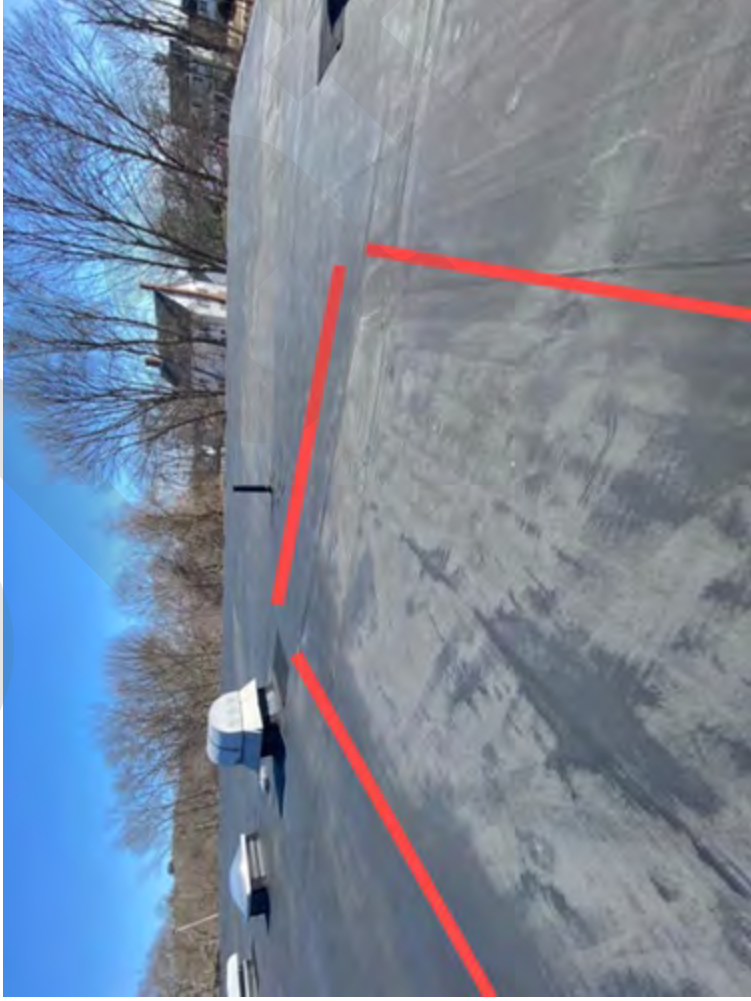
*Photo 2*

**Overview of roof section.  
"Dirty" area indicates  
ponding water.**

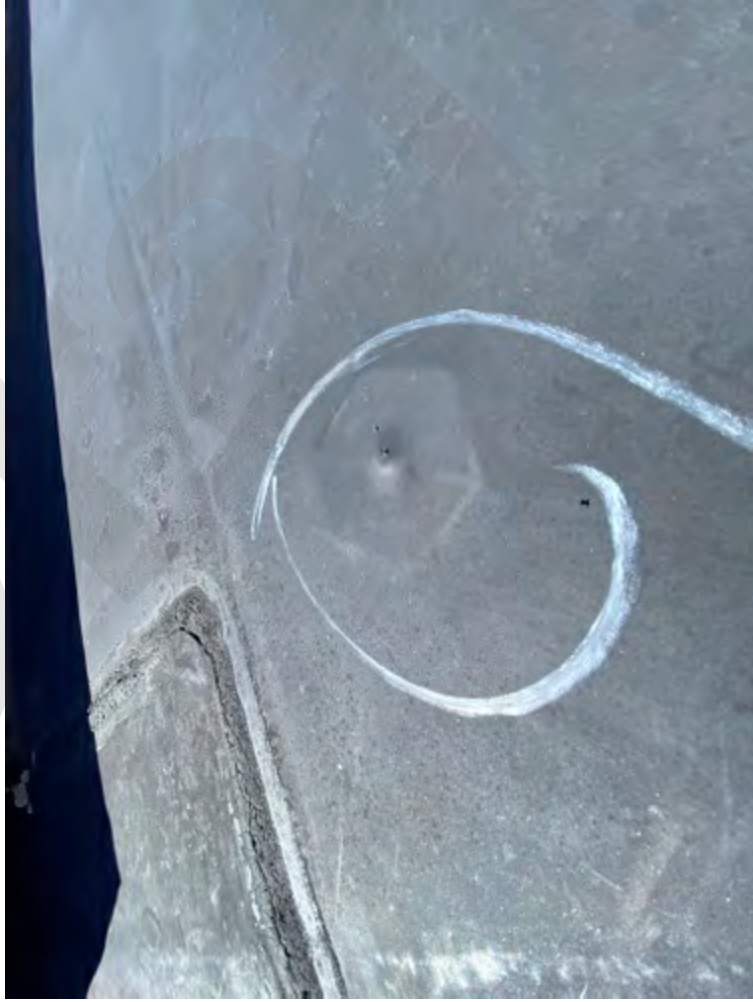
*Photo 18*

**Penetration in membrane  
above fastener location.**

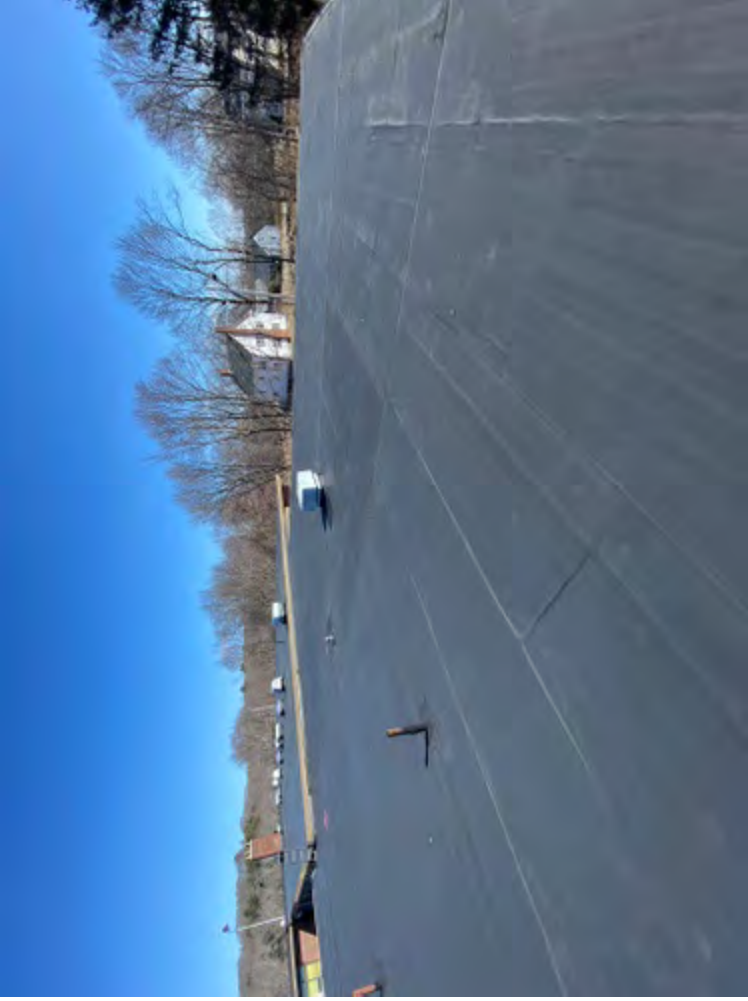
Photo 37

Overview of roof section.

**Failed patch.**

This is a source of water infiltration to the roofing assembly.

- Troubleshoot & repair **20 failed patches and flashing conditions** on all roof sections.
- Troubleshoot & repair **30 failed patches over edge metal laps** on all roof sections.
- For penetrations and failed coverstrip/flashing:
  - Clean roof surface with high grade cleaner
  - Apply peel and stick Uni-Bond 6" tape to penetration or seam
  - Apply White Knight Plus WC to Uni-Bond tape and extend coating 4" past all seams of tape. Ensure felt backing of tape is fully saturated.
- Apply GreenLock Structural Adh at termination bars.
- All debris will be cleared up and removed.
