**BUILDING ENVELOPE EVALUATION  
FOR  
THE TOWN OF SOUTHAMPTON POLICE STATION  
8 EAST STREET, SOUTHAMPTON, MA  
MI-2516-001**

**FINAL DRAFT**

**January 2021**

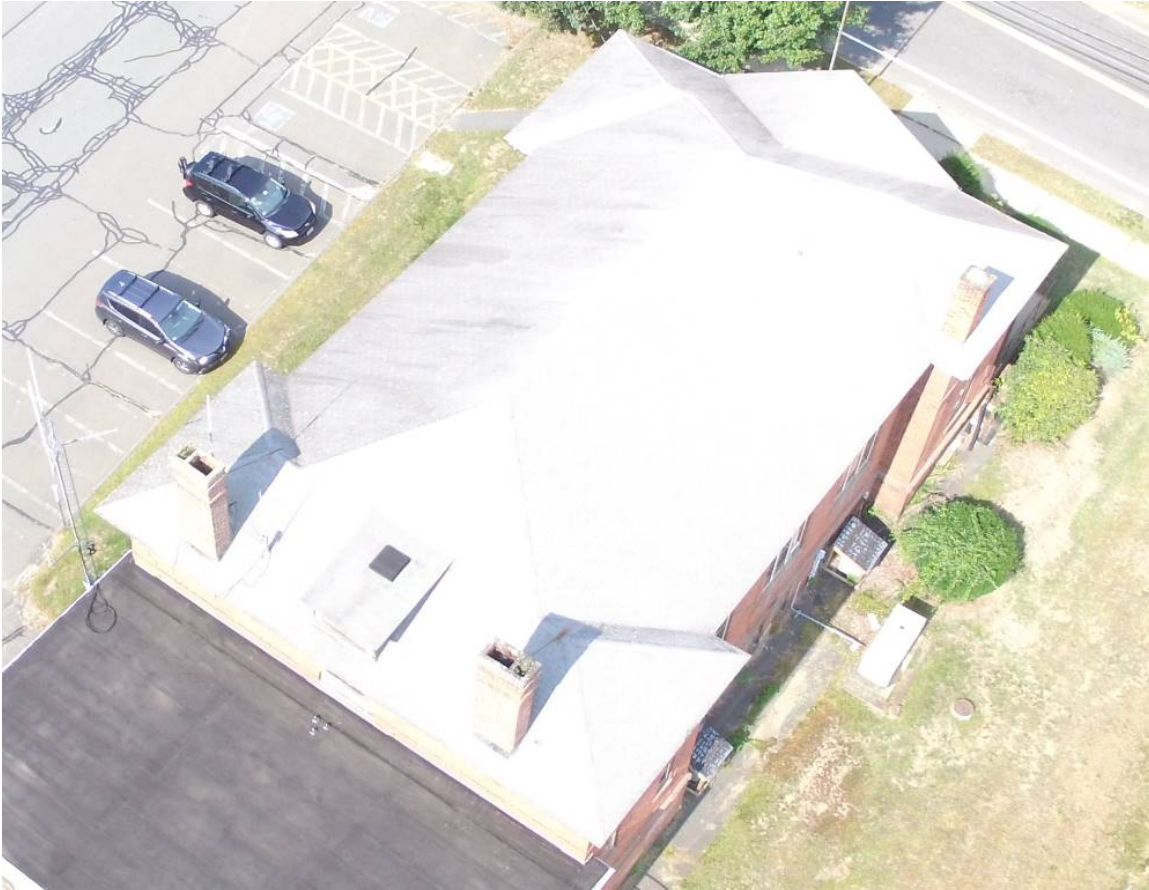
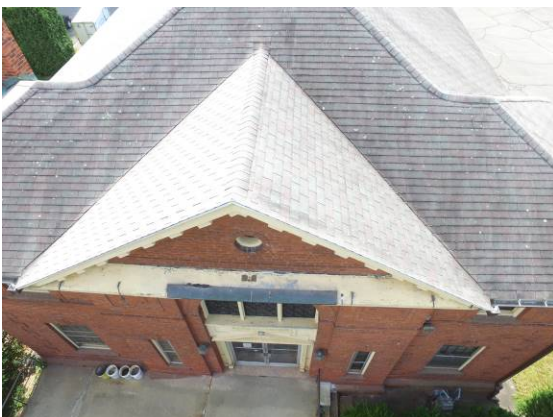
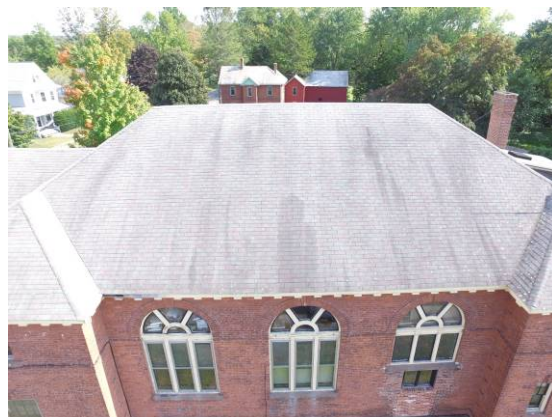
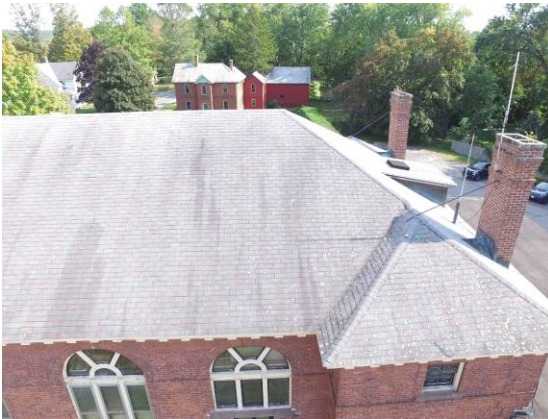
(Condition: Fair/Good) – The existing roofing appears to be a 3-tab asphalt shingle product and is in reasonably good condition. It was reported that the roof was installed around 1989 (approximately 32 years ago). Asphalt shingle roofs installed at times during this period typically has a 20-25 year life expectancy. The shingle roof is beyond its useful life.

The original roofing was slate. (This is supported by a report by the Massachusetts Historical Commission) The slate was removed and replaced with a more economical solution, asphalt shingles. It is not known if there is one (1) or two (2) layers present. The edge profile should be examined and/or shingles removed to determine how many layers are present. The Code permits two (2) layers of shingles before a complete tear off is required. Research and recommendation for roof insulation should also be discussed prior to installing a new roof. The original valleys were likely copper and were replaced by woven asphalt shingles when the roof was replaced.

There were few missing shingles observed. There are a few 'wrinkled' tabs but the shingle remains whole and intact.

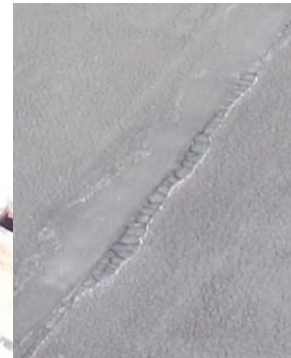
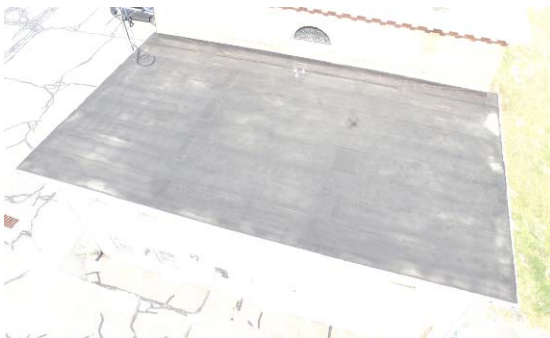
Sign of wear (below)

(Condition: Fair/Good) – According to historic records, the southerly addition was constructed in the early 1970's for two (2) garages and a meeting-voting room above. Based upon appearance, this is likely the original roof. The existing roofing appears to be a built-up torch-down roofing system. The general field appears in good condition. Due to the age, it is showing evidence of chalking and breakdown at seams. This is a common effect as the membrane ages and wears.

There are no roof drains or interior drainage. The roof is sloped to the exterior roof edges where gutters and downspouts are present for drainage.

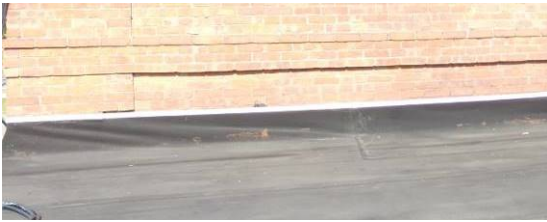
Stretched membrane - Westerly  
(Review)

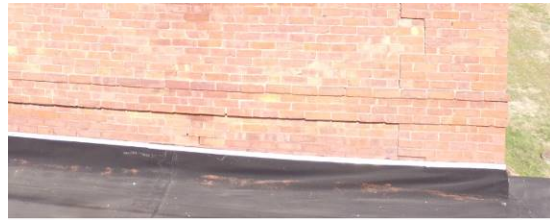
Stretched membrane - Easterly  
(Review)

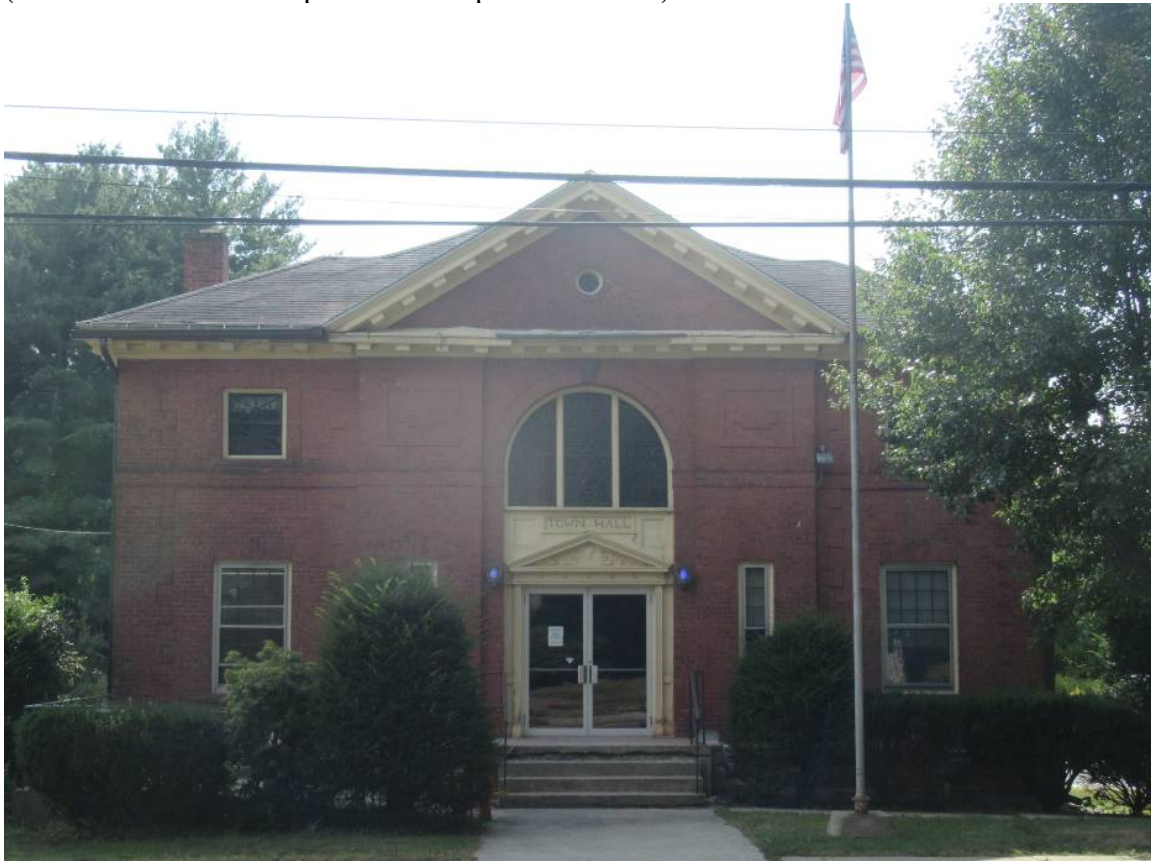
North Elevation

The front doors are aluminum and not original to the building. A historic photograph taken in 1970 shows the aluminum doors present. **The front entrance porch is in need of repair/replacement.** The doors are dated and in need of repair/weather-stripping or possibly replacement. More 'period-looking' doors would be more appropriate on this historic structure.

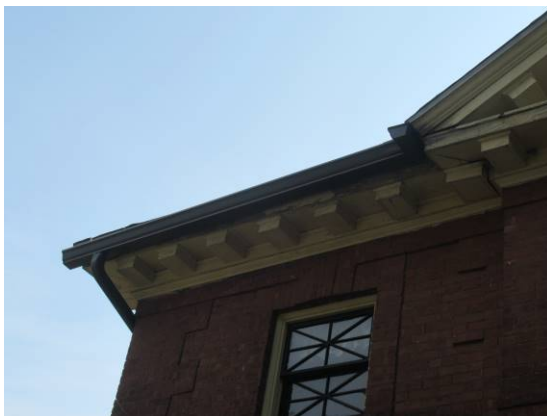
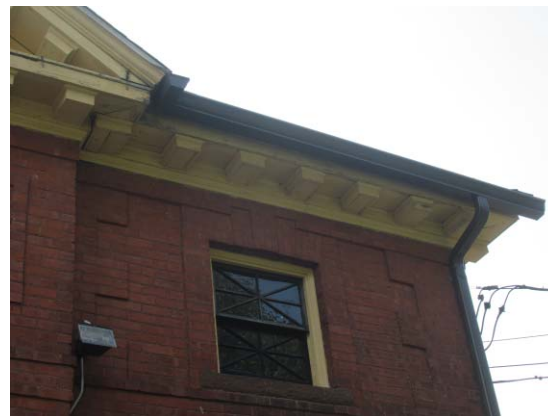
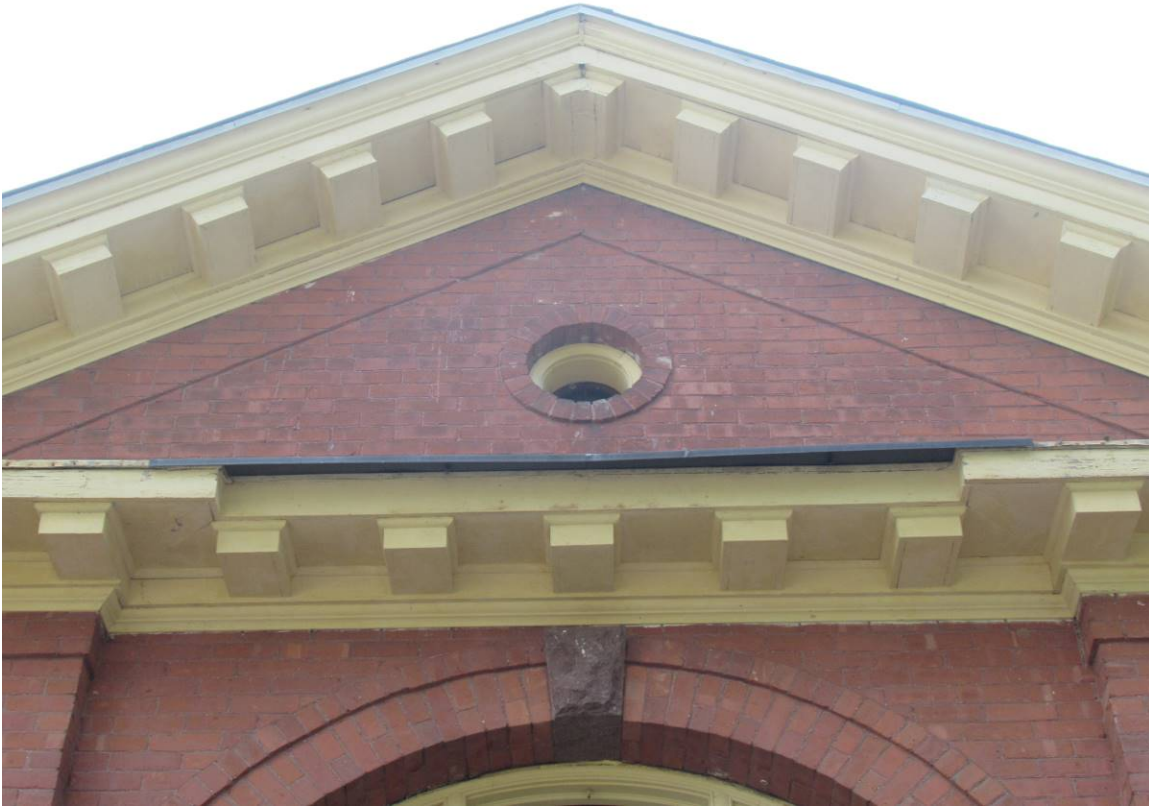
Metal trim (brown) was added above the front main entrance. It was likely added to project water away from the main entrance without installing a continuous gutter. The front fascia is not flush across the front and has projections (2 smaller photos above) making it difficult to install a continuous gutter.

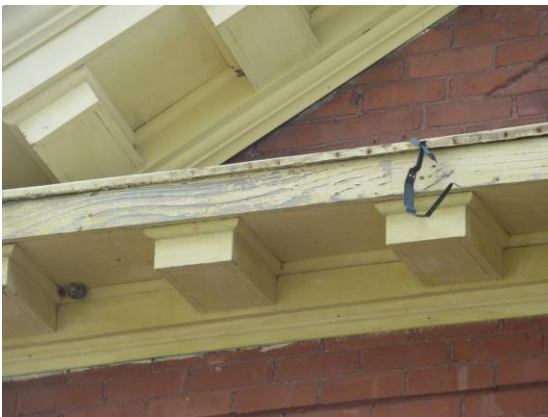
The presence of a metal strap may give indication that a gutter was present across the front, fell into disrepair or damaged, and since been removed.

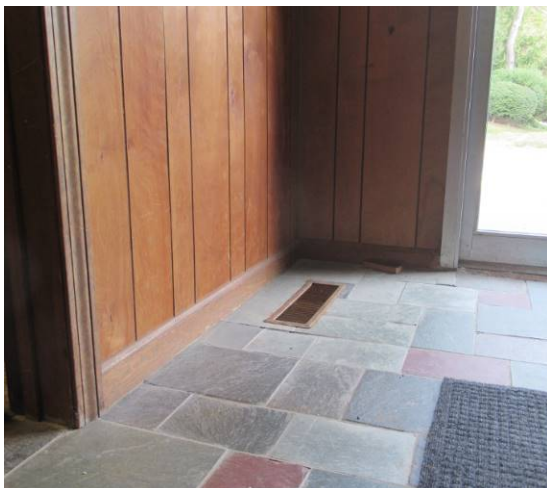
The compromised framing is most noticeable on the upper level near the front entrance with significantly sloped floors.

Sloping floor

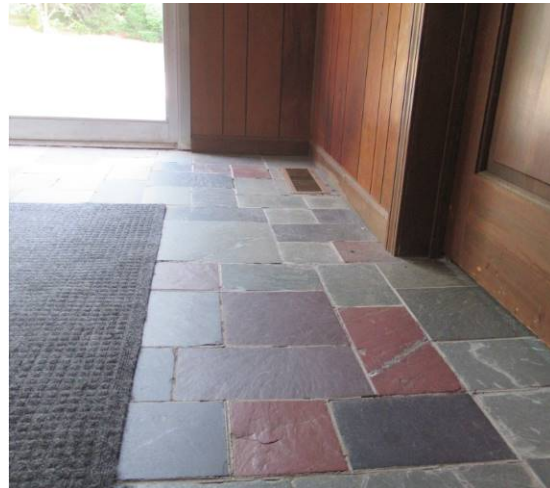
Sloping floor

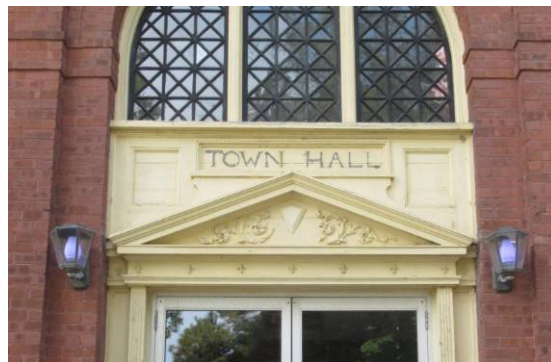
The 'TOWN HALL' lettering should be professionally lettered.

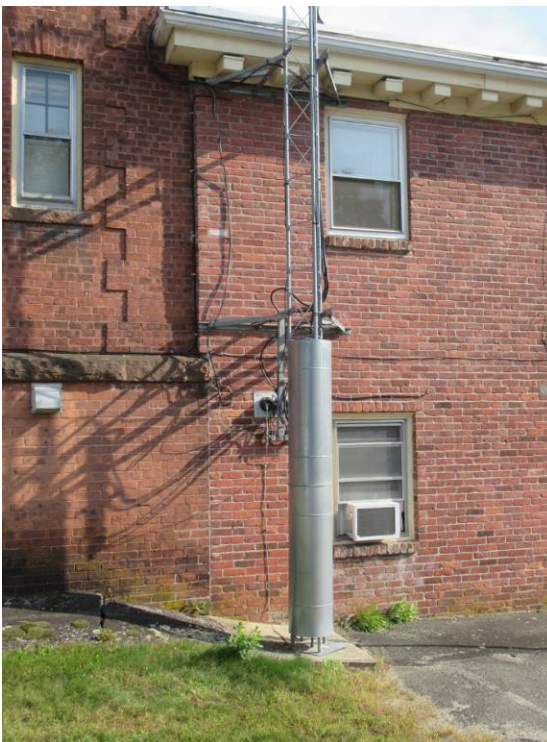
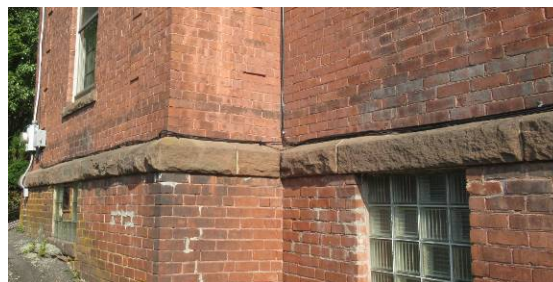
In future interior alteration(s) consideration should be given to routing cables inside of the building to lessen vulnerability of damage on the outside. A large securing barrier should also be constructed around the base of the antenna to secure the antenna cables connected to the interior equipment from damage or harm.

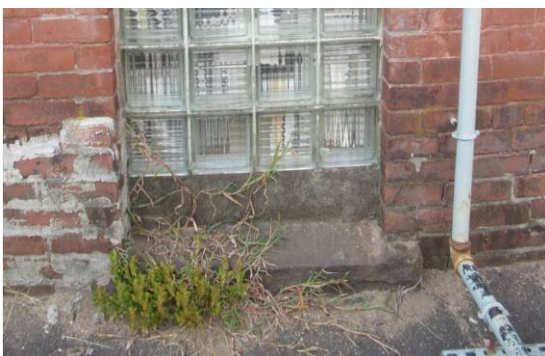
Moisture damage

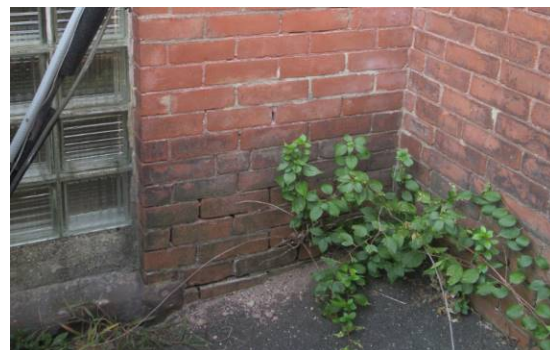
Moisture damage

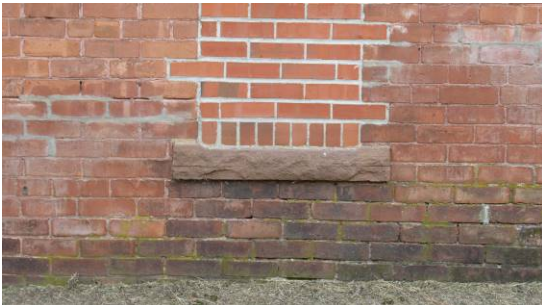
Moisture damage

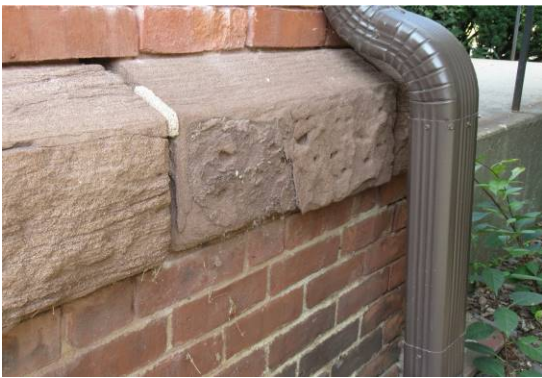
Stone spalling/deterioration

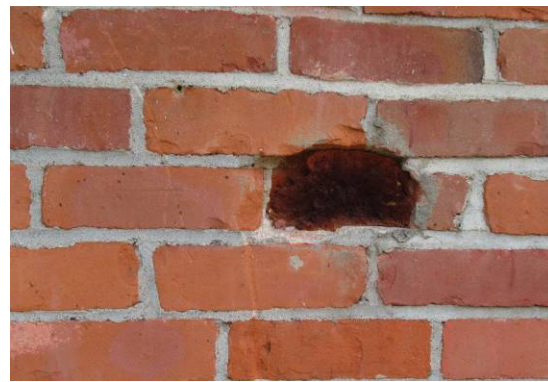
Seal penetration

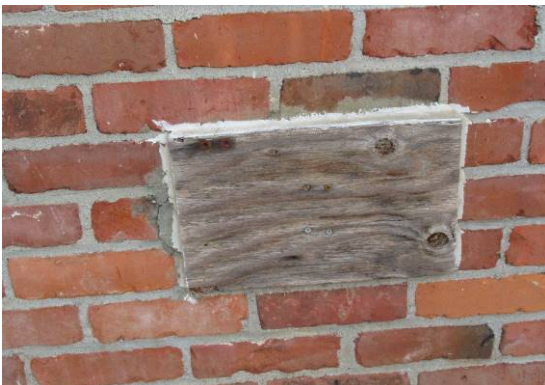
Seal penetration

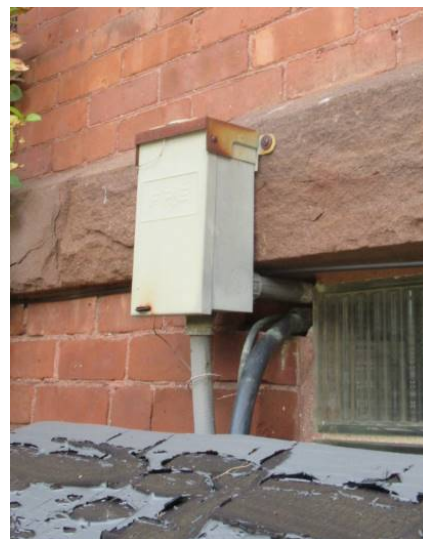
Seal penetration

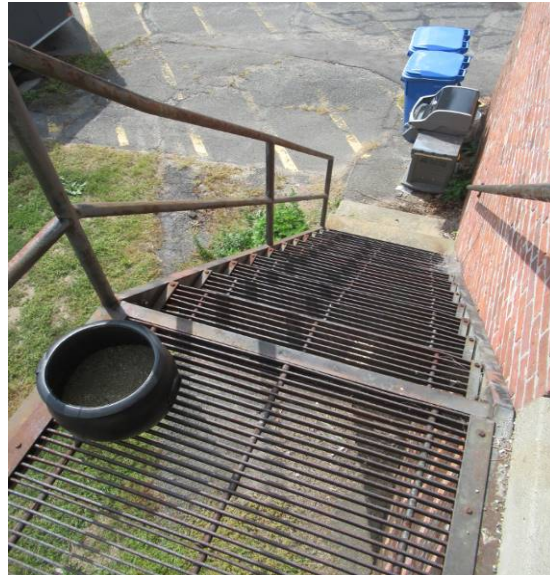
There is one fire escape assembly from the upper level meeting room to grade. It is located on the east side of the building. It requires minor repairs and repainting for weather protection. There are egress obstructions (plastic bucket with sand, gas grille and trash containers) that should be removed to provide a clear path of travel to grade. There is no emergency egress lighting present on the exterior of the building to illuminate the egress to grade and it should be added.

Pathway obstructions

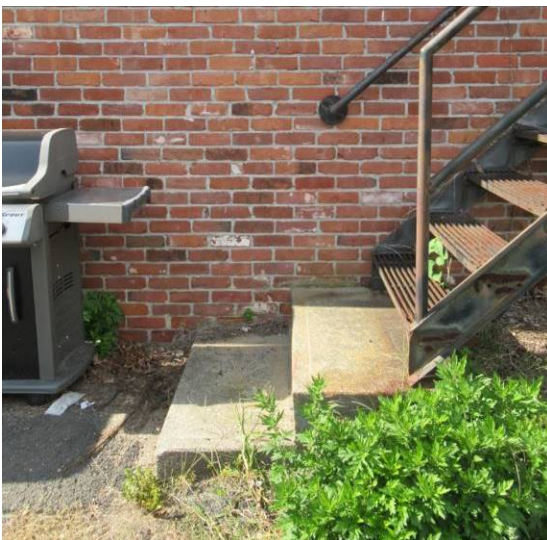
Irregular steps at the bottom should be consistent with the steel treads and handrails for the full length of the stairs.

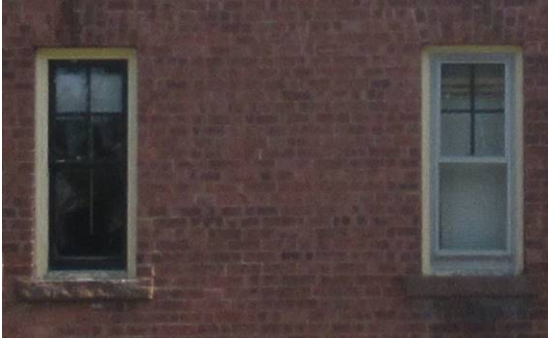
(2-Units, should match)

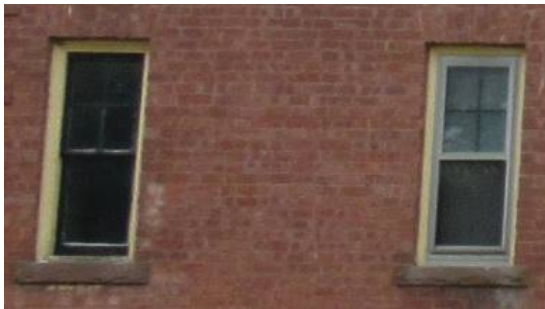
(2-Units, should match)
