# ACCESSIBILITY ASSESSMENT

## ADA TITLE III ASSESSMENT

Centennial Elementary School

March 4, 2025

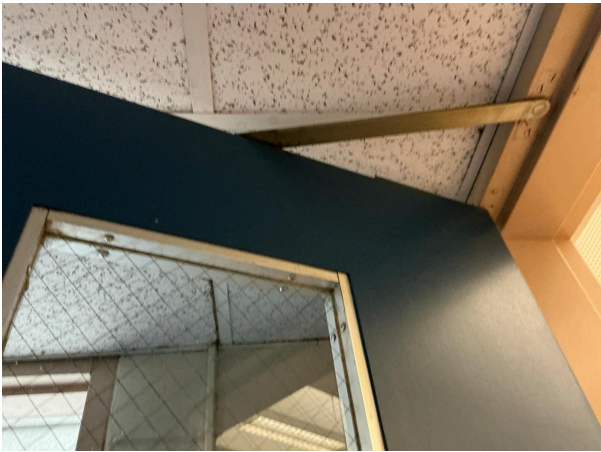
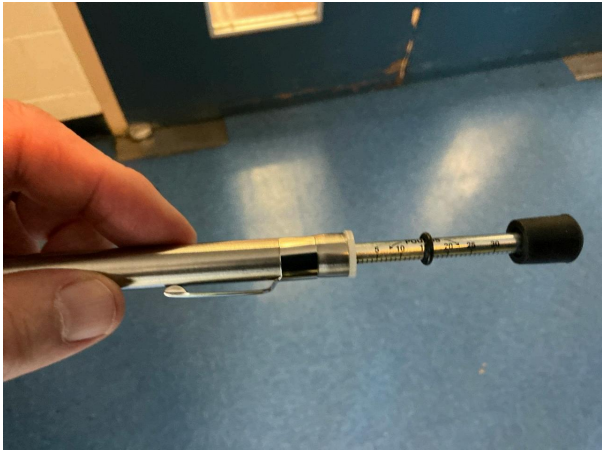
| Site Conditions | Force to open is 16 pounds at each door. |

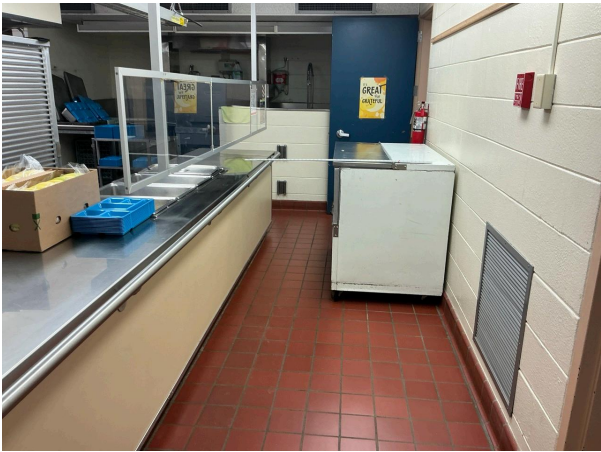
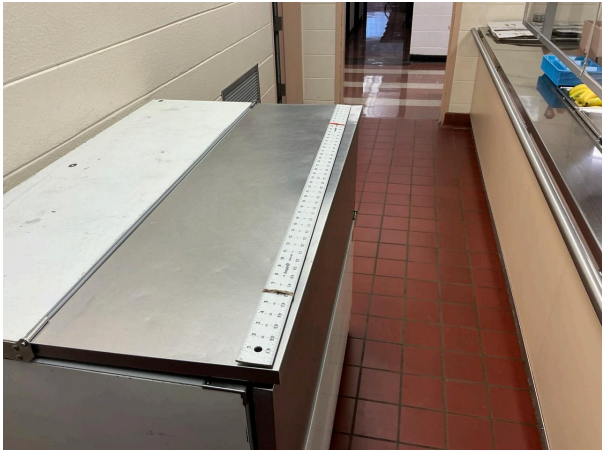
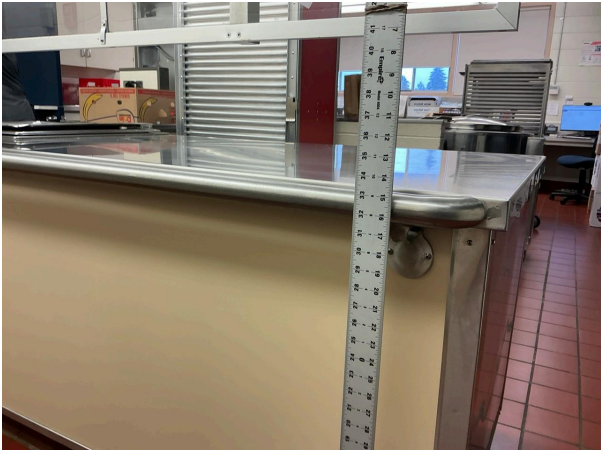
| <b>Site Conditions</b> | Service line pathway is 23" width between tray counter and refrigeration unit. |

relocate refrigeration unit outside of pathway width or provide a compliant surface on the accessible route to the end of service line and to all dining areas required to be compliant. A compliant surface In restaurants and cafeterias shall be firm, stable and slip resistant. [Advisory 302.1 General. A stable surface is one that remains unchanged by contaminants or applied force, so that when the contaminant or force is removed, the surface returns to its original condition. A firm surface resists deformation by either indentations or particles moving on its surface. A slip-resistant surface provides sufficient frictional counter force to the forces exerted in walking to permit safe ambulation.] An accessible route shall be provided to all dining areas, including raised or sunken dining areas, and outdoor dining areas. [EXCEPTIONS: 1. In buildings or facilities not required to provide an accessible route between stories, an accessible route shall not be required to a mezzanine dining area where the mezzanine contains less than 25 percent of the total combined area for seating and dining and where the same decor and services are provided in the accessible area. 2. In alterations, an accessible route shall not be required to existing raised or sunken dining areas, or to all parts of existing outdoor dining areas where the same services and decor are provided in an accessible space usable by the public and not restricted to use by people with disabilities. 3. In sports facilities, tiered dining areas providing seating shall be required to have accessible routes serving at least 25 percent of the dining area provided that accessible routes serve seating and each tier is provided with the same services.] [Advisory 206.2.5 Restaurants and Cafeterias Exception 2. Examples of "same services" include, but are not limited to, bar service, rooms having smoking and non-smoking sections, lotto and other table games, carry-out, and buffet service. Examples of "same decor" include, but are not limited to, seating at or near windows and railings with views, areas designed with a certain theme, party and banquet rooms, and rooms where entertainment is provided.] An accessible route is minimum 36" wide, minimum 1:20 (5%) running slope and minimum 1:48 (2.08%) cross slope.

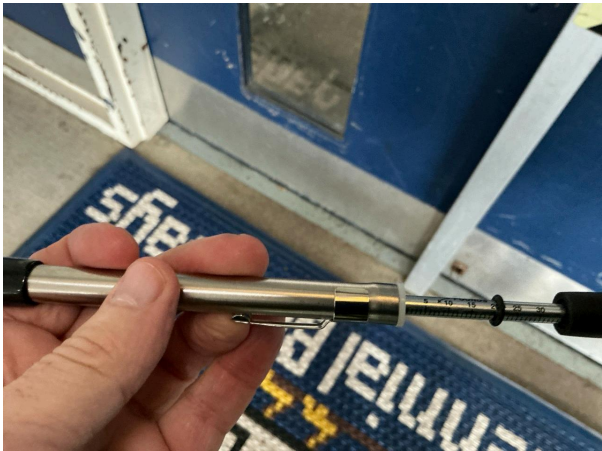
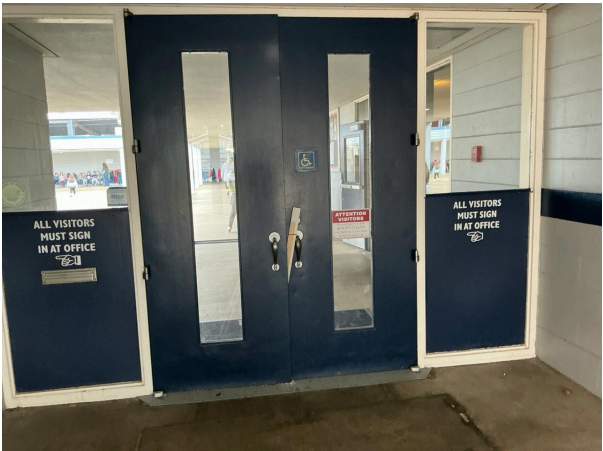
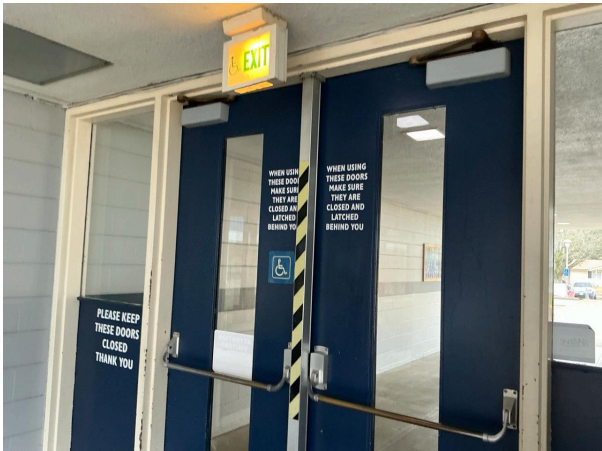
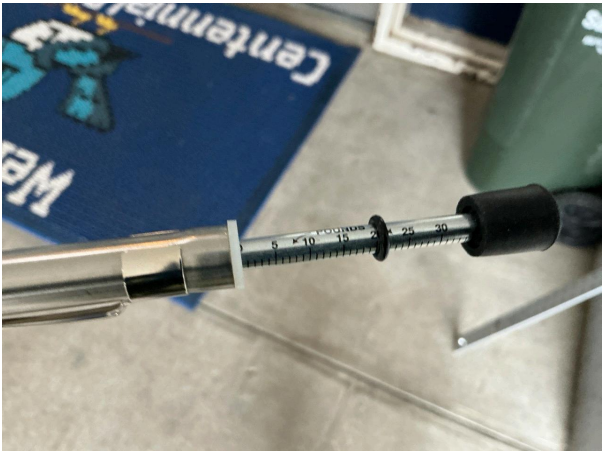
Photos for Barrier ID: AX553352

| <b>Site Conditions</b> | Force to open is in excess of 19 pounds in each door. |

Adjust the closer/opener or replace with a door which requires no more force to open and close than the minimum allowable force required by the appropriate administrative authority. The force at the latch, the force to set the door in motion, and the force to fully open the door shall be the minimum allowable. These forces do not apply to the force required to retract latch bolts or disengage other devices that hold the door or gate in a closed position.

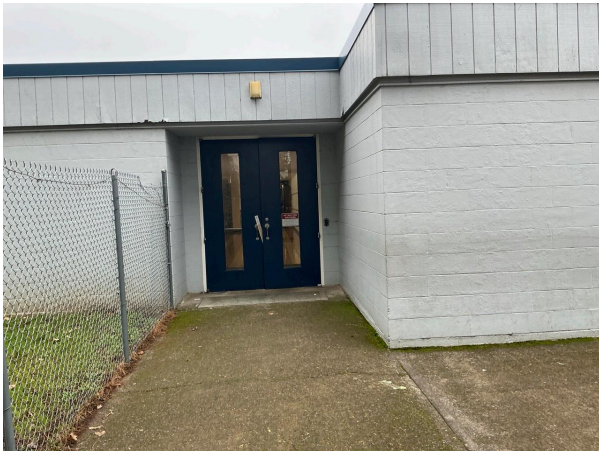
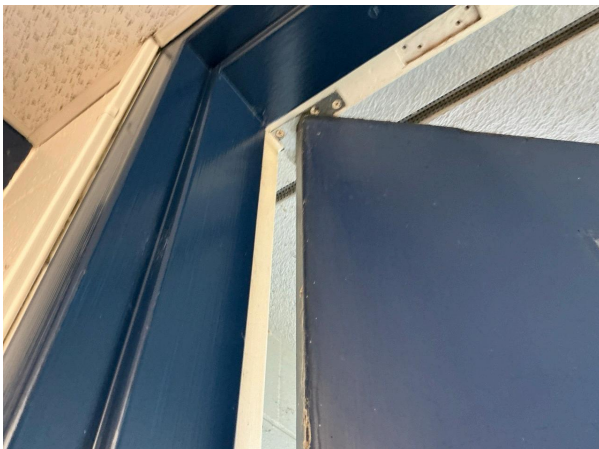
Photos for Barrier ID: AX553335

| Site Conditions | Force to open is 15 pounds in each door. |

Adjust the closer/opener or replace with a door which requires no more force to open and close than the minimum allowable force required by the appropriate administrative authority. The force at the latch, the force to set the door in motion, and the force to fully open the door shall be the minimum allowable. These forces do not apply to the force required to retract latch bolts or disengage other devices that hold the door or gate in a closed position.

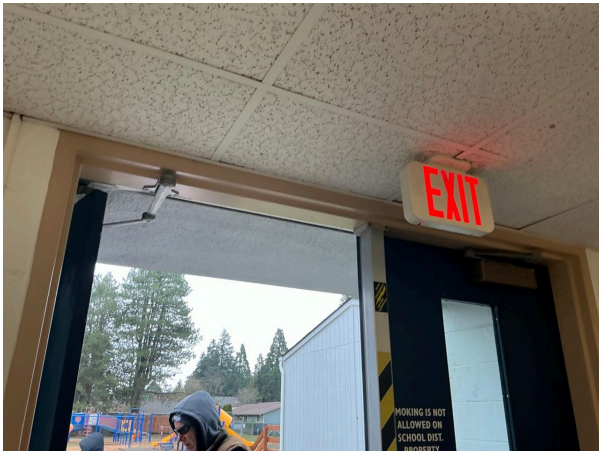
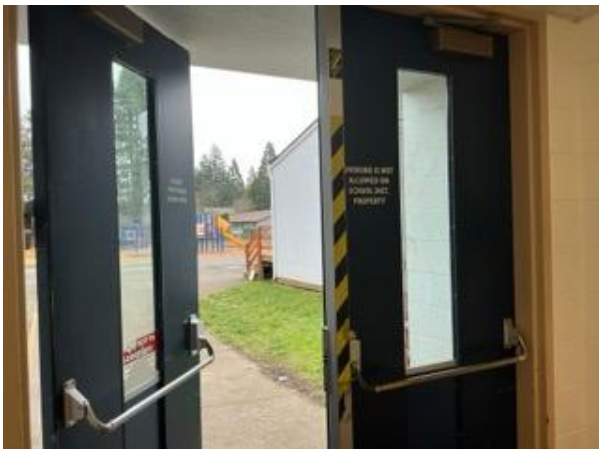
Photos for Barrier ID: AX553341

| Site Conditions | Force to open is 16 pounds in each door. |

Adjust the closer/opener or replace with a door which requires no more force to open and close than the minimum allowable force required by the appropriate administrative authority. The force at the latch, the force to set the door in motion, and the force to fully open the door shall be the minimum allowable. These forces do not apply to the force required to retract latch bolts or disengage other devices that hold the door or gate in a closed position.

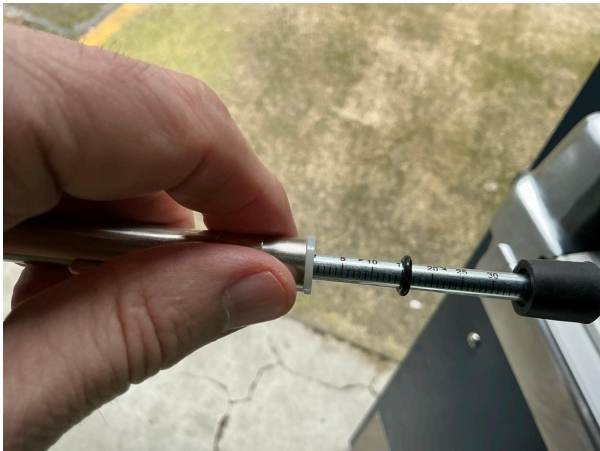
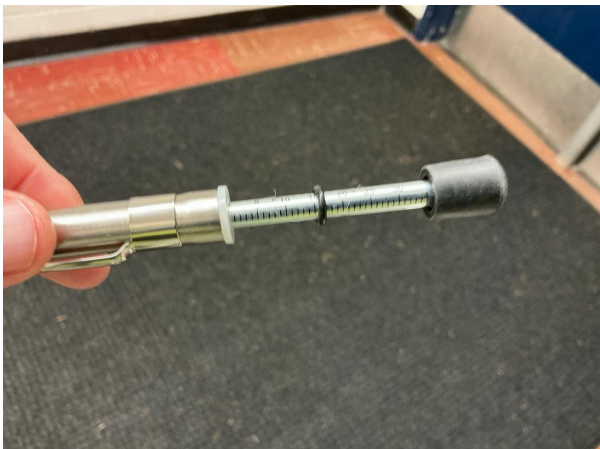
Photos for Barrier ID: AX553338

| Site Conditions | Force to open is 10 pounds and 10.5 pounds at each door. |

Adjust the closer/opener or replace with a door which requires no more force to open and close than the minimum allowable force required by the appropriate administrative authority. The force at the latch, the force to set the door in motion, and the force to fully open the door shall be the minimum allowable. These forces do not apply to the force required to retract latch bolts or disengage other devices that hold the door or gate in a closed position.

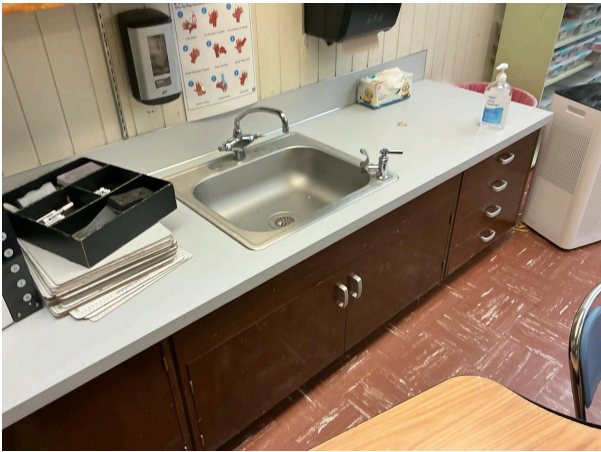
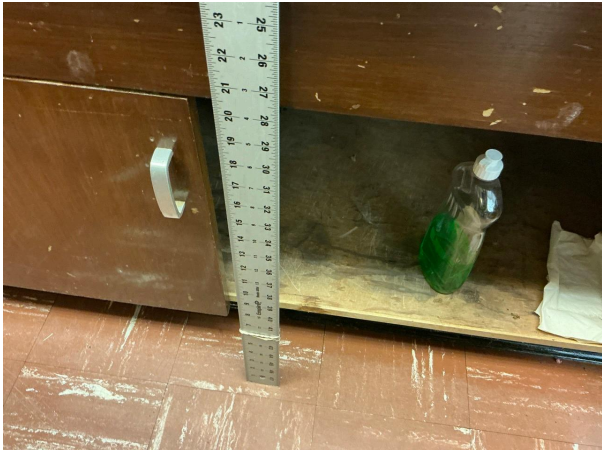
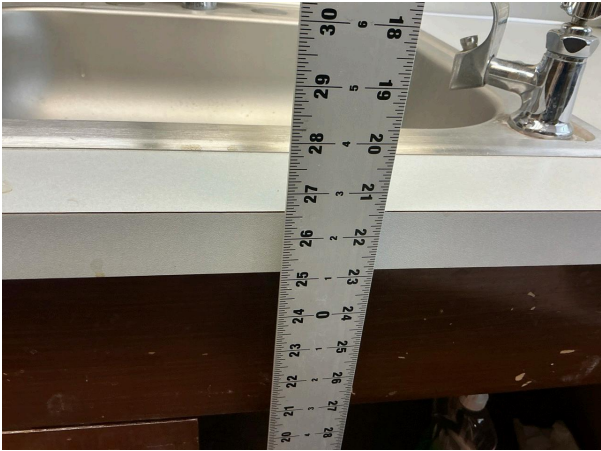
| <b>Site Conditions</b> | No knee or toe clearance is provided beneath sink due to the cabinets. |

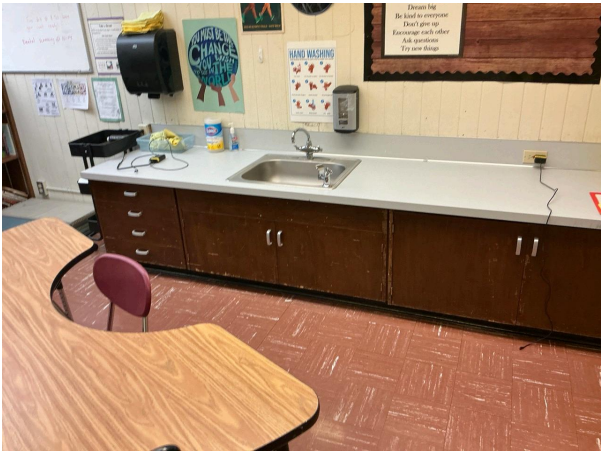
| <b>Site Conditions</b> | No knee or toe clearance is provided beneath sink due to cabinets. |

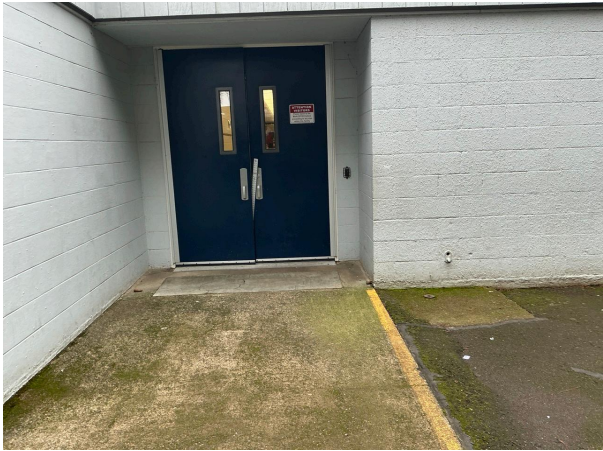
| Site Conditions | Bottom edge of vision panel measures 52" off of the floor surface. |

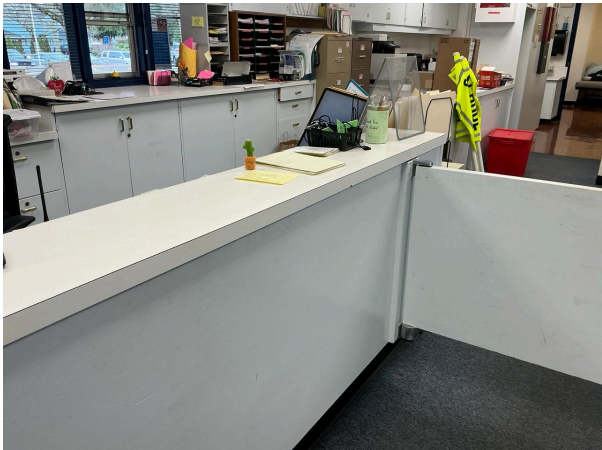
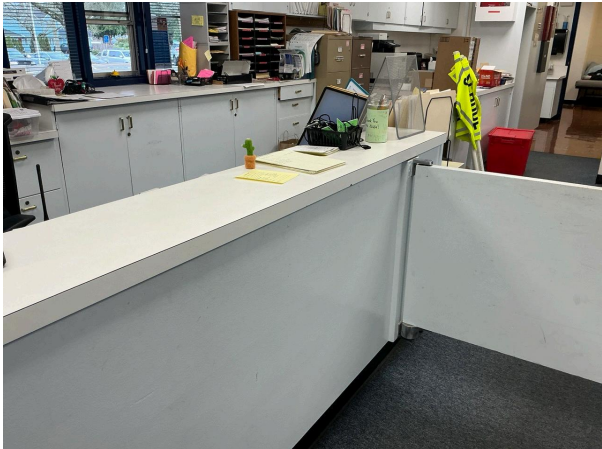
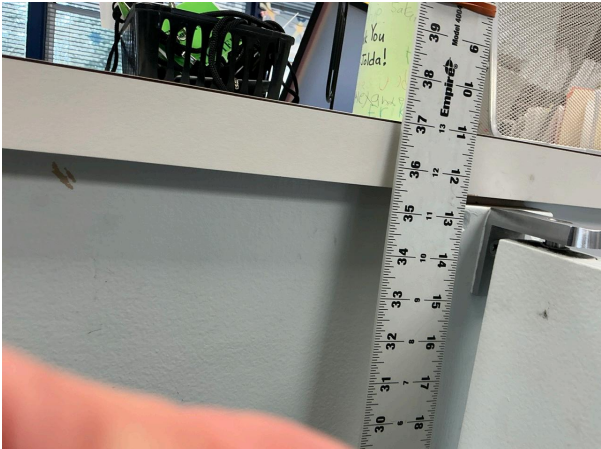
| <b>Site Conditions</b> | Counter measures 37" from floor surface. |

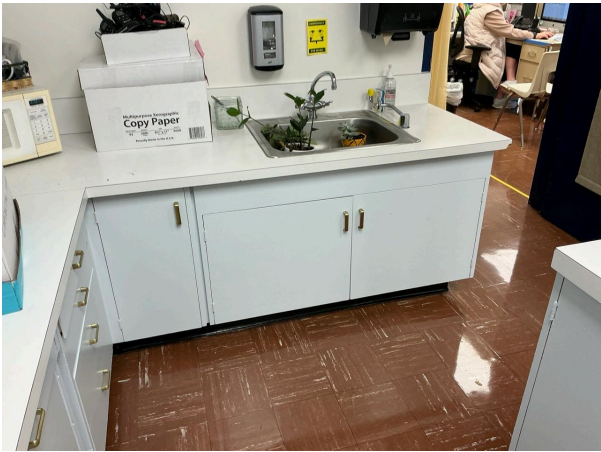
| <b>Site Conditions</b> | No knee or toe clearance is provided at sink due to cabinets. |

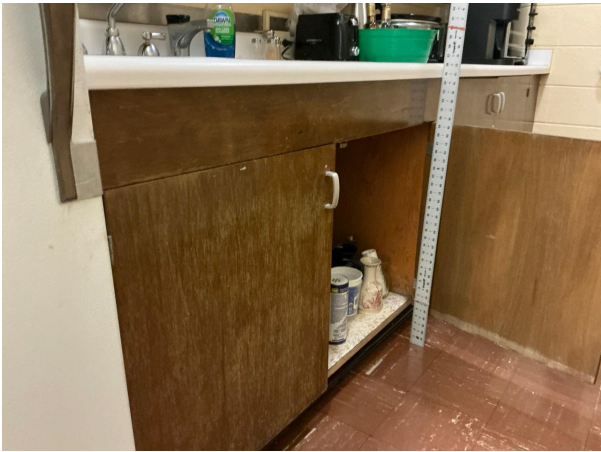
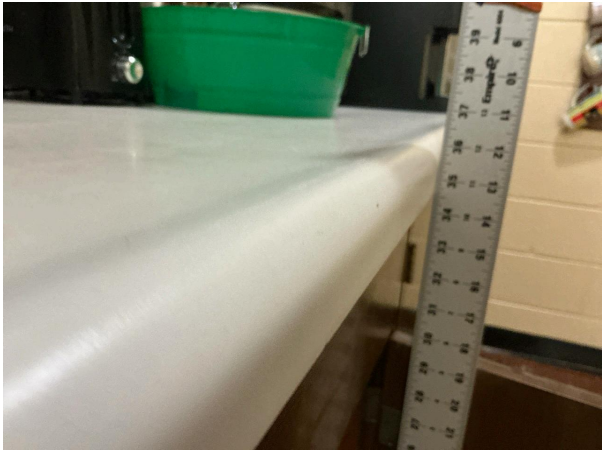
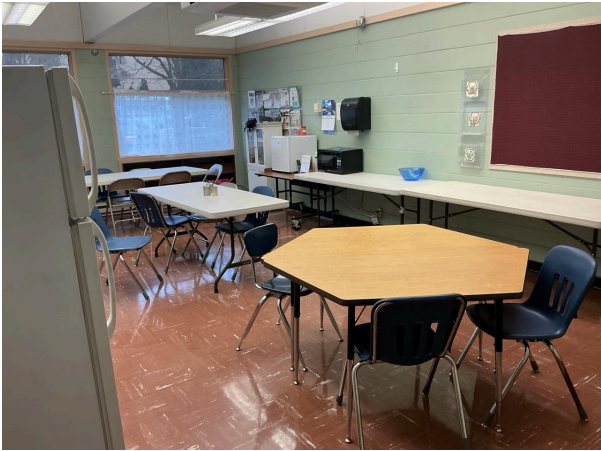
| <b>Site Conditions</b> | No knee or toe clearance is provided at sink due to cabinets. |

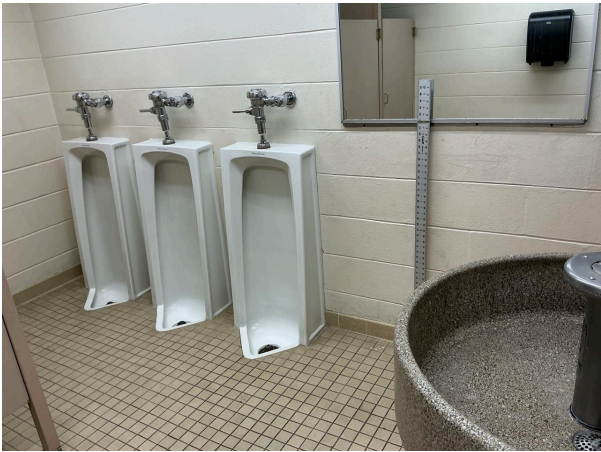
| Site Conditions | Bottom edge of reflective surface measures 42 1/4" above floor surface. |

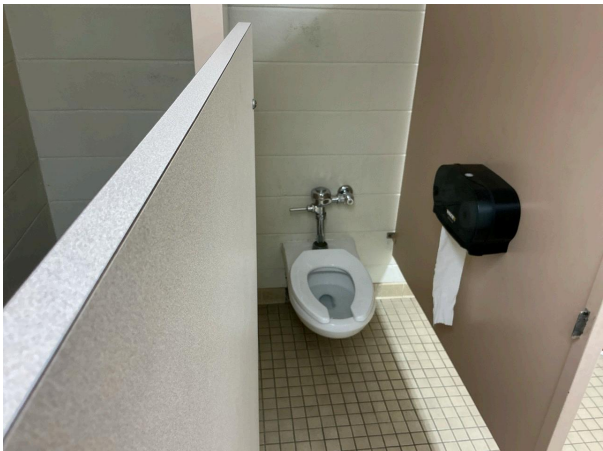
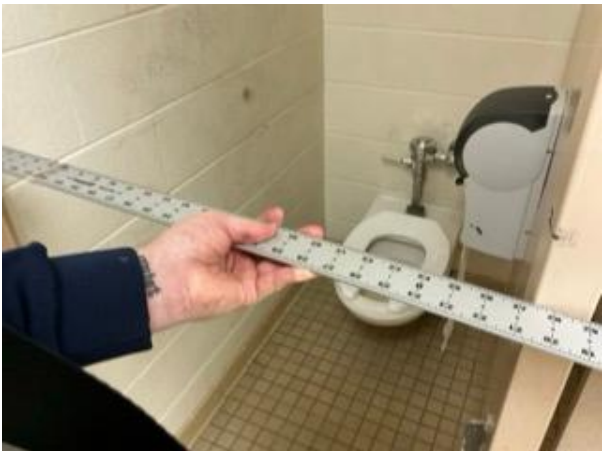
Photos for Barrier ID: AX553365

| Site Conditions | Wheelchair stall does not have flush handle mounted on the open side. |

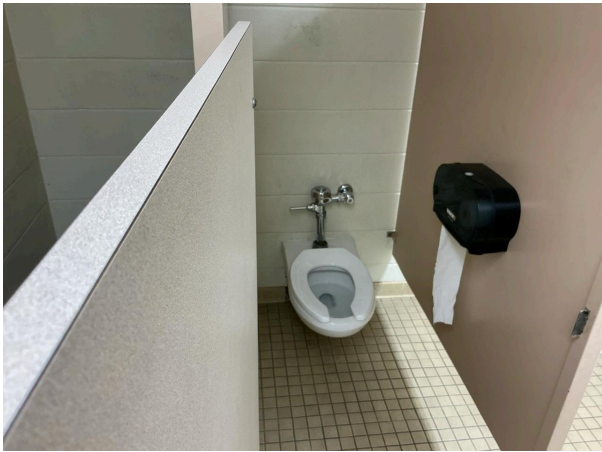
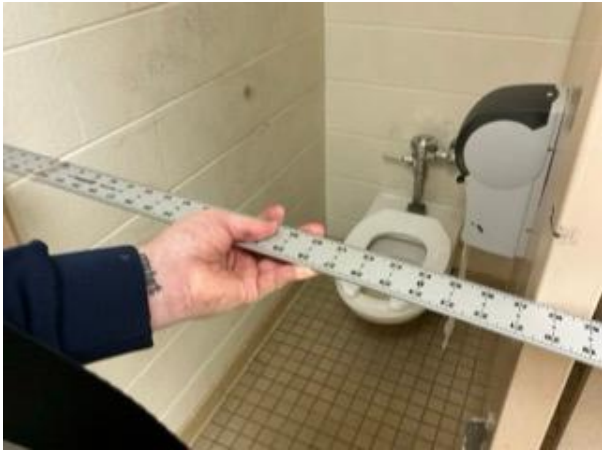
| Site Conditions | The stall provided in multiuser restroom measures 33" wide. |

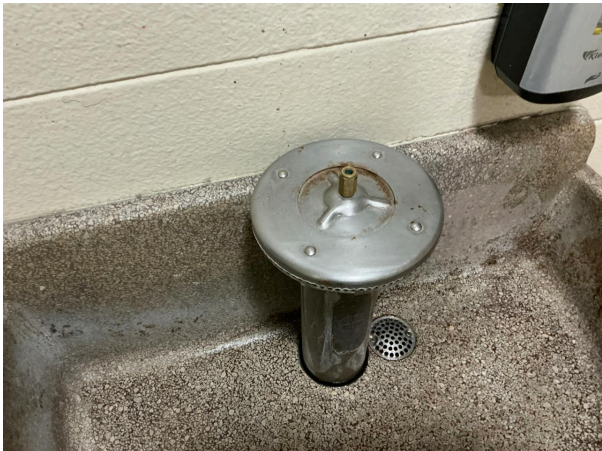
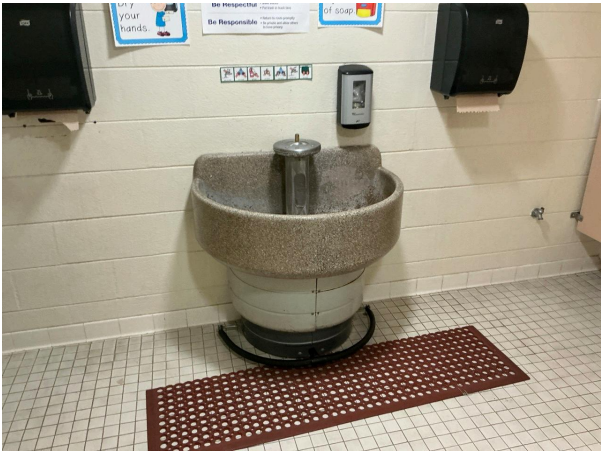
Photos for Barrier ID: AX553343

| Site Conditions | Lavatory faucet is not operable. |

Provide push/lever hardware for the faucet. Replace faucet operating hardware with compliant handles. Operable parts, such as faucet hardware, shall be operable with one hand and shall not require tight grasping, pinching, or twisting of the wrist. The force required to activate operable parts shall be 5 pounds (22.2 N) maximum. Hand-operated metering faucets shall remain open for 10 seconds minimum. Provide a minimum of one accessible sink with push/lever hardware.

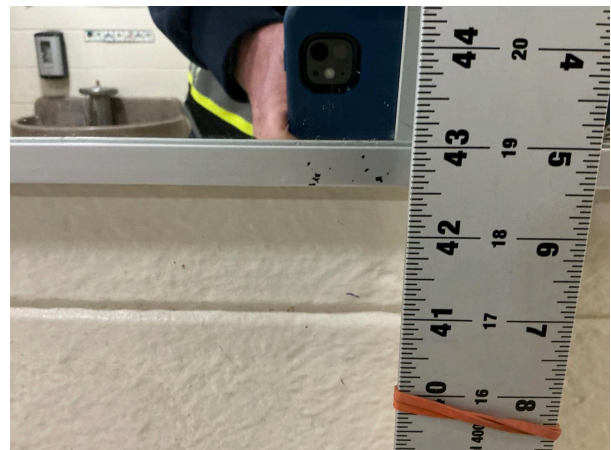
## Photos for Barrier ID: AX553344

| <b>Site Conditions</b> | Bottom edge of reflective surface measures 43" off floor. |

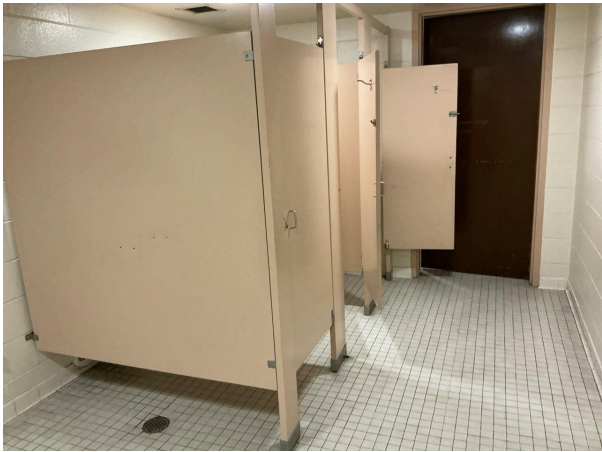
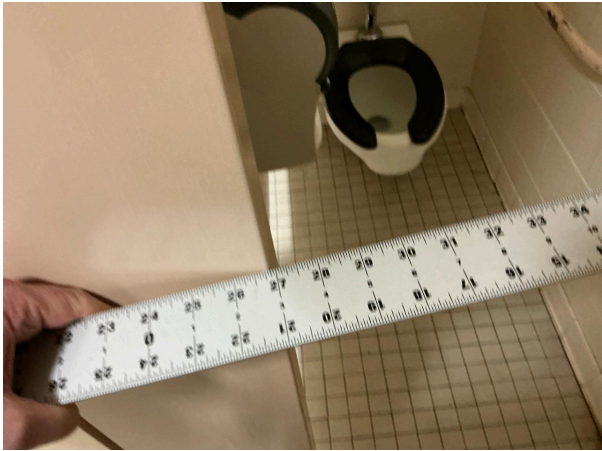
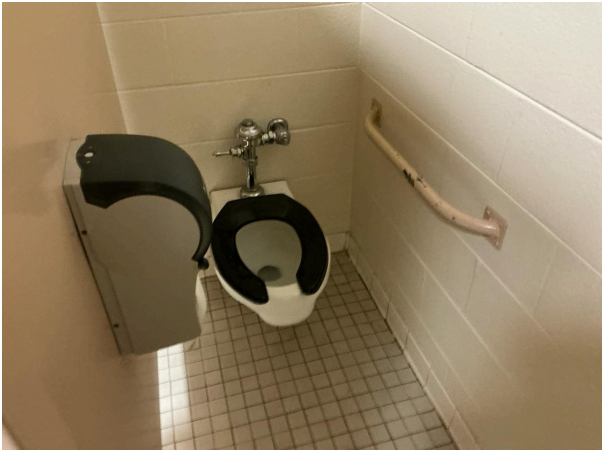
| Site Conditions | Stall door width is 27". Interior stall width is 32". No grout provided above rear of toilet. |

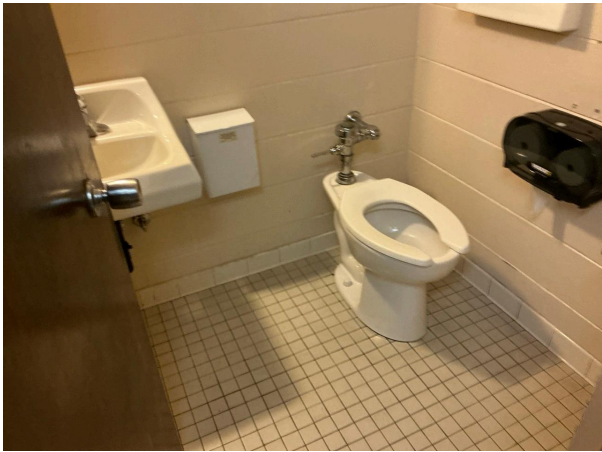
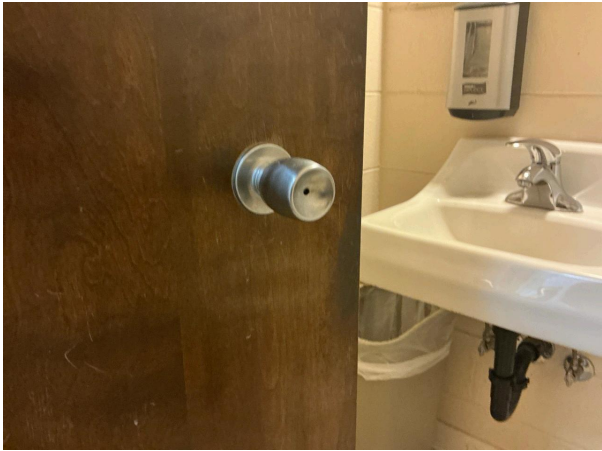
| Site Conditions | Restroom door hardware requires, twisting, grasping, and turning of the wrist. |

Remove hardware and replace with hardware that has a shape that is easy to grasp such as lever, push-type or U-shaped handles. Handles, pulls, latches, locks, and other operable parts on doors and gates shall be compliant. Operable parts of such hardware shall be 34" minimum and 48" maximum above the finish floor or ground. Where sliding doors are in the fully open position, operating hardware shall be exposed and usable from both sides. [EXCEPTIONS: 1. Existing locks shall be permitted in any location at existing glazed doors without stiles, existing overhead rolling doors or grilles, and similar existing doors or grilles that are designed with locks that are activated only at the top or bottom rail. 2. Access gates in barrier walls and fences protecting pools, spas, and hot tubs shall be permitted to have operable parts of the release of latch on self-latching devices at 54" maximum above the finish floor or ground provided the self-latching devices are not also self-locking devices and operated by means of a key, electronic opener, or integral combination lock.]

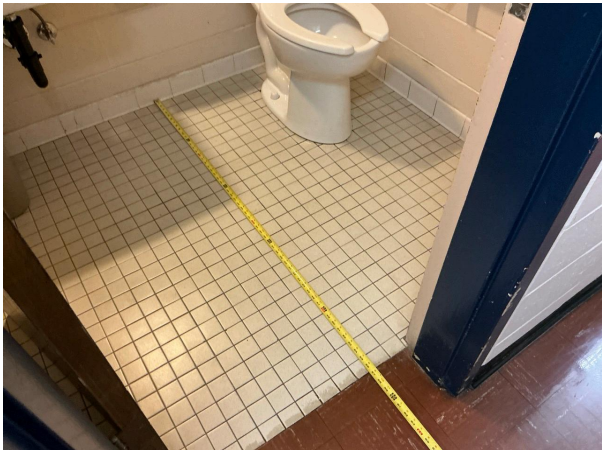
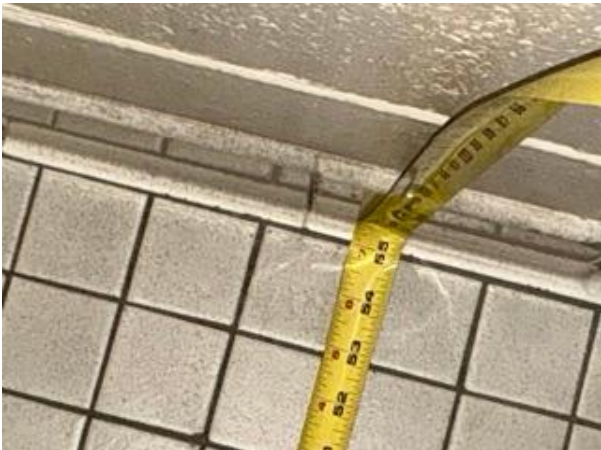
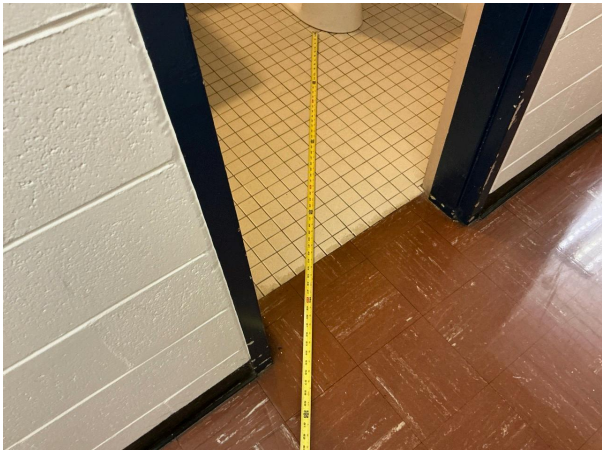
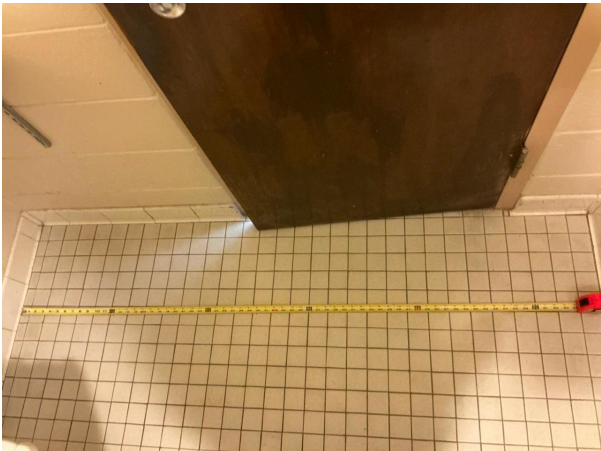
Photos for Barrier ID: AX553322

| Site Conditions | The dimensions of the restroom are 67-1/2" wide and 55" deep. |

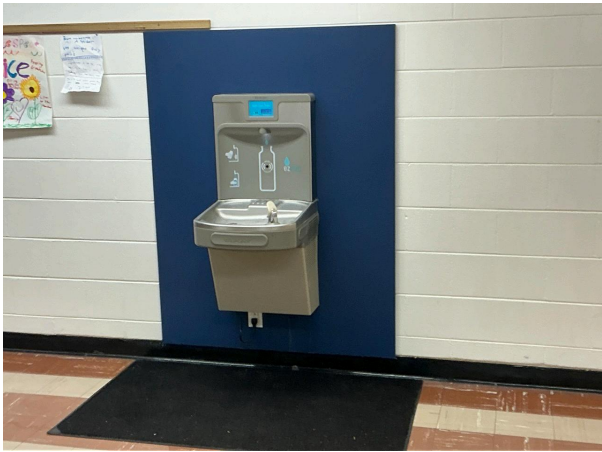
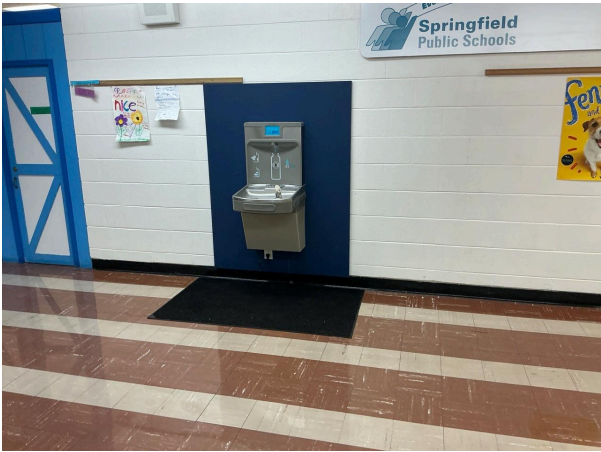
| <b>Site Conditions</b> | No standing level fountain is provided. |

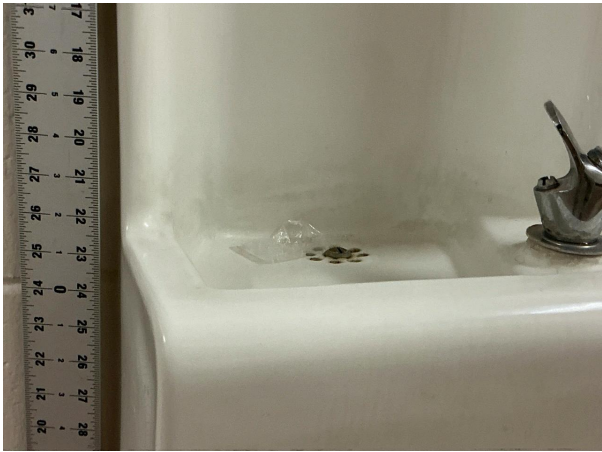
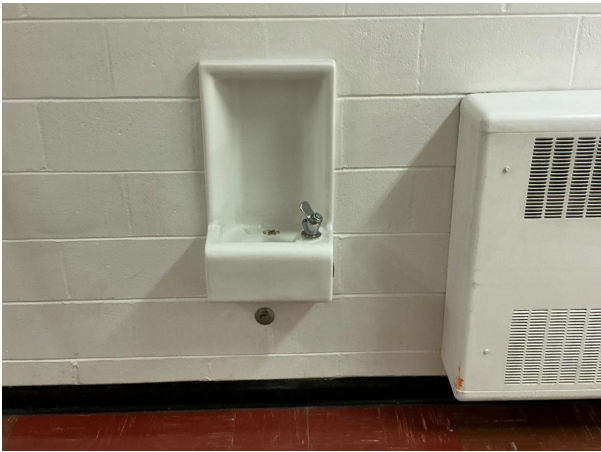
| <b>Site Conditions</b> | No standing level fountain is provided. |
