# ACCESSIBILITY ASSESSMENT

February 24, 2025

## **ADA TITLE II ASSESSMENT**

Thurston Elementary School

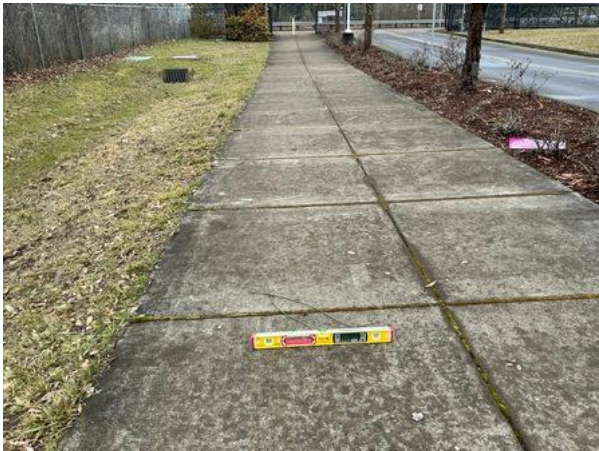
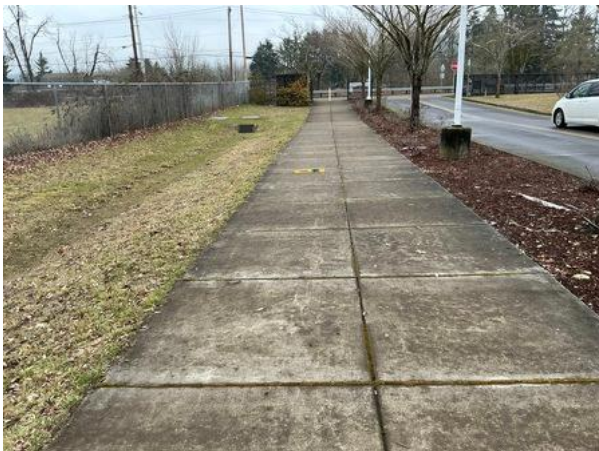
Photos for Barrier ID: AX563294

| <b>Site Conditions</b> | The exterior accessible route has cross slopes of 2.2%. |

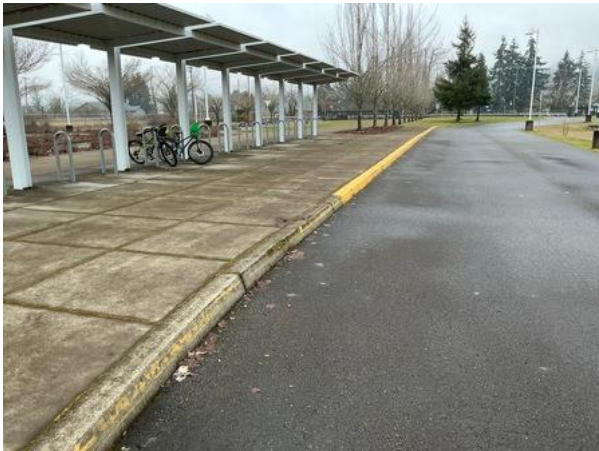
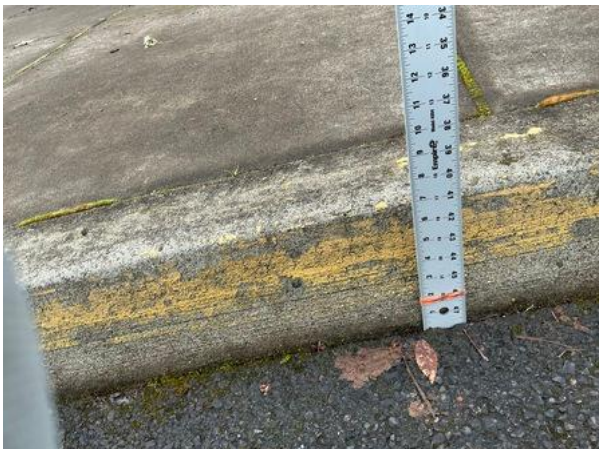
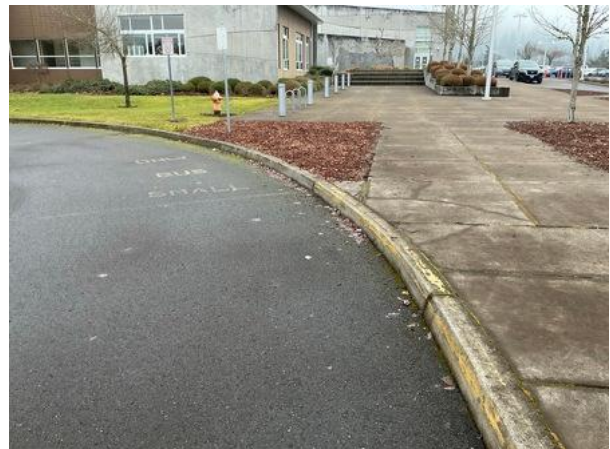
Photos for Barrier ID: AX563293

| Site Conditions | An accessible loading/unloading zone is not provided. | |

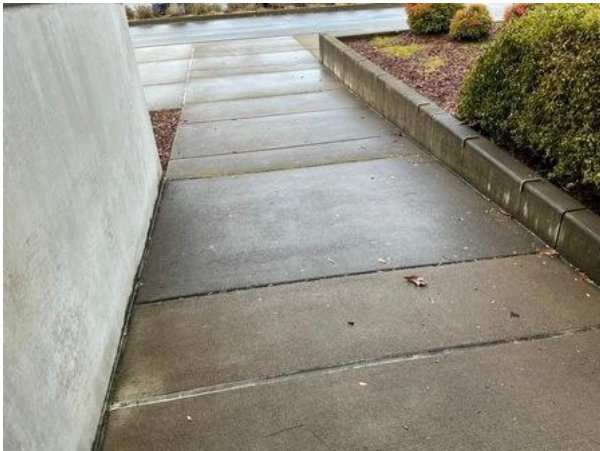
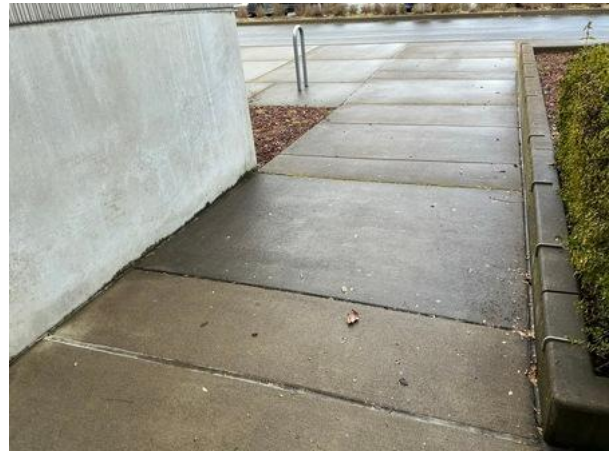
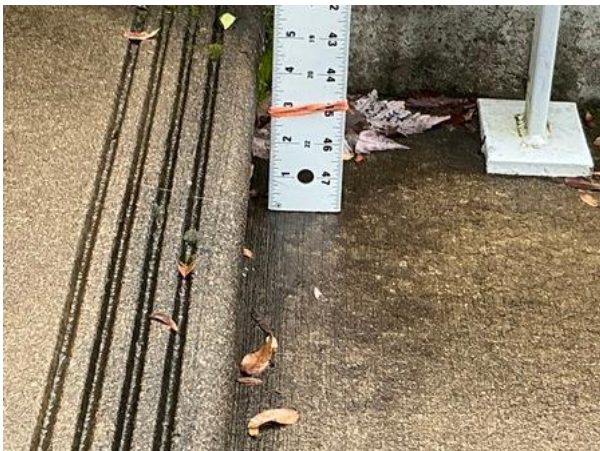
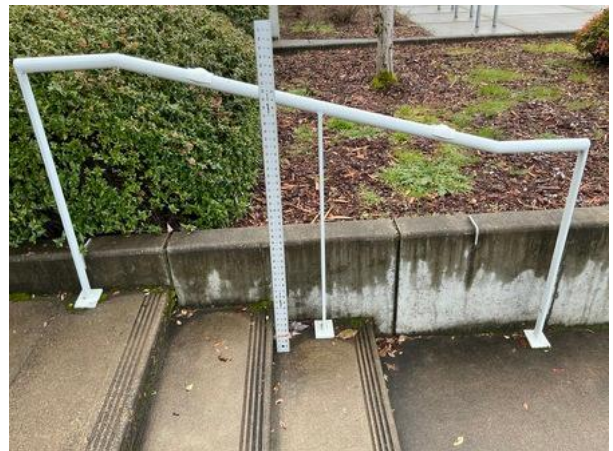
Photos for Barrier ID: AX563265

| Site Conditions | Handrails are not provided at ramp. |

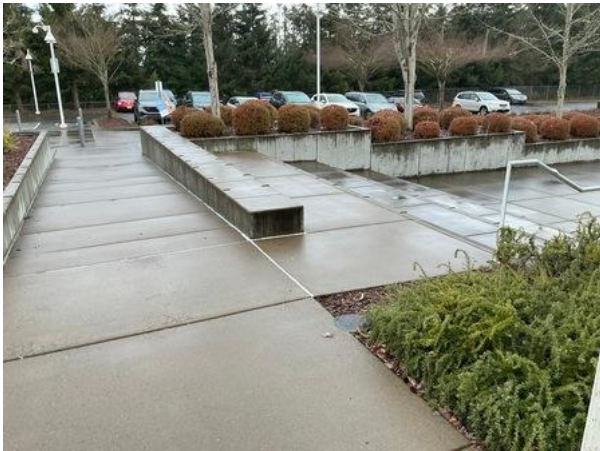
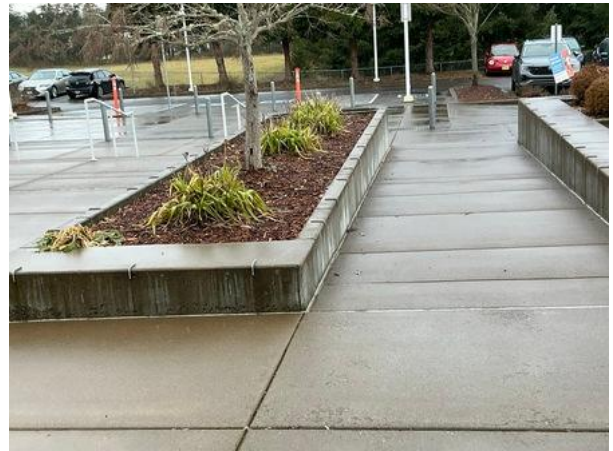
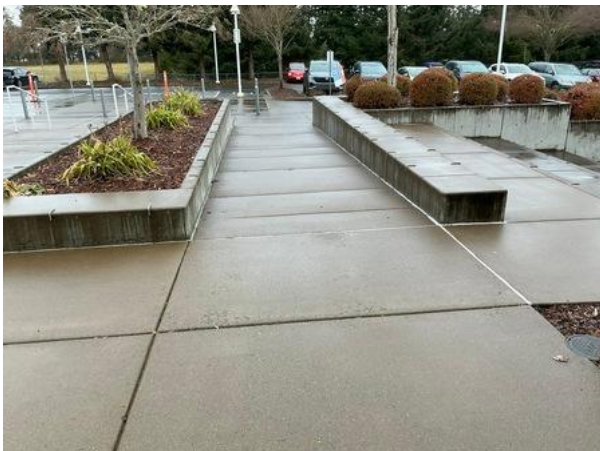
Photos for Barrier ID: AX563268

| Site Conditions | No handrails are provided at the ramp. |

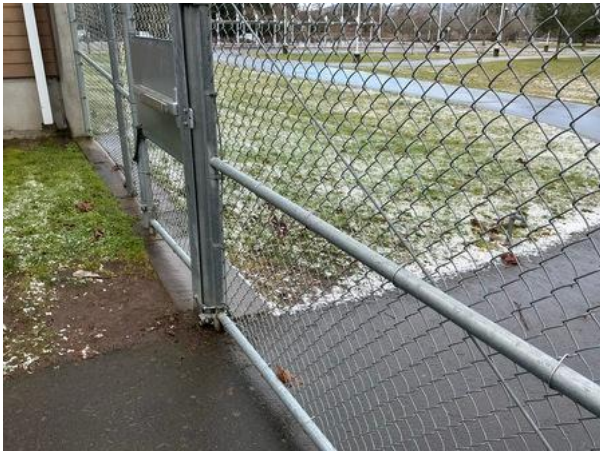
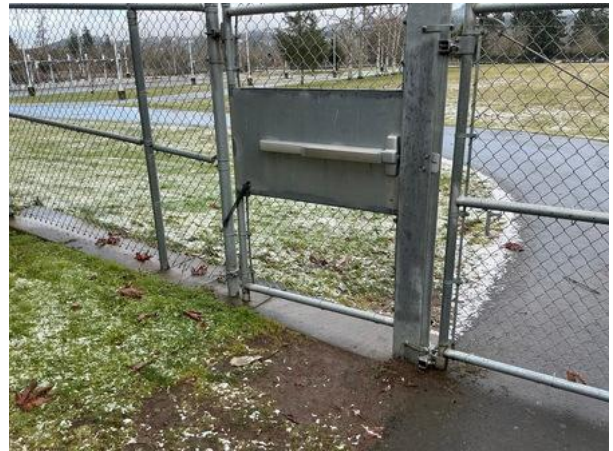
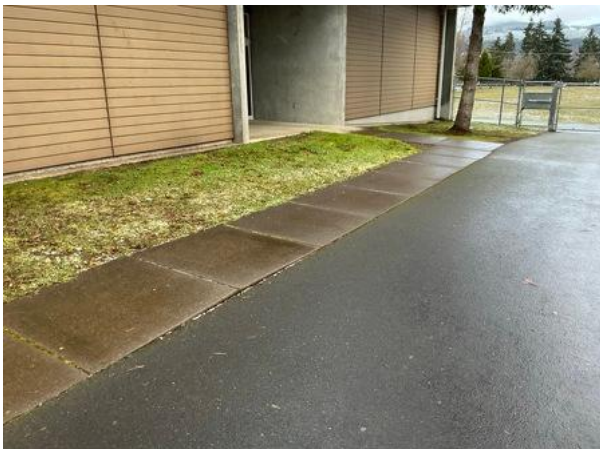
Photos for Barrier ID: AX563251

| Site Conditions | A compliant accessible route is not provided to the gate and path beyond. | |

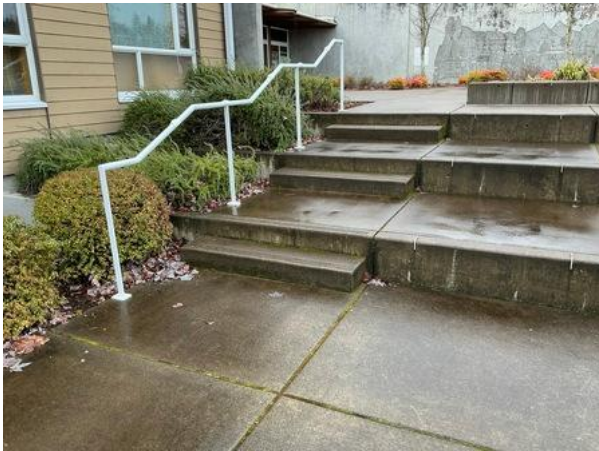
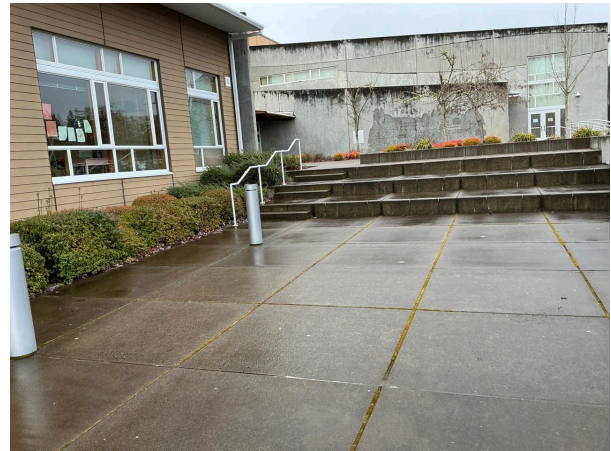
Photos for Barrier ID: AX563267

| <b>Site Conditions</b> | Handrails are provided on one side only. |

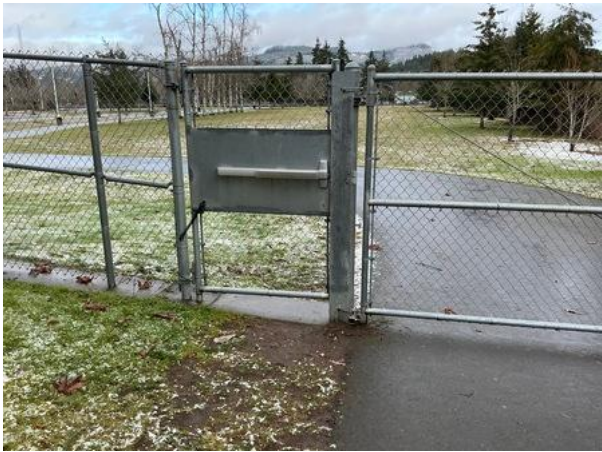
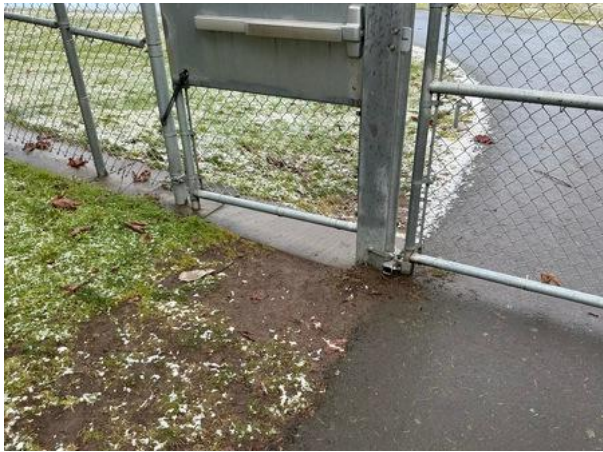
| Site Conditions | The gate does not have a smooth surface within 10" of the ground. |

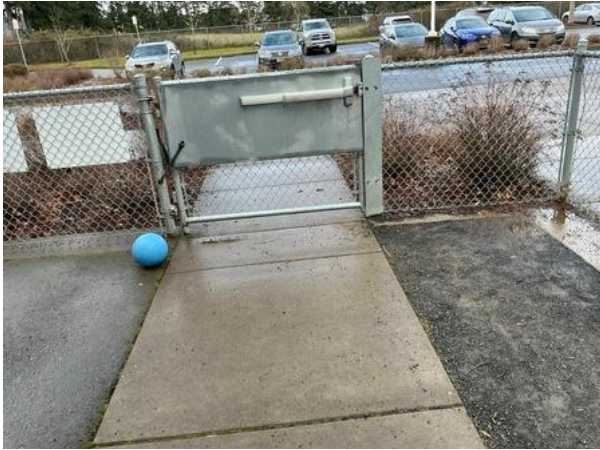
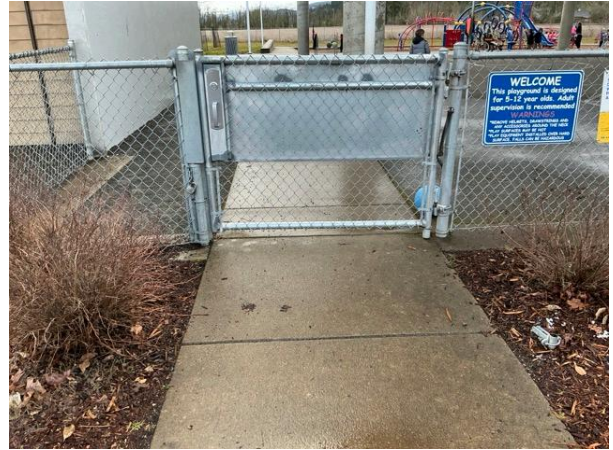
## Photos for Barrier ID: AX563264

| Site Conditions | The gate does not have a smooth surface within 10" of the ground. |

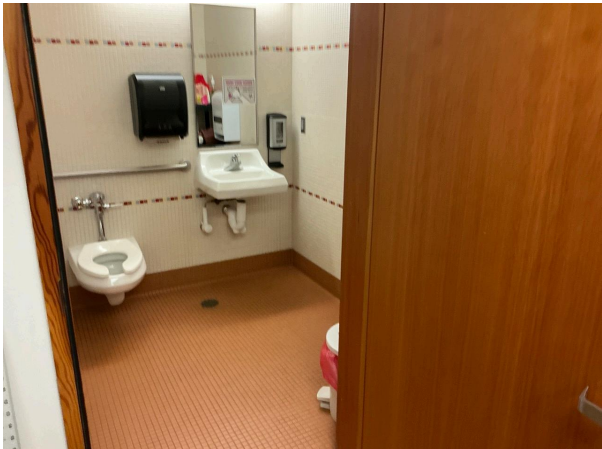
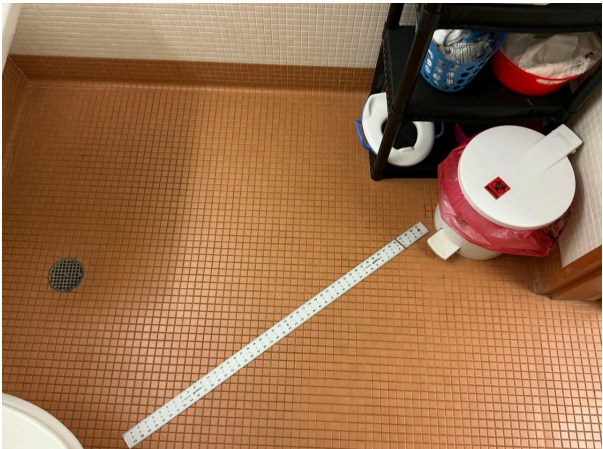
Photos for Barrier ID: AX563255

| Site Conditions | Maneuvering room obstructed by bio-hazard waste dispenser and storage. |

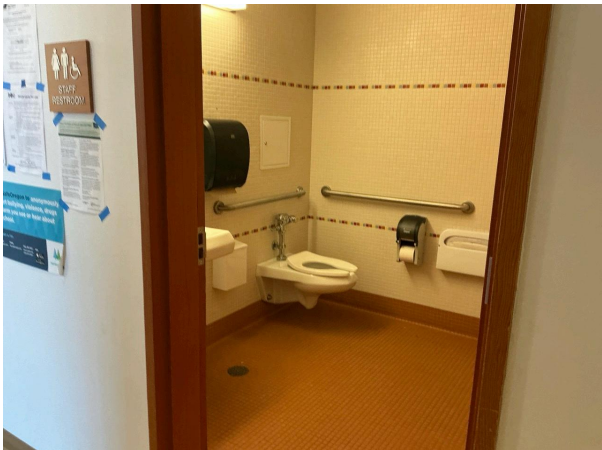
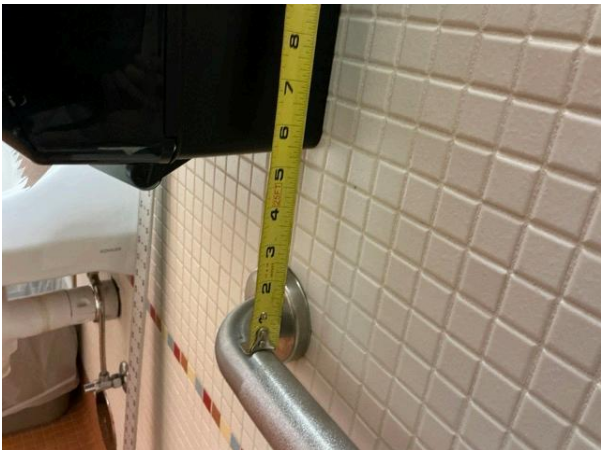
Photos for Barrier ID: AX563256

| Site Conditions | The paper towel dispenser is positioned 5-1/2" above end of grab bar. |

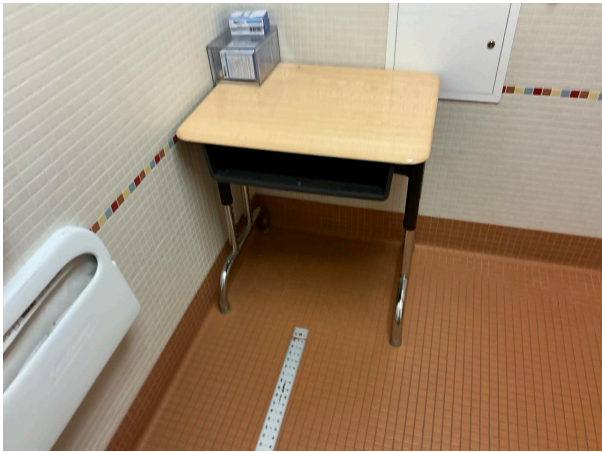
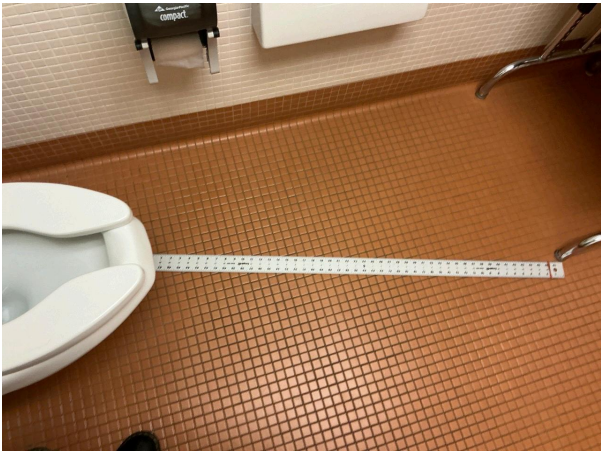
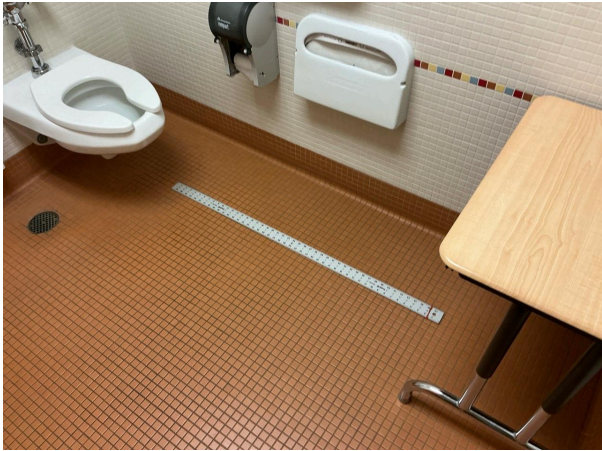
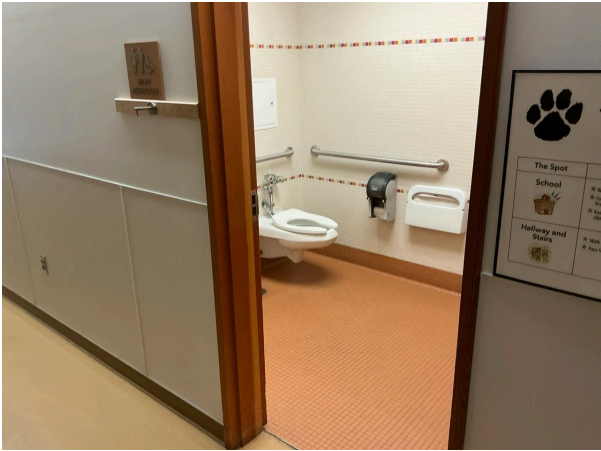
| <b>Site Conditions</b> | The required turning space within the restroom is obstructed by the table. |
