# ACCESSIBILITY ASSESSMENT

February 5, 2025

## **ADA TITLE II ASSESSMENT**

Walterville Elementary School

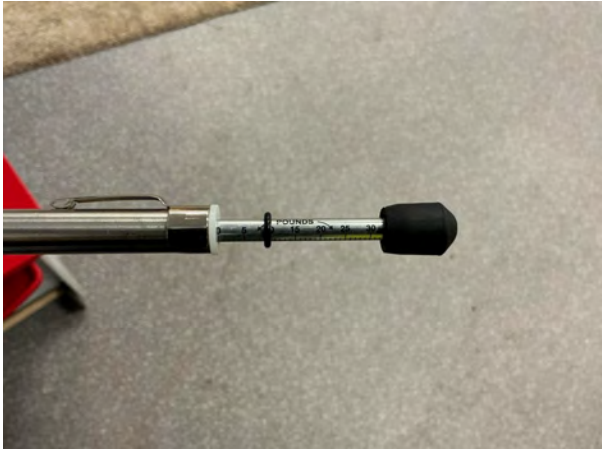
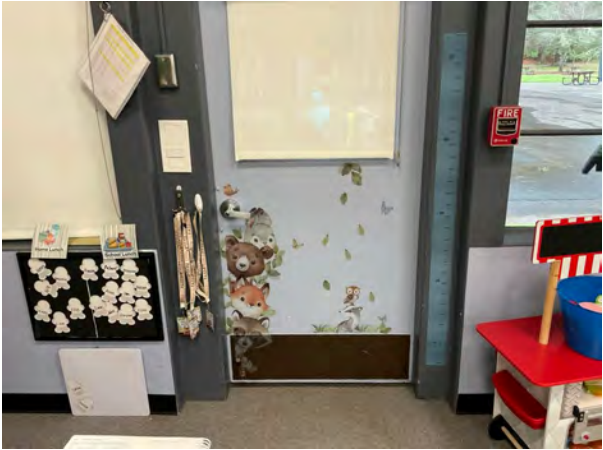
Photos for Barrier ID: AX525925

| Site Conditions | The opening force is 10 pounds. |

Adjust the closer or replace with an exterior door that requires no more 8.5 pounds of force for pushing or pulling the door open. The opening force of doors along an accessible route shall be as follows: 1. Exterior doors: 8.5 pounds maximum (lbf) (37.8 N). 2. Interior doors: 5 pounds maximum (lbf) (22.2 N). 3. Stairway doors at pressurized stair enclosures: 15 pounds maximum (6.8 kg) at exterior doors. 4. Where environmental conditions require greater closing pressure, power-operated doors shall be used within the accessible route. [Exception: The force required to retract latch bolts or disengage other devices that hold the door or gate in a closed position shall not apply to panic hardware, delayed egress devices or fire-rated hardware.]

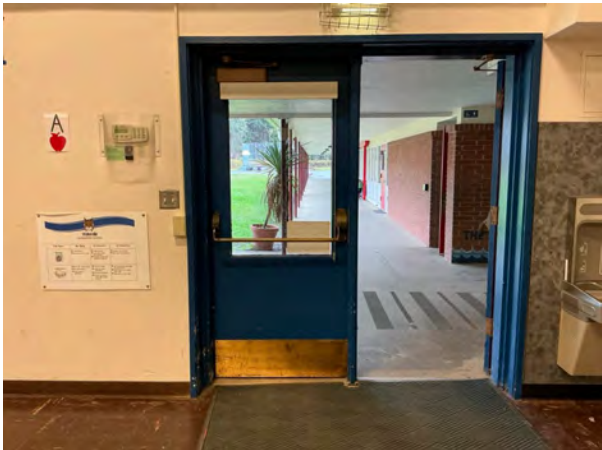
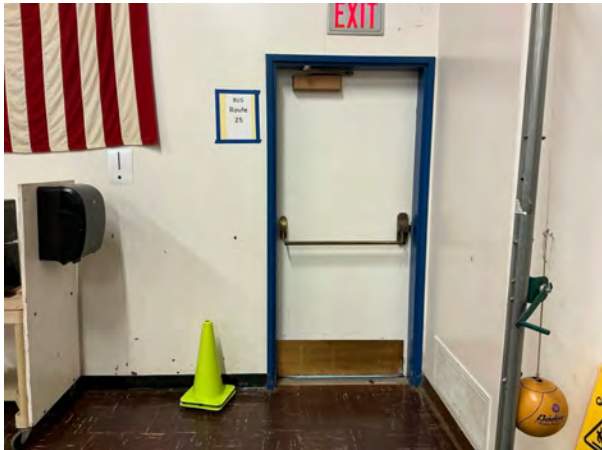
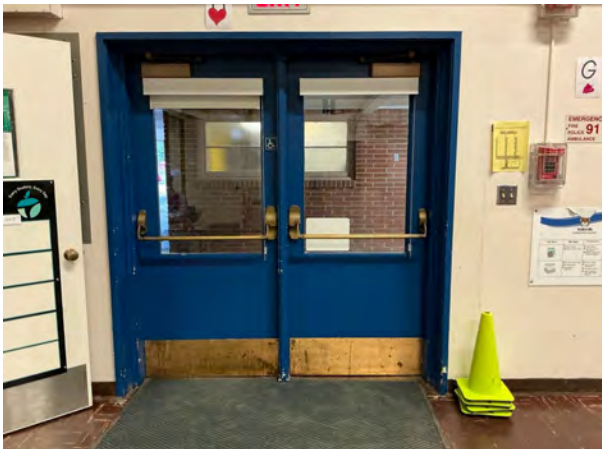
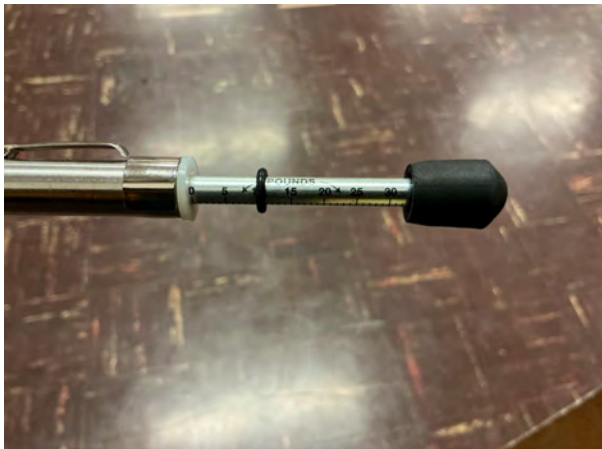
| Site Conditions | The opening force is up to 11 pounds. | |

| Resolution | Adjust the closer or replace with an exterior door that requires no more 8.5 pounds of force for pushing or pulling the door open. This barrier must be removed in conjunction with barrier ID 561089. The opening force of doors along an accessible route shall be as follows: 1. Exterior doors: 8.5 pounds maximum (lbf) (37.8 N). 2. Interior doors: 5 pounds maximum (lbf) (22.2 N). 3. Stairway doors at pressurized stair enclosures: 15 pounds maximum (6.8 kg) at exterior doors. 4. Where environmental conditions require greater closing pressure, power-operated doors shall be used within the accessible route. [Exception: The force required to retract latch bolts or disengage other devices that hold the door or gate in a closed position shall not apply to panic hardware, delayed egress devices or fire-rated hardware.] | |

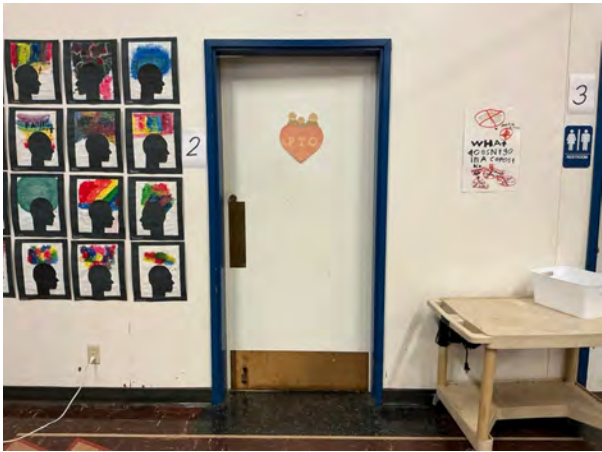
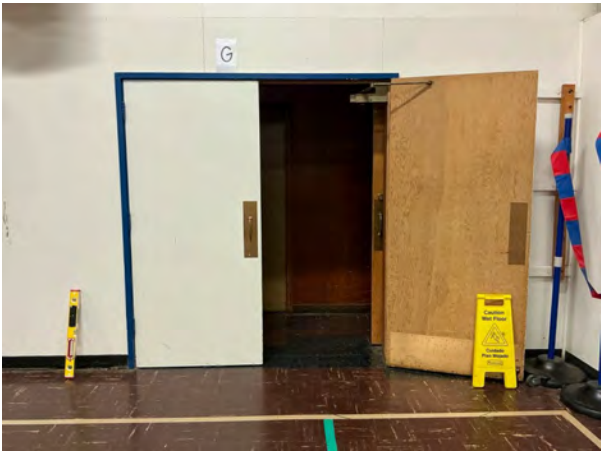
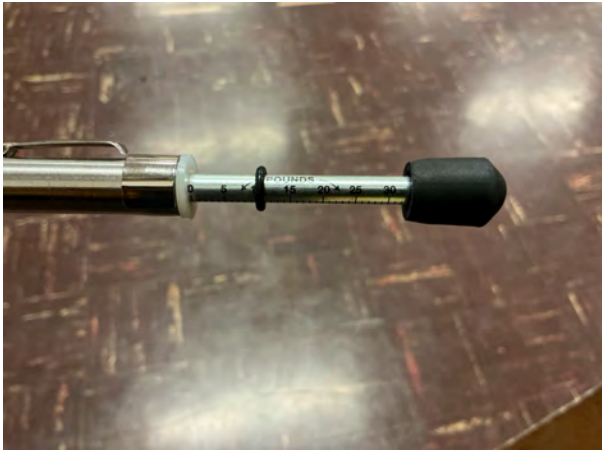
| Site Conditions | The opening force is up to 11 pounds. | |

| Adjust the closer or replace with a door that requires no more than 5 pounds of force for pushing or pulling the door open. This barrier must be removed in conjunction with barrier ID 525920. The force at the latch, the force to set the door in motion, and the force to fully open the door shall be maximum 5 pounds. These forces do not apply to the force required to retract latch bolts or disengage other devices that hold the door or gate in a closed position. | | |

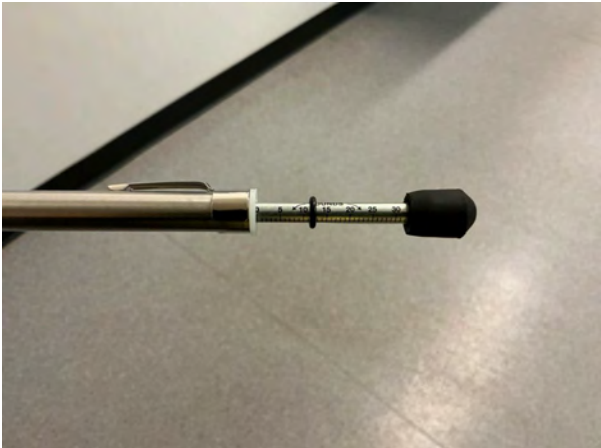
Photos for Barrier ID: AX525932

| Site Conditions | The opening force is 12 pounds. |

Adjust the closer or replace with an exterior door that requires no more 8.5 pounds of force for pushing or pulling the door open. This barrier must be removed in conjunction with barrier ID 525933. The opening force of doors along an accessible route shall be as follows: 1. Exterior doors: 8.5 pounds maximum (lbf) (37.8 N). 2. Interior doors: 5 pounds maximum (lbf) (22.2 N). 3. Stairway doors at pressurized stair enclosures: 15 pounds maximum (6.8 kg) at exterior doors. 4. Where environmental conditions require greater closing pressure, power-operated doors shall be used within the accessible route. [Exception: The force required to retract latch bolts or disengage other devices that hold the door or gate in a closed position shall not apply to panic hardware, delayed egress devices or fire-rated hardware.]

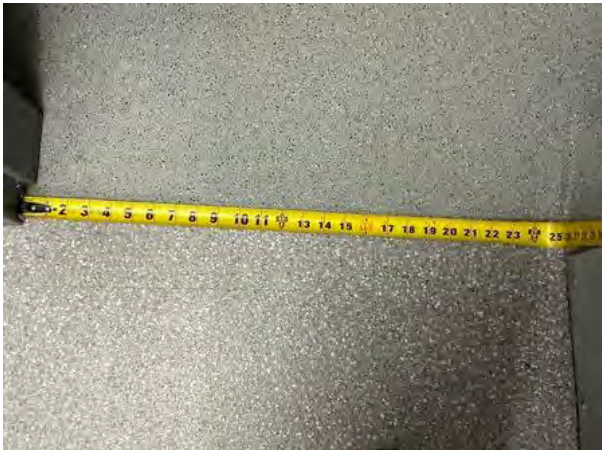
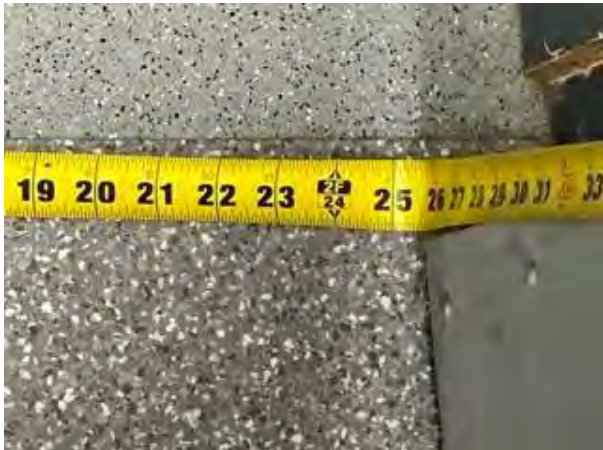
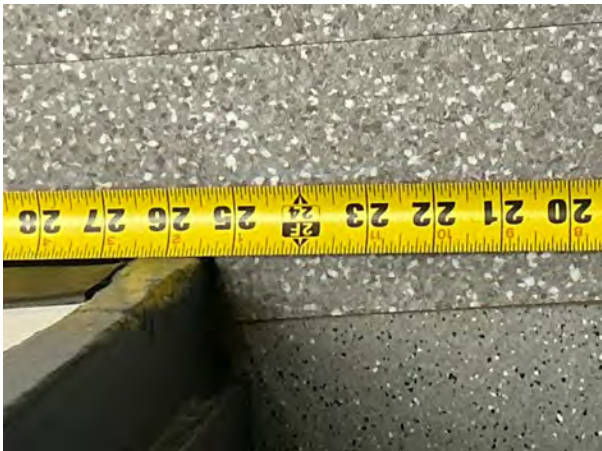
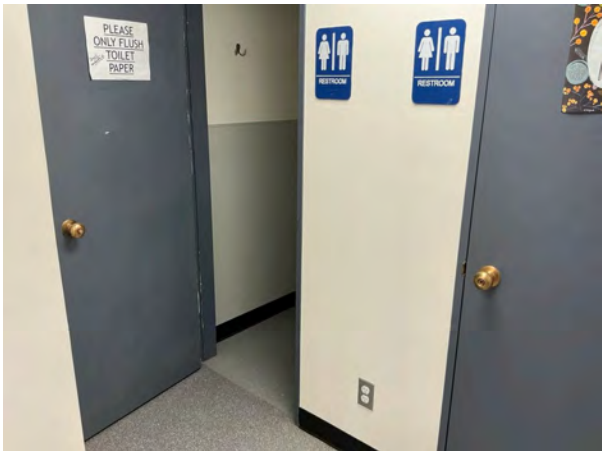
| Site Conditions | The clear width of the doors is 25 inches. | |

| Resolution | <p>Remove and replace with a door that has a minimum clear opening of 32". Door openings shall provide a clear width of 32" minimum. Clear openings of doorways with swinging doors shall be measured between the face of the door and the stop, with the door open 90 degrees. Openings more than 24" deep shall provide a clear opening of 36" minimum. There shall be no projections into the required clear opening width lower than 34" above the finish floor or ground. Projections into the clear opening width between 34" and 80" above the finish floor or ground shall not exceed 4". [EXCEPTIONS: 1. In alterations, a projection of 5/8" maximum into the required clear width shall be permitted for the latch side stop. 2. Door closers and door stops shall be permitted to be 78" minimum above the finish floor or ground.]</p> | |

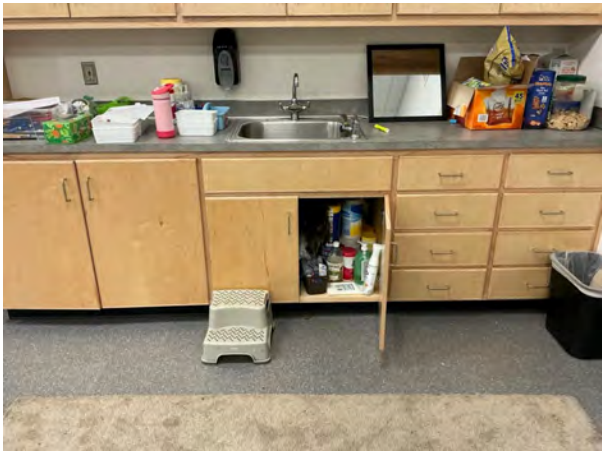
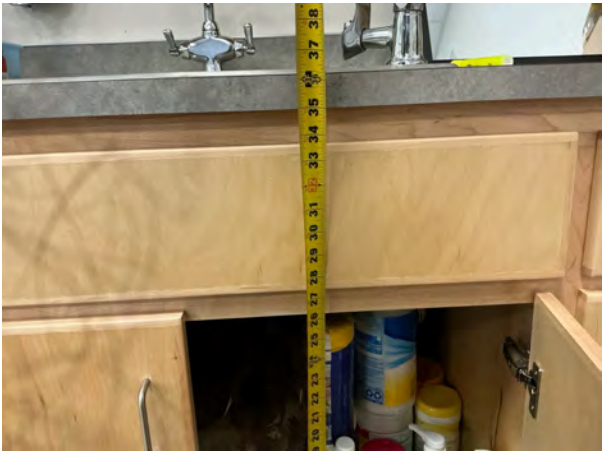
Photos for Barrier ID: AX525923

Relocate children's use sink to compliant height with knee and toe clearances. It is recommended that the sink which is used by children ages 6 to 9 be installed at 31" maximum height with knee clearance to 24" height provided (see exception 4 below). Sinks shall be installed with the front of the higher of the rim or counter surface 34" maximum above the finish floor or ground. [EXCEPTIONS: 1. A lavatory in a toilet or bathing facility for a single occupant accessed only through a private office and not for common use or public use shall not be required to comply. 2. In residential dwelling unit kitchens, sinks that are adjustable to variable heights, 29" minimum and 36" maximum, shall be permitted where rough-in plumbing permits connections of supply and drain pipes for sinks mounted at the height of 29".] Compliant knee and toe clearance shall be provided. [EXCEPTIONS: 2. A lavatory in a toilet room or bathing facility for a single occupant accessed only through a private office and not for common use or public use shall not be required to provide knee and toe clearance. 3. In residential dwelling units, cabinetry shall be permitted under lavatories and kitchen sinks provided that all of the following conditions are met: (a) the cabinetry can be removed without removal or replacement of the fixture; (b) the finish floor extends under the cabinetry; and (c) the walls behind and surrounding the cabinetry are finished. 4. A knee clearance of 24" minimum above the finish floor or ground shall be permitted at lavatories and sinks used primarily by children 6 through 12 years where the rim or counter surface is 31" maximum above the finish floor or ground. 5. A parallel approach complying with 305 shall be permitted to lavatories and sinks used primarily by children 5 years and younger. 6. The dip of the overflow shall not be considered in determining knee and toe clearances. 7. No more than one bowl of a multi-bowl sink shall be required to provide knee and toe clearance.] Space under an element between 9" and 27" above the finish floor or ground shall be considered knee clearance and shall comply. Knee clearance shall extend 25" maximum under an element at 9" above the finish floor or ground. Floor or ground surfaces of a clear floor or ground space shall comply. Changes in level are not permitted. [EXCEPTION: Slopes not steeper than 1:48 shall be permitted.] The clear floor or ground space shall be 30" minimum by 48" minimum. Unless otherwise specified, clear floor or ground space shall be permitted to include compliant clear space. Unless otherwise specified, clear floor or ground space shall be positioned for either forward or parallel approach to an element. One full unobstructed side of the clear floor or ground space shall adjoin an accessible route or adjoin another clear floor or ground space. Where a clear floor or ground space is located in an alcove or otherwise confined on all or part of three sides, additional maneuvering clearance shall be provided. Alcoves shall be 36" wide minimum where the depth exceeds 24". Alcoves shall be 60" wide minimum where the depth exceeds 15".

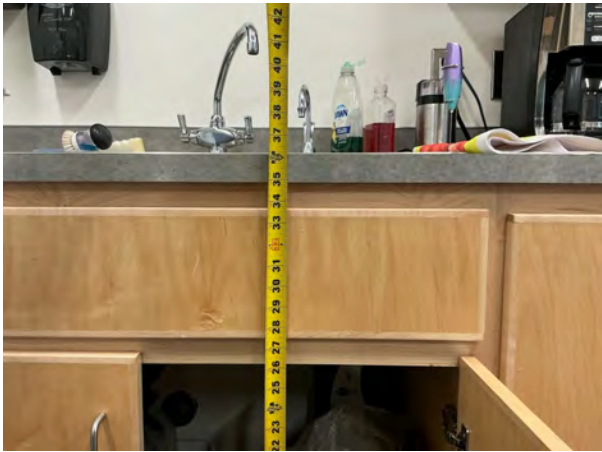
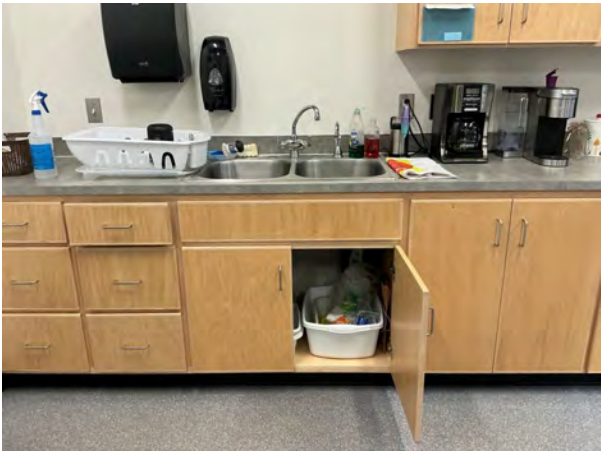
| Site Conditions | The counter is 38-3/4 inches above the finished floor. | |

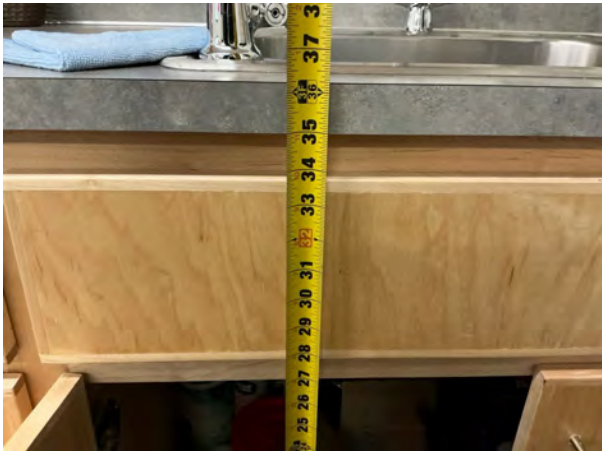
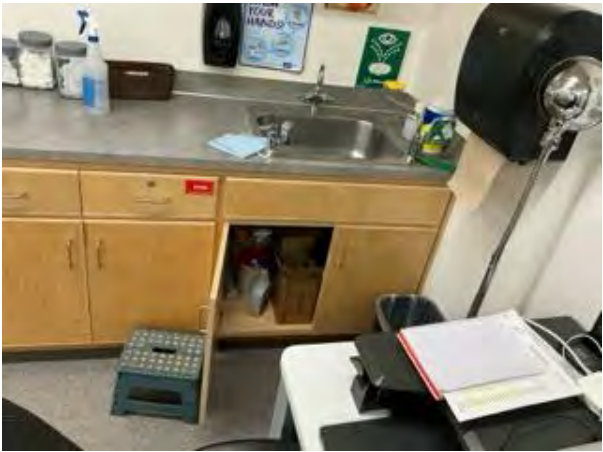
| Site Conditions | The lavatory drainpipe and water supply lines are not fully insulated. |

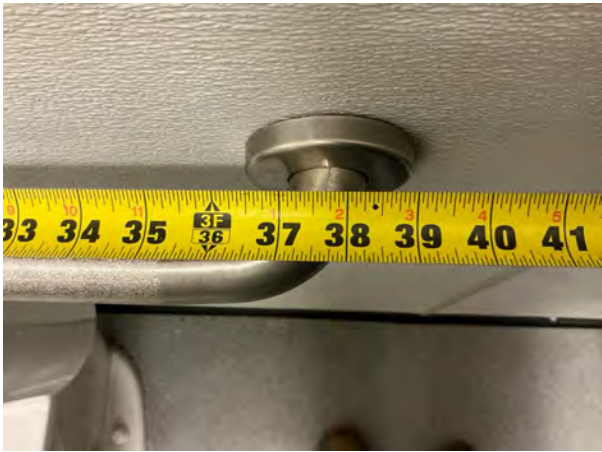
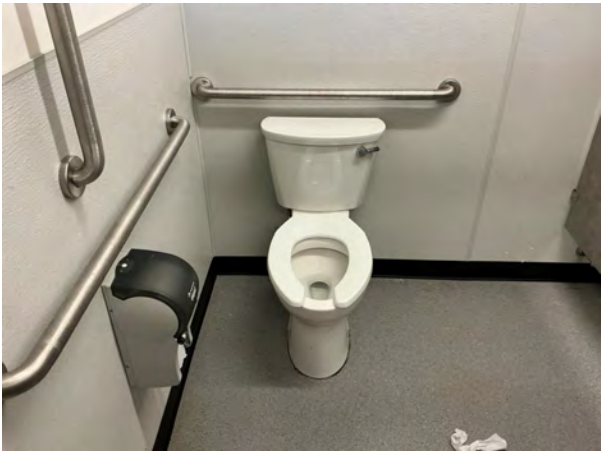
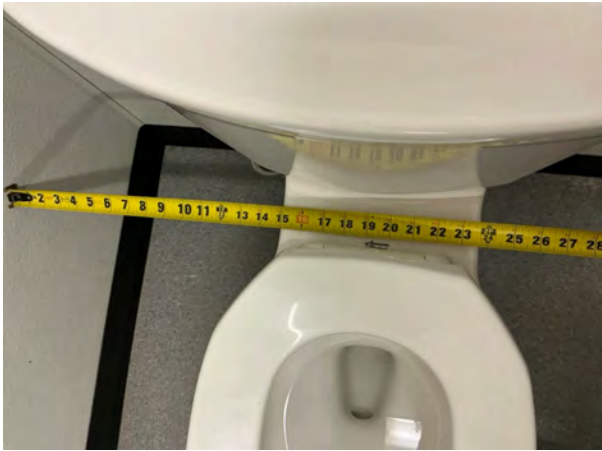
| Site Conditions | The side grab bar is mounted 12-1/2 inches from the rear wall. |

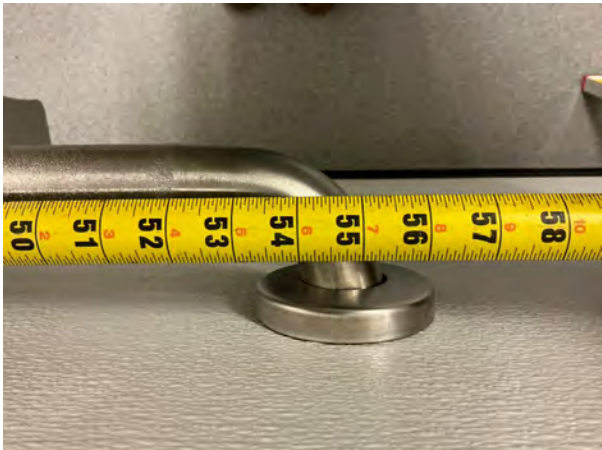
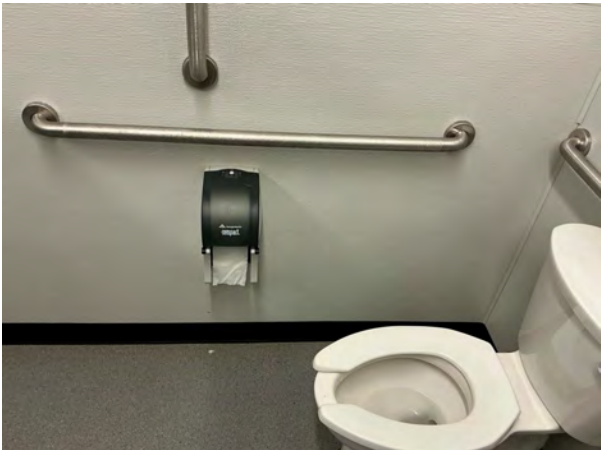
| Site Conditions | The centerline of the water closet is 19-1/2 inches from the side wall. | |

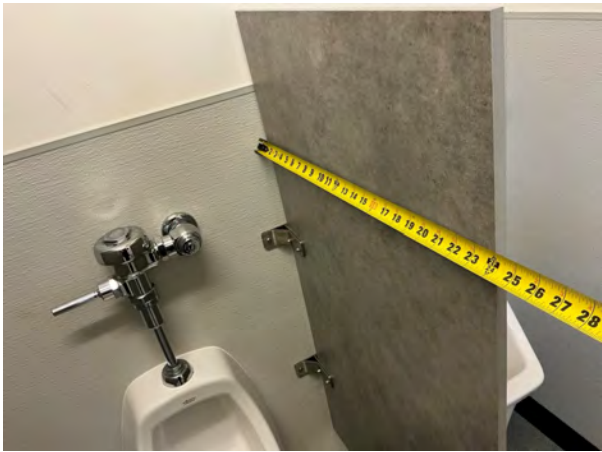
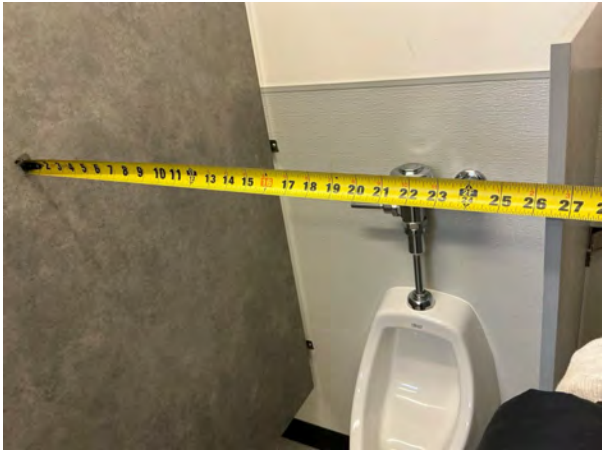
| Site Conditions | The restroom does not have the minimum required depth and width. |

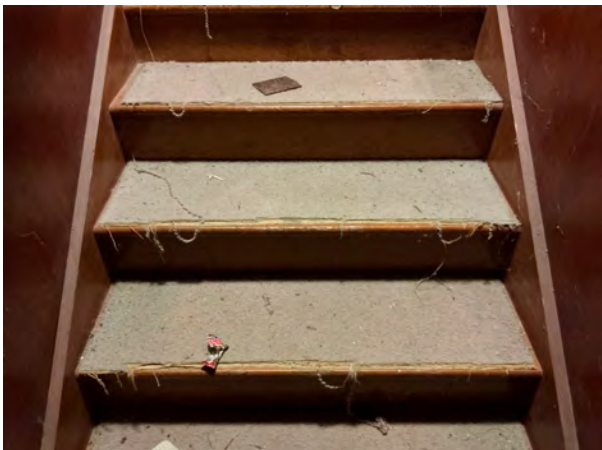
Photos for Barrier ID: AX525940

Site Conditions

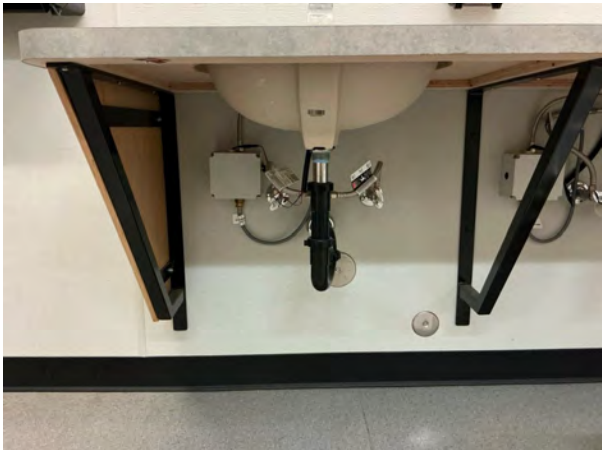
Photos for Barrier ID: AX525934

| Site Conditions | The lavatory drainpipe and water supply lines are not insulated. |

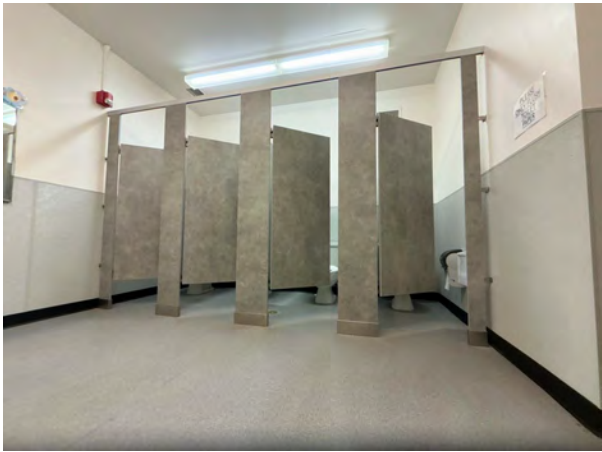
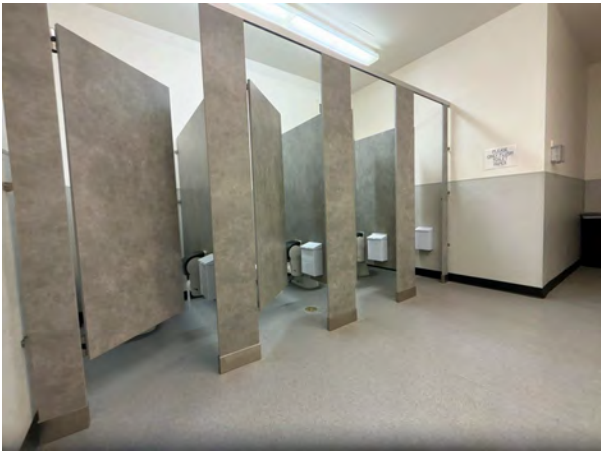
| Site Conditions | Four toilet stalls exist with no wheelchair accessible stall provided. |

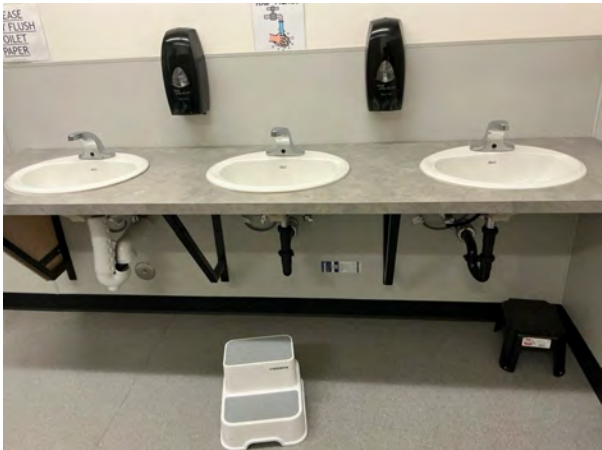
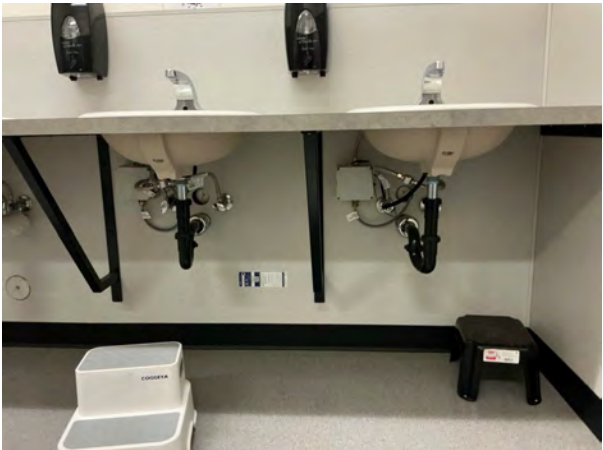
Photos for Barrier ID: AX525950

| Site Conditions | The lavatory drainpipe and water supply lines are not insulated. |

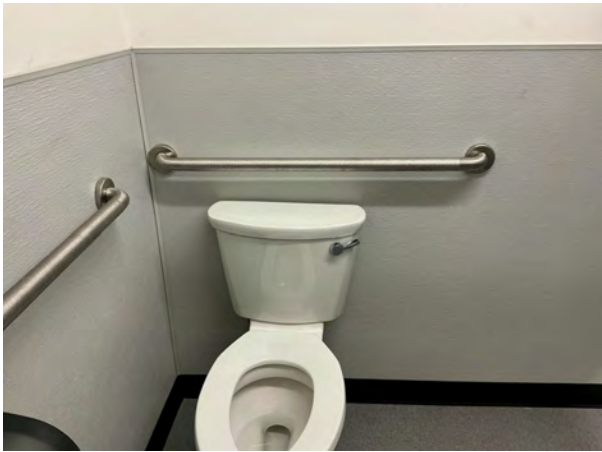
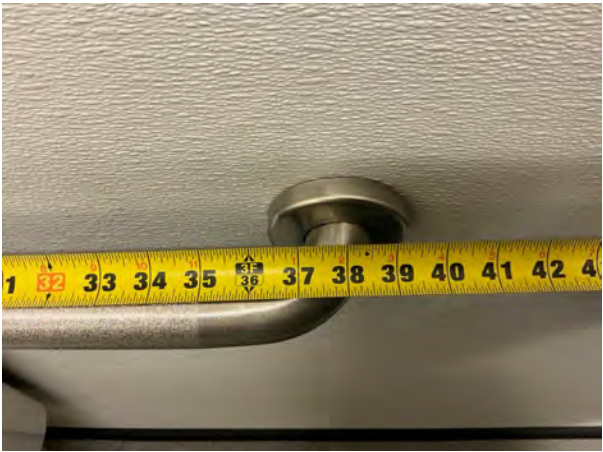
Site Conditions

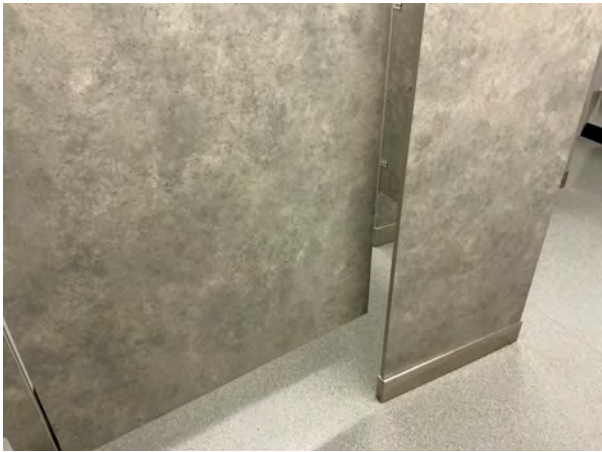
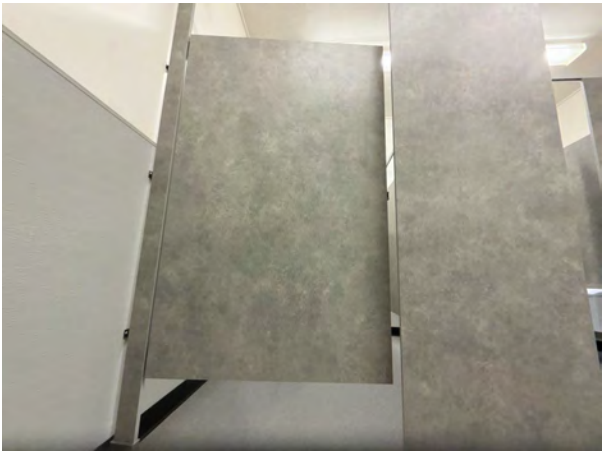
Photos for Barrier ID: AX525955

| Site Conditions | The wheelchair stall door is not self-closing. | |

| Remove hinge hardware and replace with hardware which provides self-closing of the door. | | |

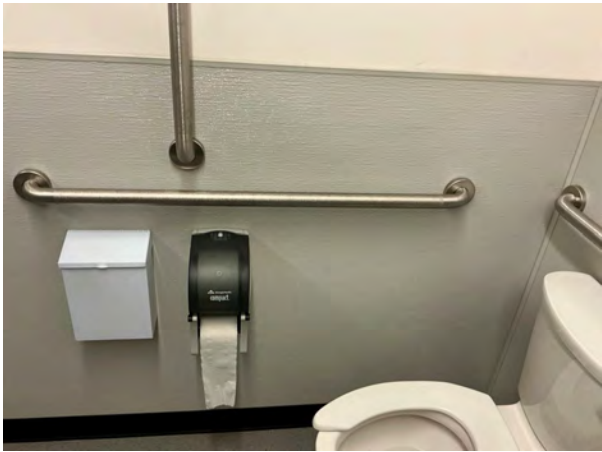
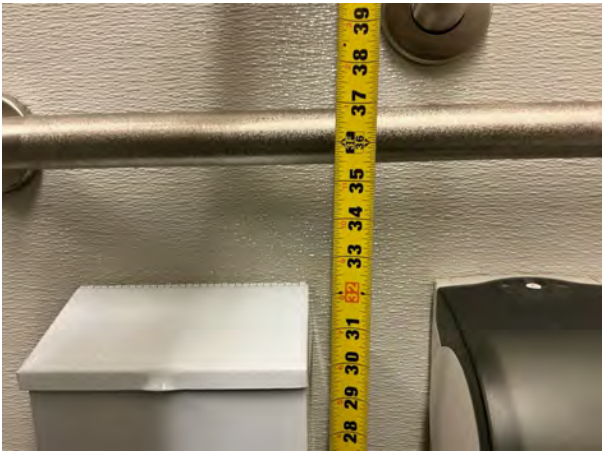
| Site Conditions | The side grab bar is located 36 inches above the floor. | |

| It is recommended to install the grab bars at a height using children's specifications. [ADVISORY: It is advisable, but not required, to use the specifications for children where children are the primary users of the restroom. Guidance in applying the specifications for children according to the age group served reflects the differences in the size, stature, and reach ranges of children ages 3 to 12. The specifications chosen should correspond to the age of the primary user group. The specifications of one age group should be applied consistently in the installation of a water closet and related elements. Water Closet Centerline: Ages 3 and 4- 12"; Ages 5 through 8- 12" to 15"; Ages 9 through 12- 15" to 18". Toilet Seat Height: Ages 3 and 4- 11" to 12"; Ages 5 through 8- 12" to 15"; Ages 9 through 12- 15" to 17". Grab Bar Height: Ages 3 and 4- 18" to 20"; Ages 5 through 8- 20" to 25"; Ages 9 through 12- 25" to 27"; Dispenser Height: Ages 3 and 4- 14"; Ages 5 through 8- 14" to 17"; Ages 9 through 12- 17" to 19".] Grab bars shall be installed in a horizontal position, at a height of 33" minimum and 36" maximum above the finish floor measured to the top of the gripping surface, except that at water closets for children's use, grab bars shall be installed in a horizontal position 18" minimum and 27" maximum above the finish floor measured to the top of the gripping surface. The rear wall grab bar shall be 36" long minimum and extend from the centerline of the water closet 12" minimum on one side and 24" minimum on the other side. [EXCEPTIONS: 1. The rear grab bar shall be permitted to be 24" long minimum, centered on the water closet, where wall space does not permit a length of 36" minimum due to the location of a recessed fixture adjacent to the water closet. 2. Where an administrative authority requires flush controls for flush valves to be located in a position that conflicts with the location of the rear grab bar, then the rear grab bar shall be permitted to be split or shifted to the open side of the toilet area.] The side wall grab bar shall be 42" long minimum, located 12" maximum from the rear wall and extending 54" minimum from the rear wall. | | |

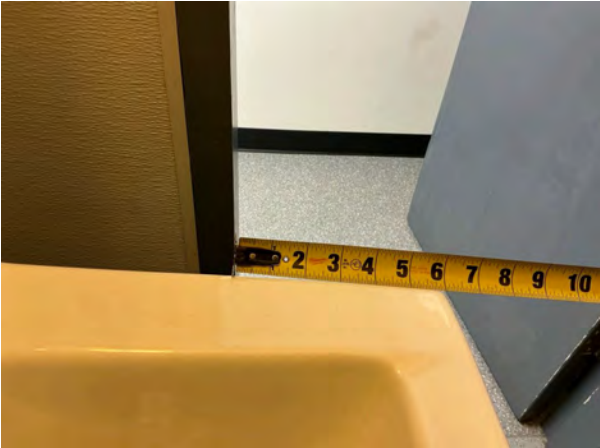
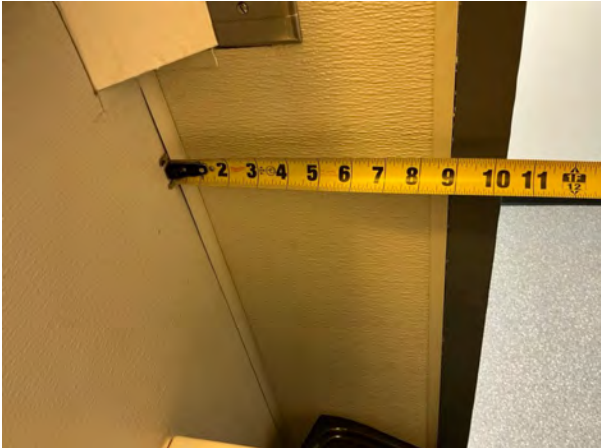
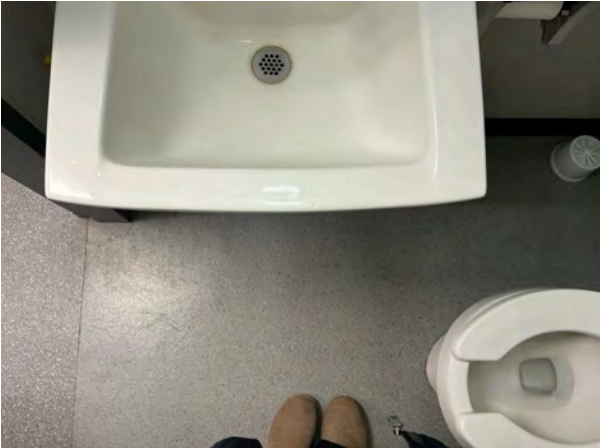
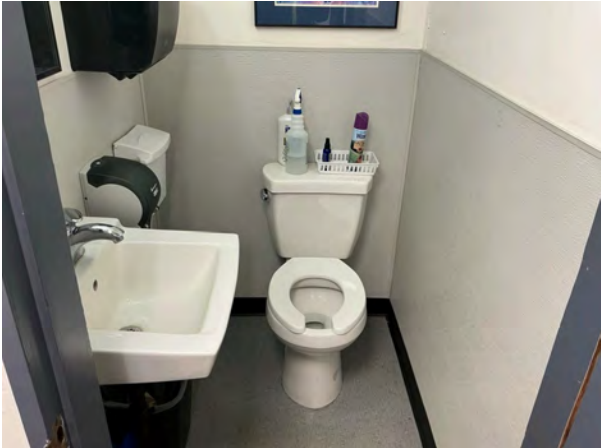
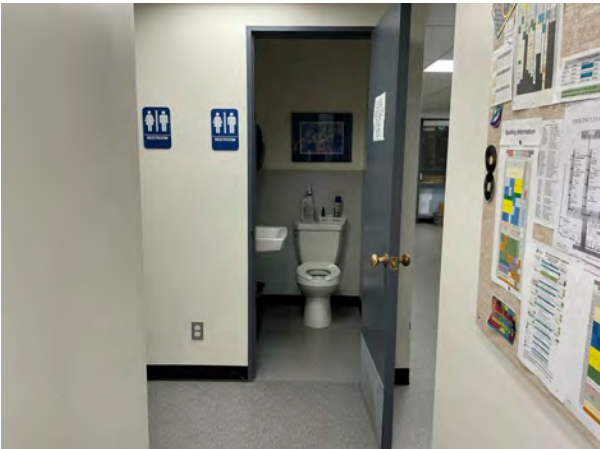
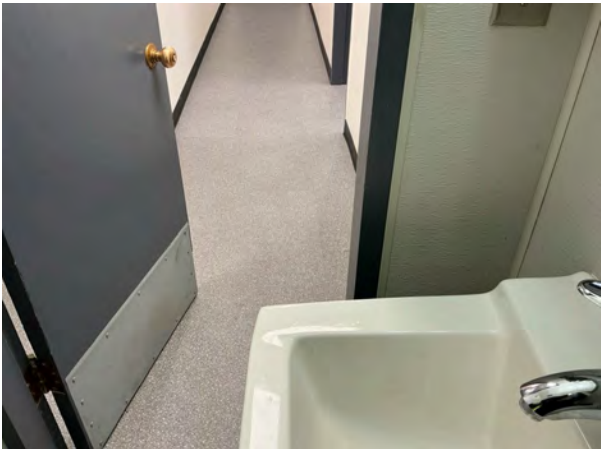
Photos for Barrier ID: AX525911

| Site Conditions | The two single user restrooms do not have the minimum required clear width. |

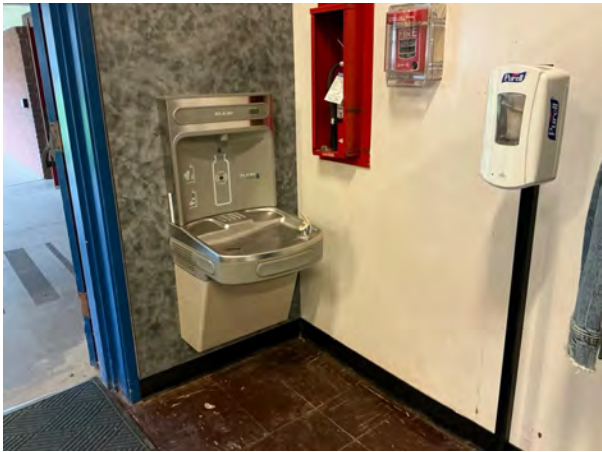
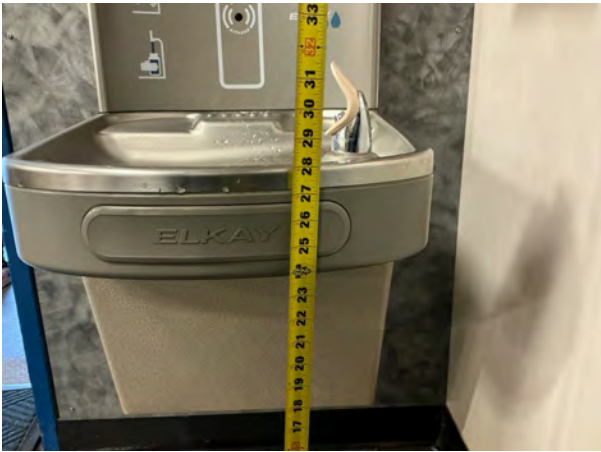
| Site Conditions | A standing height drinking fountain is not provided. |
