# ACCESSIBILITY ASSESSMENT

February 25, 2025

## **ADA TITLE II ASSESSMENT**

Thurston Middle School  
6300 Thurston Road  
Springfield, OR 97478

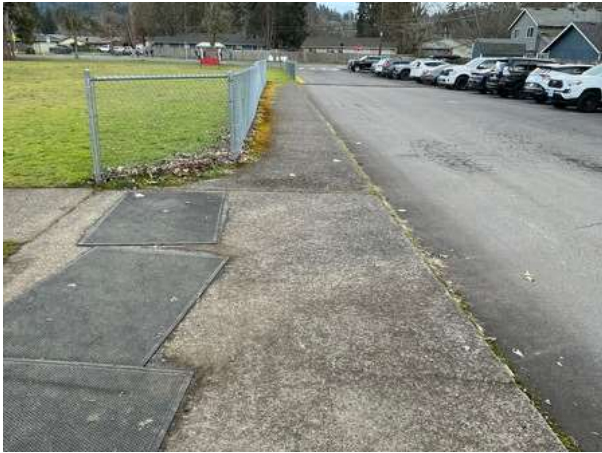
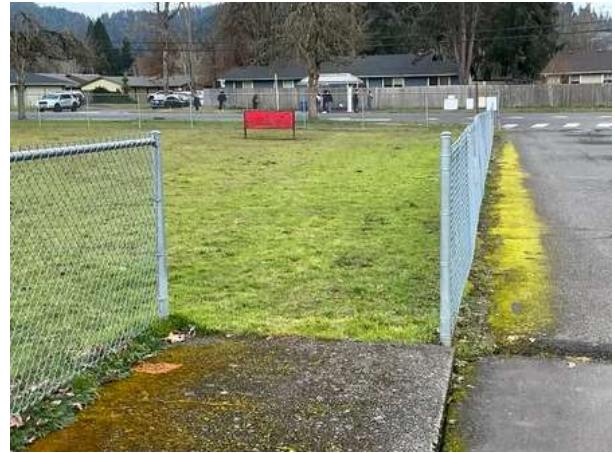
Photos for Barrier ID: AX563776

| Site Conditions | The accessible route has cross slopes of 2.2% to 2.6%. | |

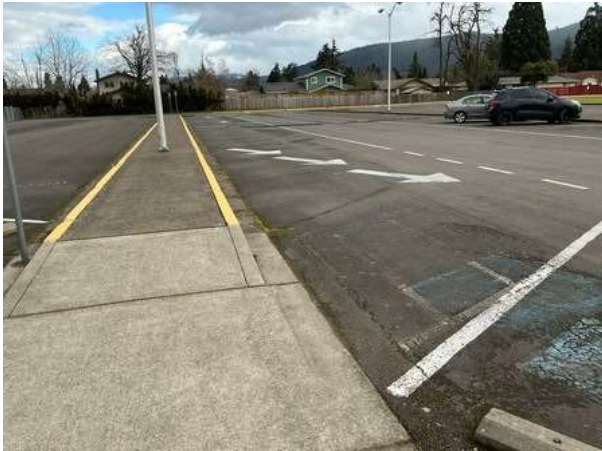
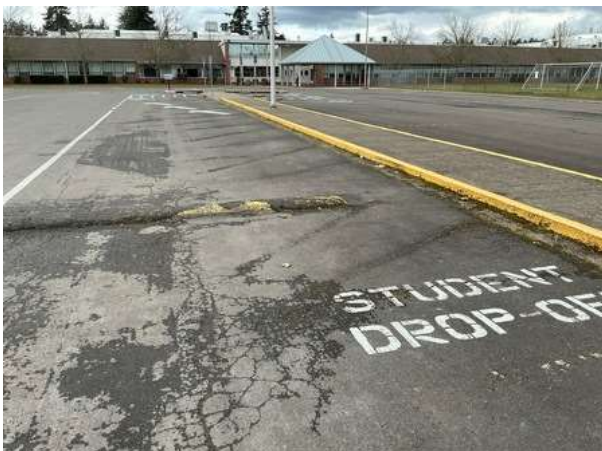
Photos for Barrier ID: AX563778

| <b>Site Conditions</b> | No compliant curb ramp is present in loading/unloading zone. |

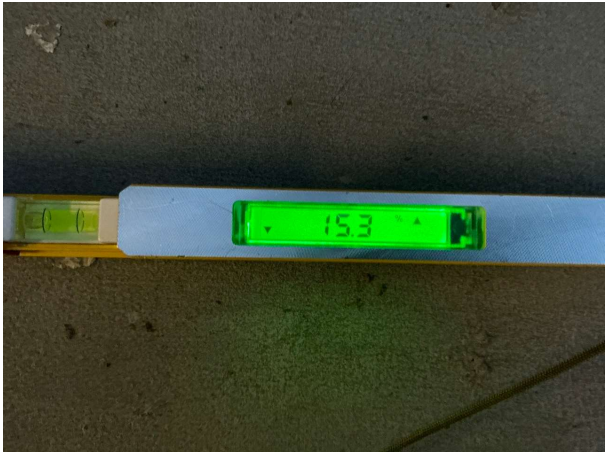
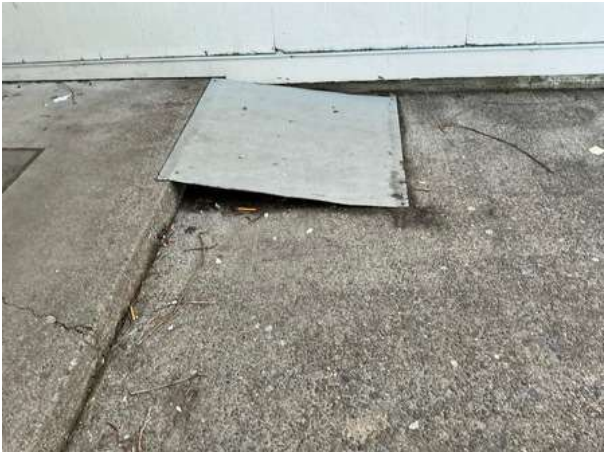
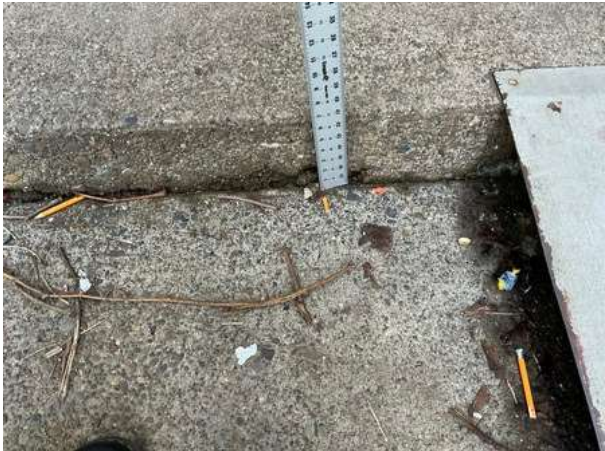
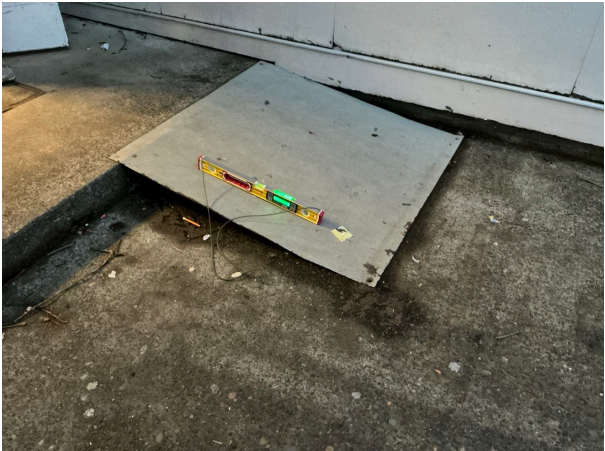
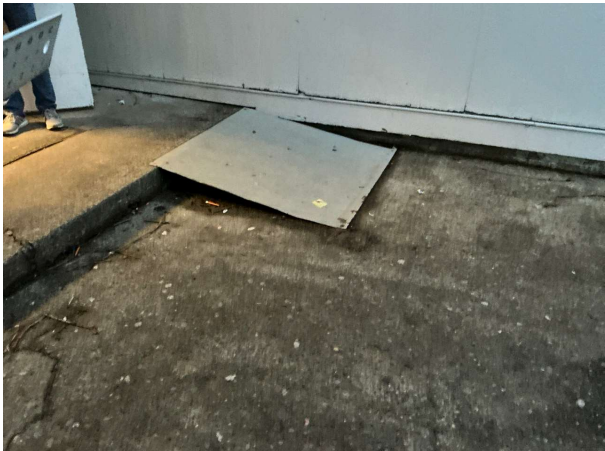
| <b>Site Conditions</b> | The ramp run rises 15" but has no handrails. |

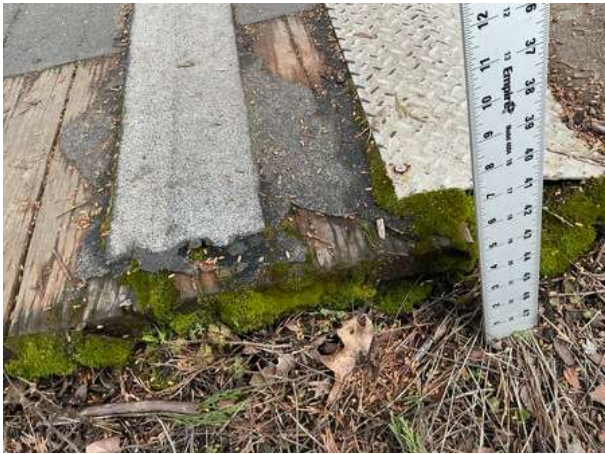
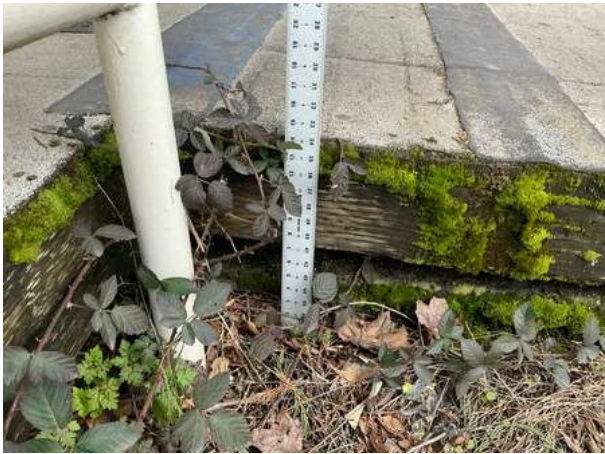
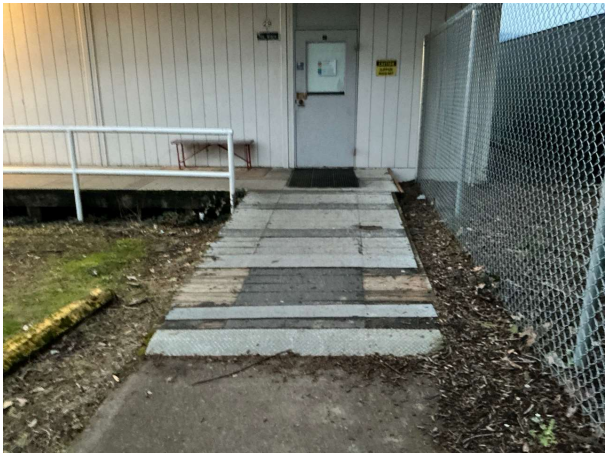
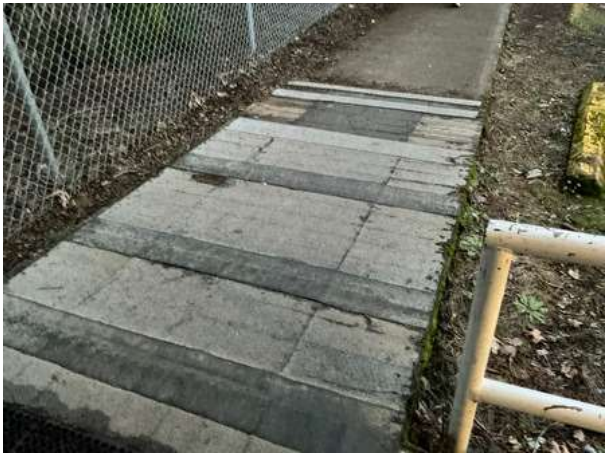
| Site Conditions | The ramp run rises 15" but has no handrails. (16' x 6') |

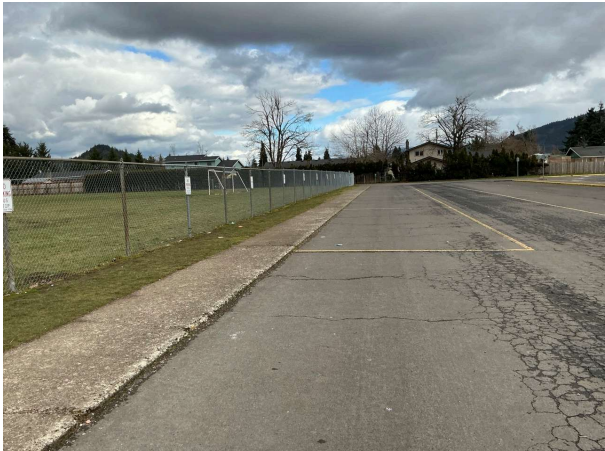
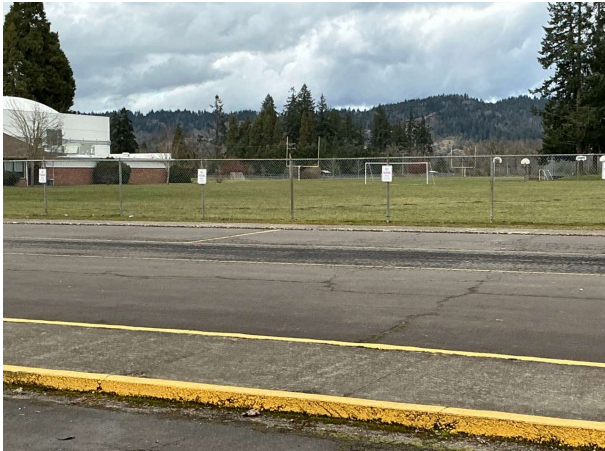
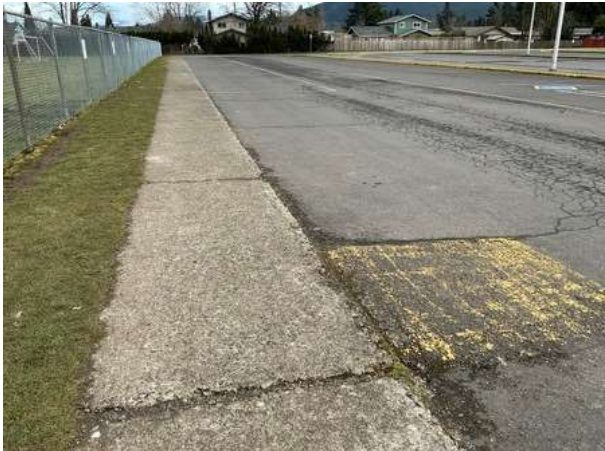
Photos for Barrier ID: AX563777

| <b>Site Conditions</b> | No compliant curb ramp is present in loading zone. |

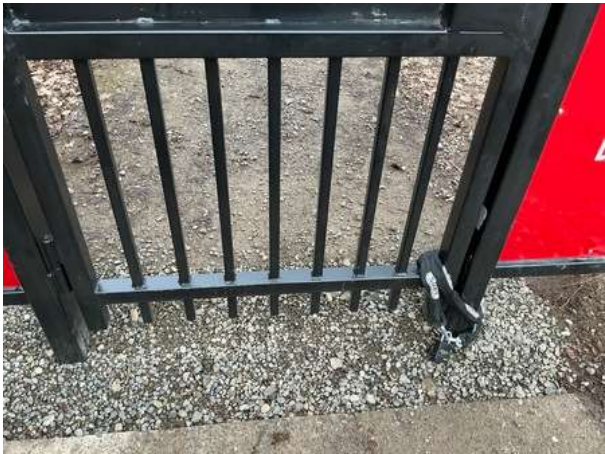
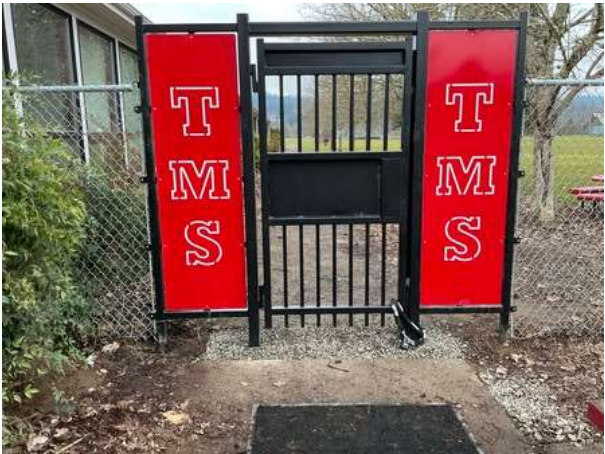
| Site Conditions | The gate does not have a smooth surface within 10" of the ground. |

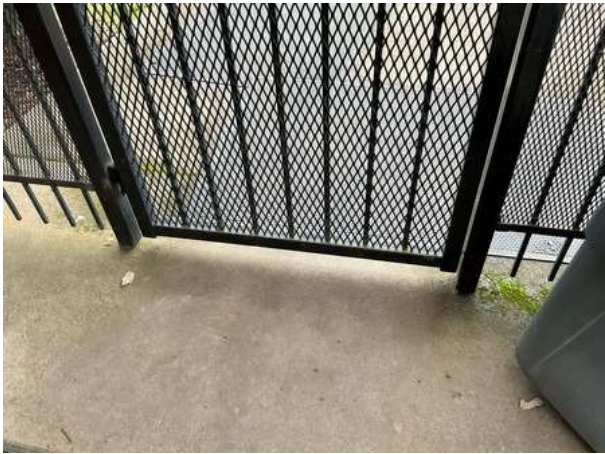
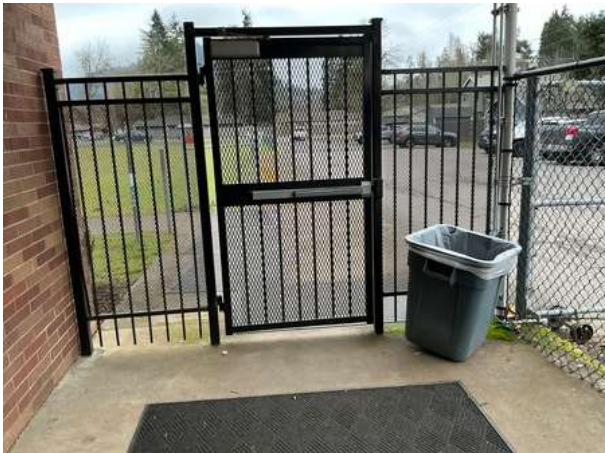
| Site Conditions | The gate does not have a smooth surface within 10" of the ground. | |

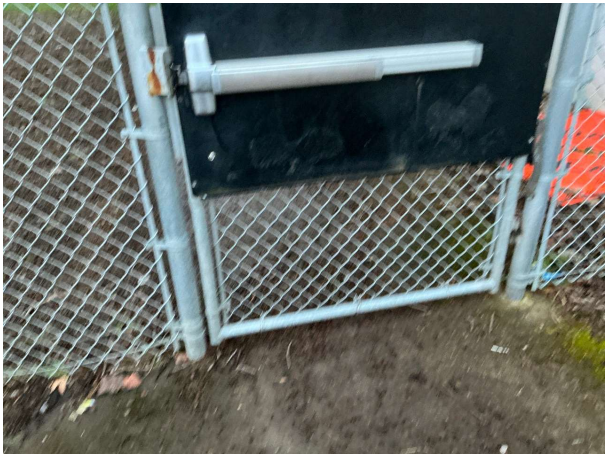
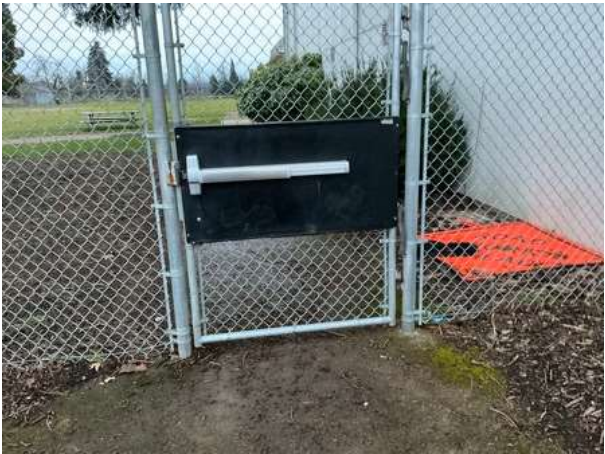
| Site Conditions | The gate does not have a smooth surface within 10" of the ground. |

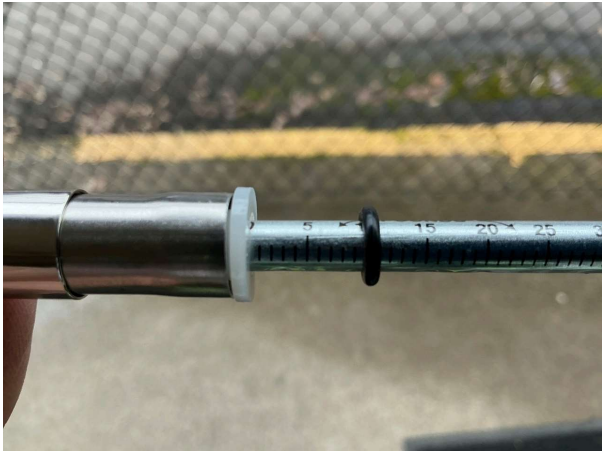
Photos for Barrier ID: AX563786

| Site Conditions | The hinged accessible exterior door requires 10 pounds of pressure to operate | |

| Resolution | Adjust the closer or replace with an exterior door that requires no more 8.5 pounds of force for pushing or pulling the door open. The opening force of doors along an accessible route shall be as follows: 1. Exterior doors: 8.5 pounds maximum (lbf) (37.8 N). 2. Interior doors: 5 pounds maximum (lbf) (22.2 N). 3. Stairway doors at pressurized stair enclosures: 15 pounds maximum (6.8 kg) at exterior doors. 4. Where environmental conditions require greater closing pressure, power-operated doors shall be used within the accessible route. [Exception: The force required to retract latch bolts or disengage other devices that hold the door or gate in a closed position shall not apply to panic hardware, delayed egress devices or fire-rated hardware.] | |

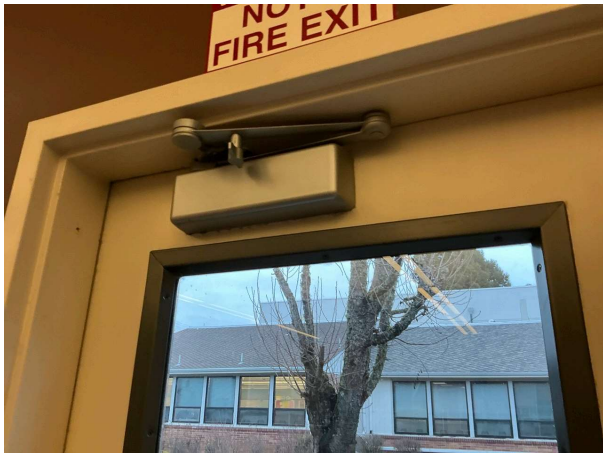
Photos for Barrier ID: AX563795

## Site Conditions

Adjust the closer or replace with an exterior door that requires no more 8.5 pounds of force for pushing or pulling the door open. The opening force of doors along an accessible route shall be as follows: 1. Exterior doors: 8.5 pounds maximum (lbf) (37.8 N). 2. Interior doors: 5 pounds maximum (lbf) (22.2 N). 3. Stairway doors at pressurized stair enclosures: 15 pounds maximum (6.8 kg) at exterior doors. 4. Where environmental conditions require greater closing pressure, power-operated doors shall be used within the accessible route. [Exception: The force required to retract latch bolts or disengage other devices that hold the door or gate in a closed position shall not apply to panic hardware, delayed egress devices or fire-rated hardware.]

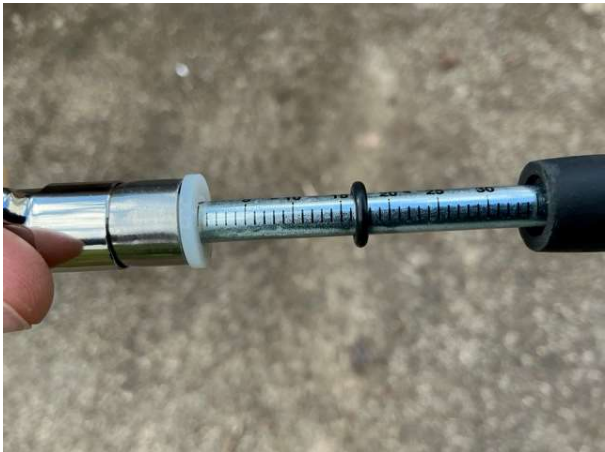
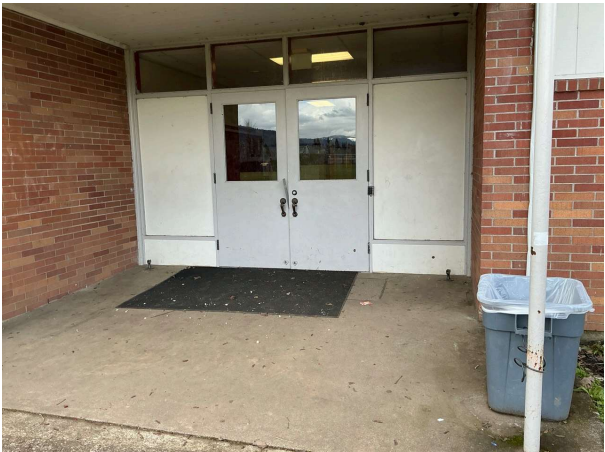
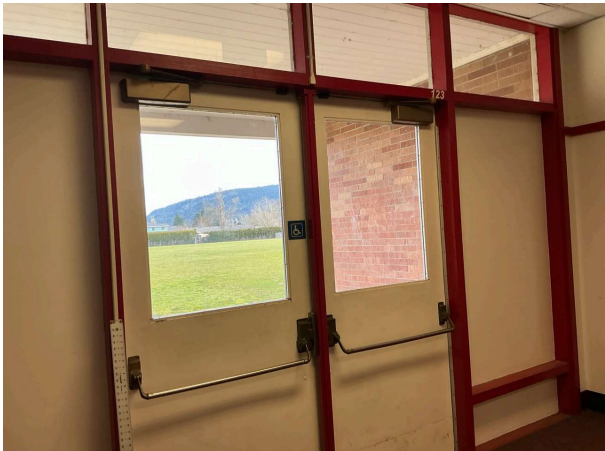
## Site Conditions

Adjust the closer or replace with an exterior door that requires no more 8.5 pounds of force for pushing or pulling the door open. The opening force of doors along an accessible route shall be as follows: 1. Exterior doors: 8.5 pounds maximum (lbf) (37.8 N). 2. Interior doors: 5 pounds maximum (lbf) (22.2 N). 3. Stairway doors at pressurized stair enclosures: 15 pounds maximum (6.8 kg) at exterior doors. 4. Where environmental conditions require greater closing pressure, power-operated doors shall be used within the accessible route. [Exception: The force required to retract latch bolts or disengage other devices that hold the door or gate in a closed position shall not apply to panic hardware, delayed egress devices or fire-rated hardware.]

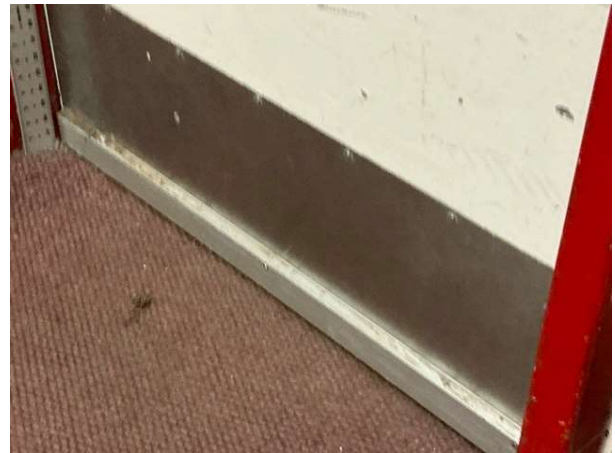
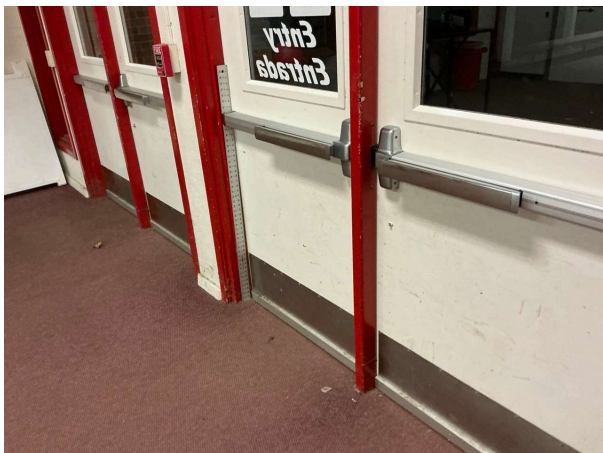
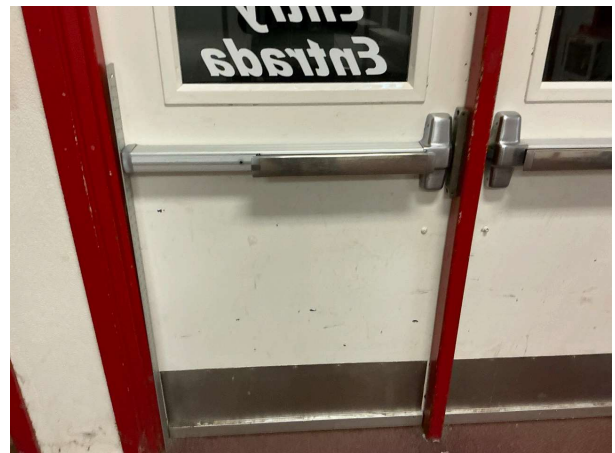
Photos for Barrier ID: AX563796

| Site Conditions | | |

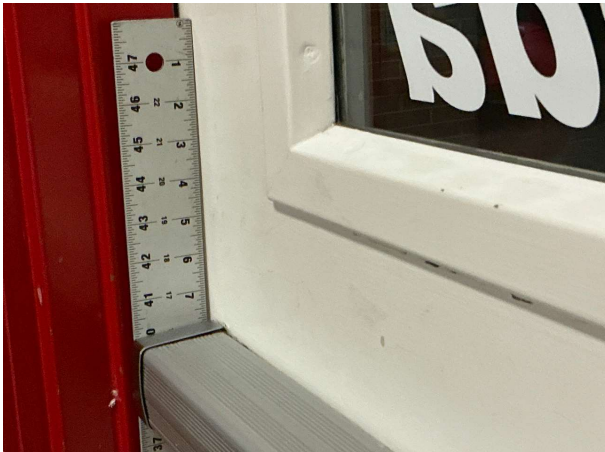
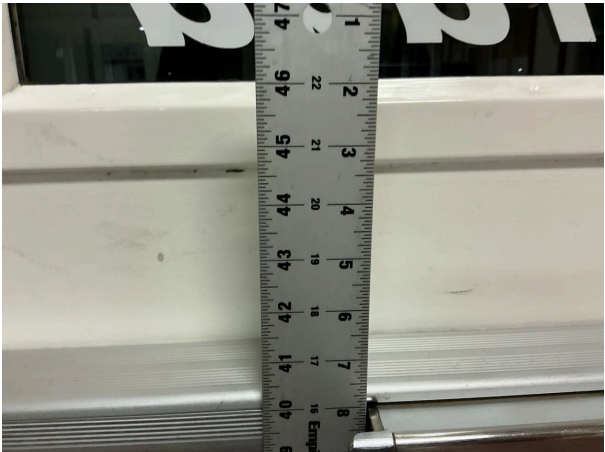
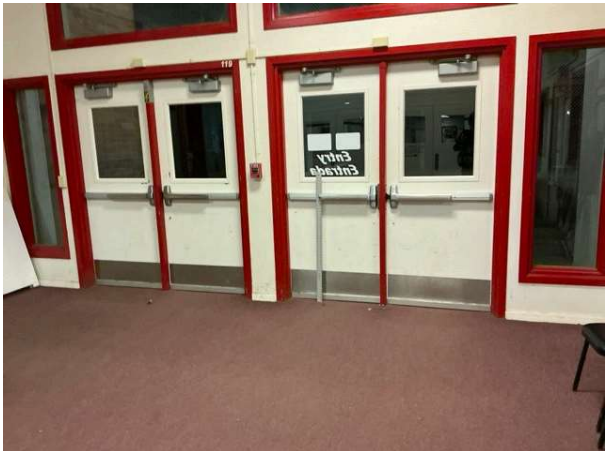
| Site Conditions | The bottom of the entry door vision lights are 46" above the finished floor. |

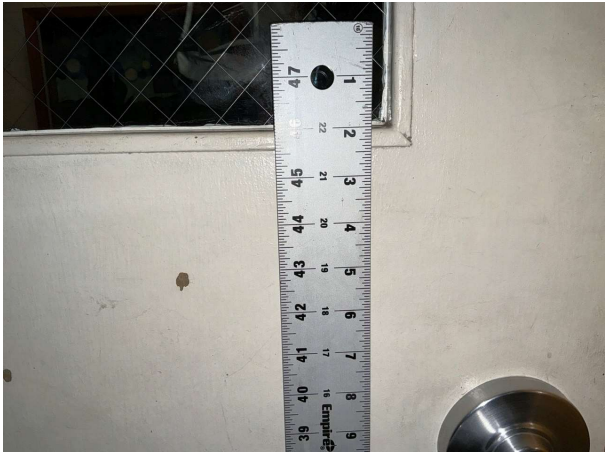
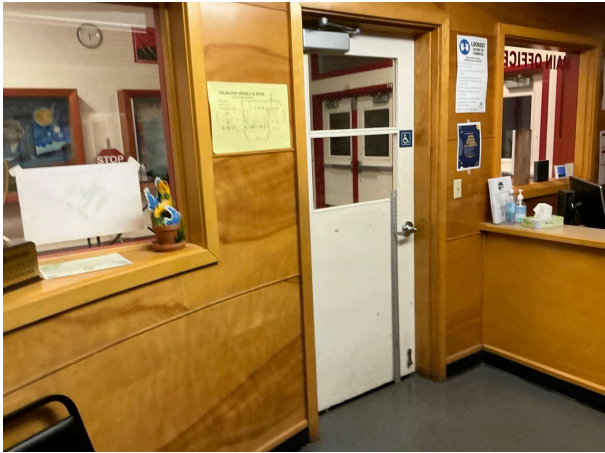
Photos for Barrier ID: AX563799

| Site Conditions | The bottom of the entry door vision light is 46-1/8" above the finished floor. | |

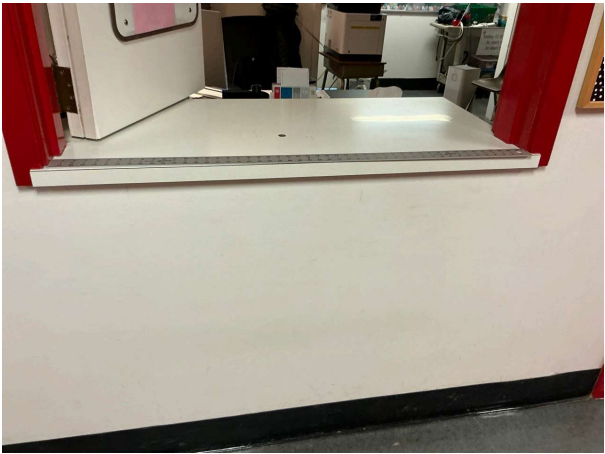
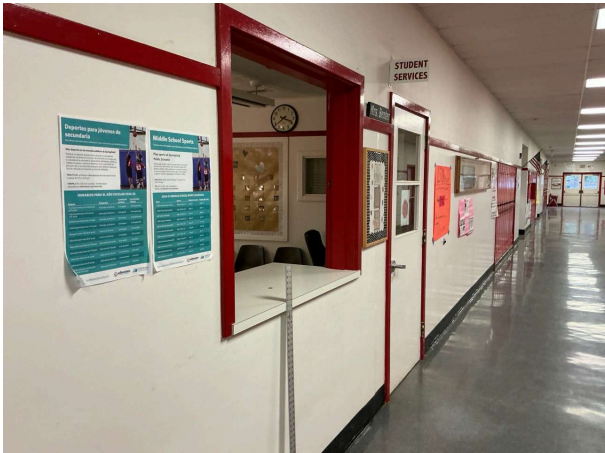
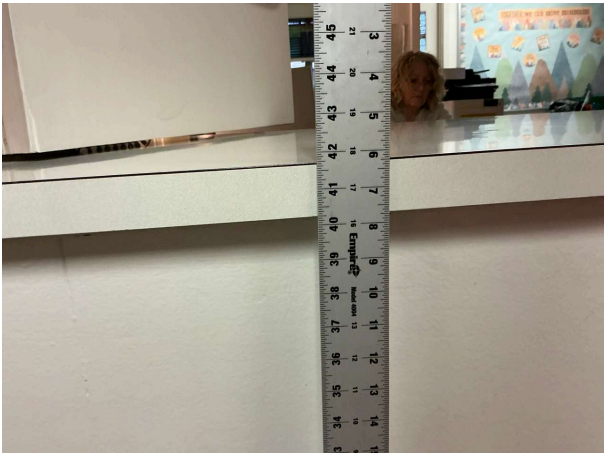
| Site Conditions | The service counter is 41-3/4" above floor surface. |

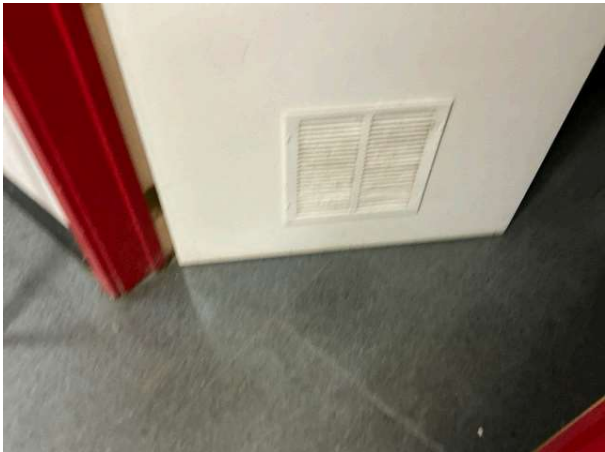
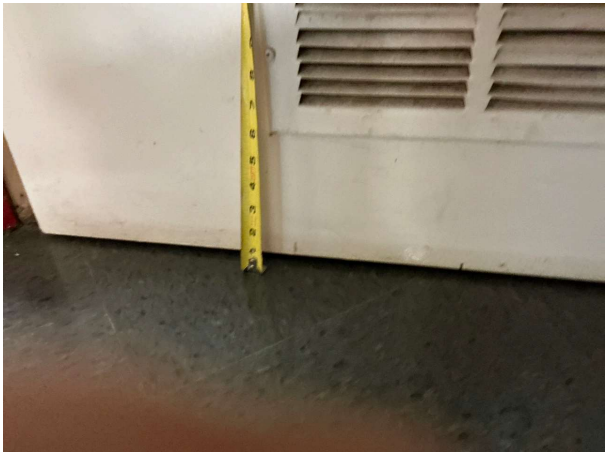
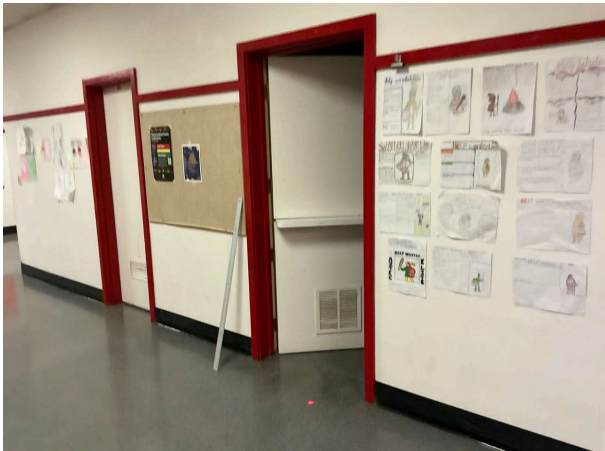
| <b>Site Conditions</b> | The louver is installed in the required smooth area of the door. |

Modify or replace the door to provide a smooth surface on the door within 10 inches of the finish floor or ground for the full width of the door on the push side. Parts creating horizontal or vertical joints in these surfaces shall be within 1/16 inch of the same plane as the other and be free of sharp or abrasive edges. Cavities created by added kick plates shall be capped. Swinging door and gate surfaces within 10 inches of the finish floor or ground measured vertically shall have a smooth surface on the push side extending the full width of the door or gate. Parts creating horizontal or vertical joints in these surfaces shall be within 1/16 inch of the same plane as the other. Cavities created by added kick plates shall be capped. [EXCEPTIONS: 1. Sliding doors shall not be required to comply. 2. Tempered glass doors without stiles and having a bottom rail or shoe with the top leading edge tapered at 60 degrees minimum from the horizontal shall not be required to meet the 10 inch bottom smooth surface height requirement. 3. Doors and gates that do not extend to within 10 inches of the finish floor or ground shall not be required to comply. 4. Existing doors and gates without smooth surfaces within 10 inches of the finish floor or ground shall not be required to provide smooth surfaces provided that if added kick plates are installed, cavities created by such kick plates are capped.]

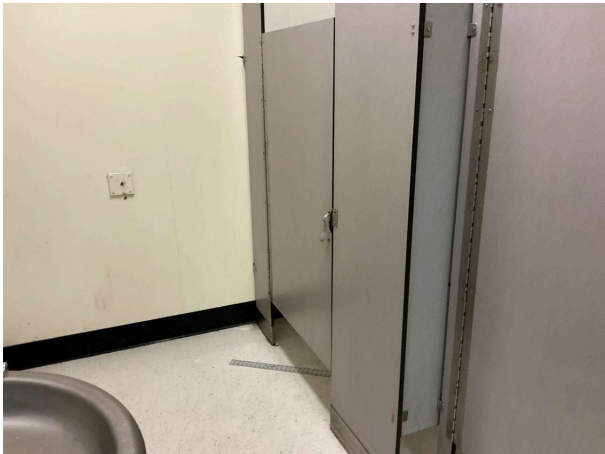
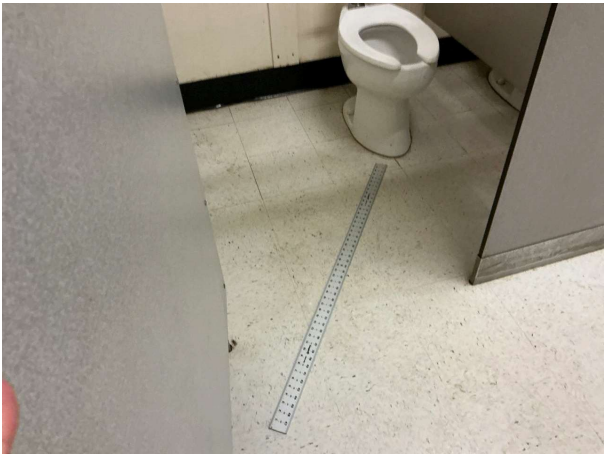
| Site Conditions | A wheelchair stall is not provided in the multi-user restroom. |

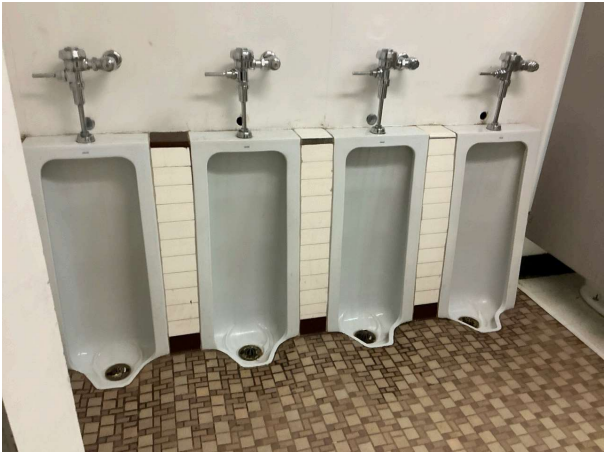
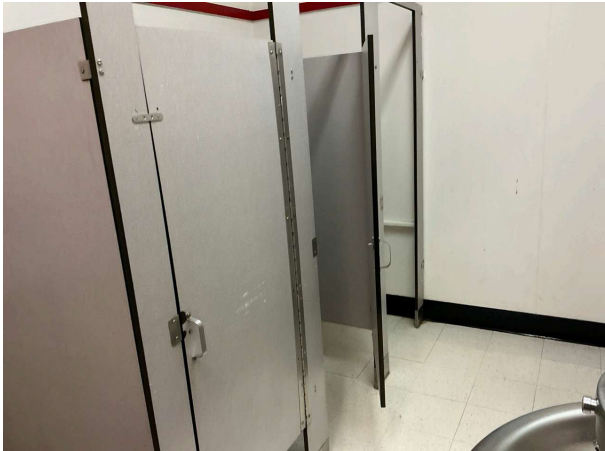
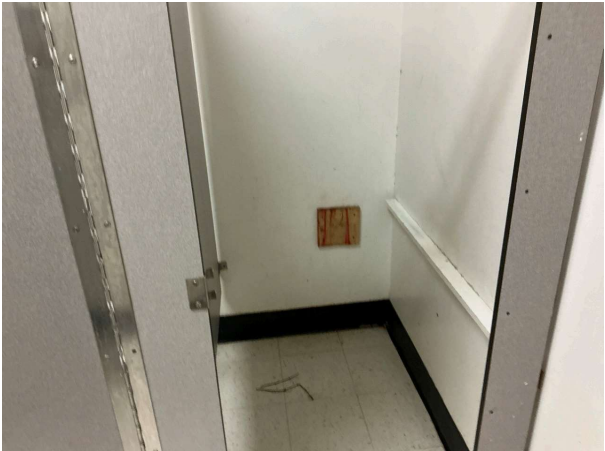
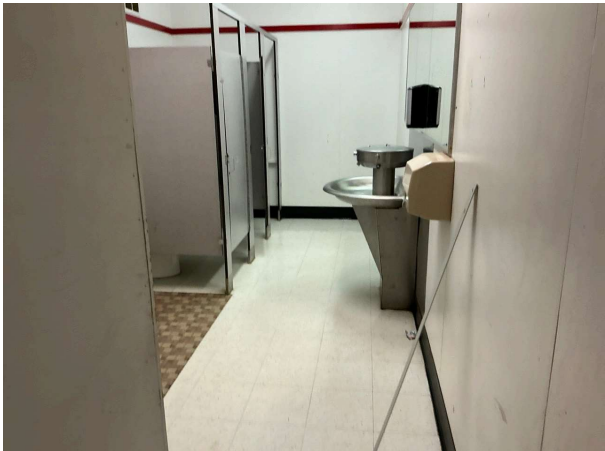
| Site Conditions | A wheelchair stall is not provided in the multi-user restroom. |

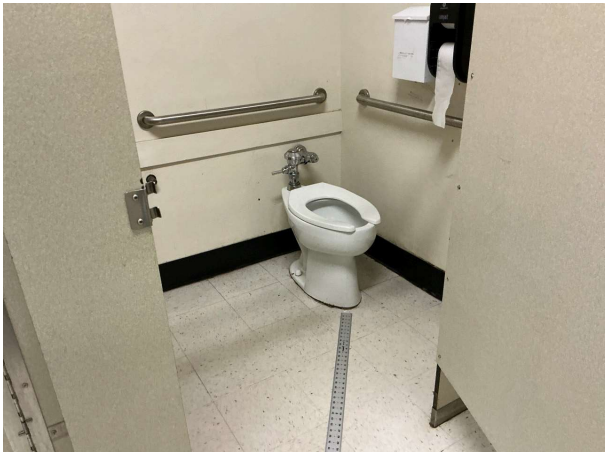
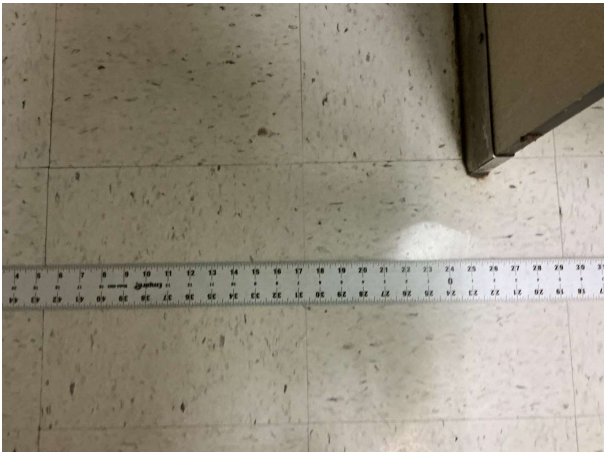
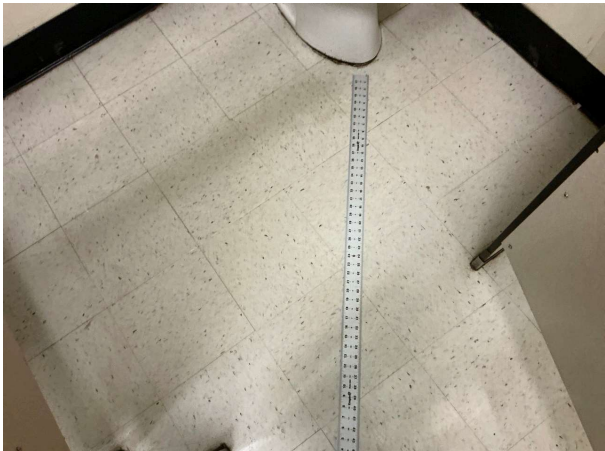
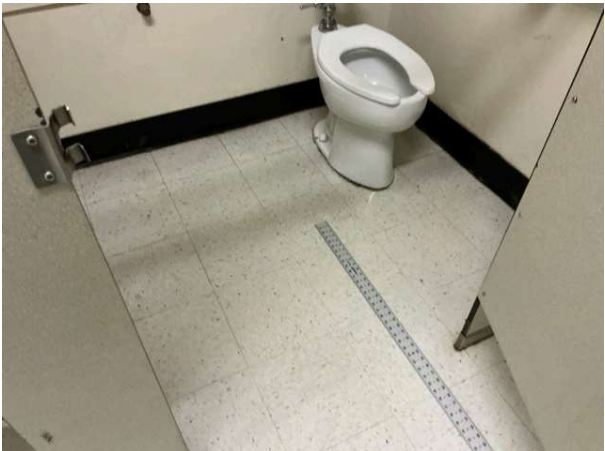
| Site Conditions | A wheelchair stall is not provided in the multi-user restroom. |

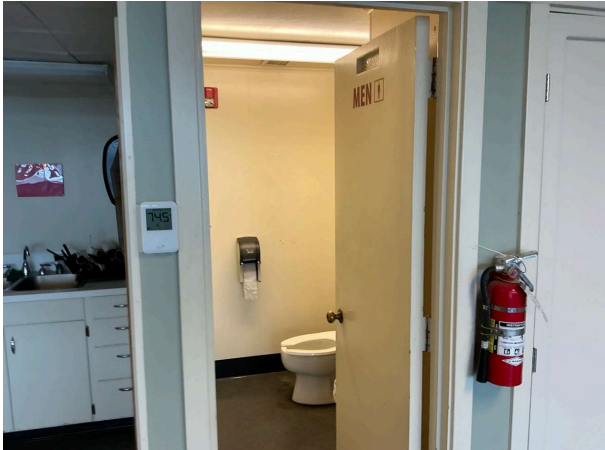
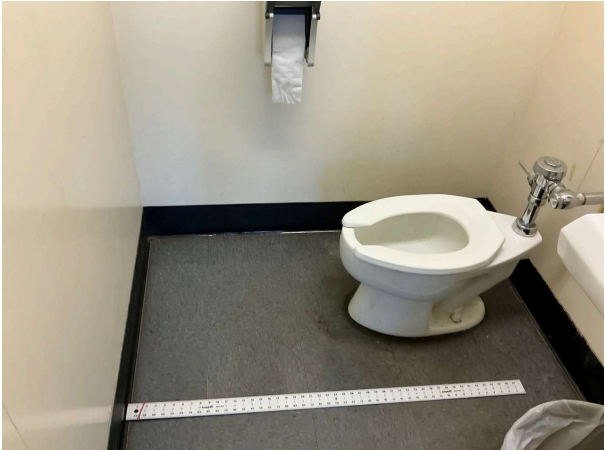
Photos for Barrier ID: AX563779

| Site Conditions | The restroom is less than 56" deep and has less than 60" minimum clearance to the lavatory. |

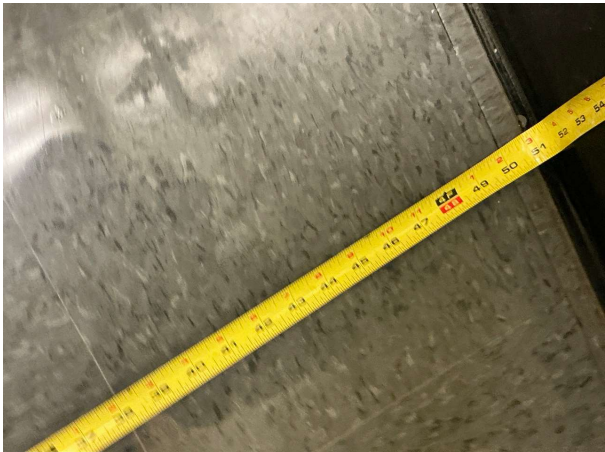
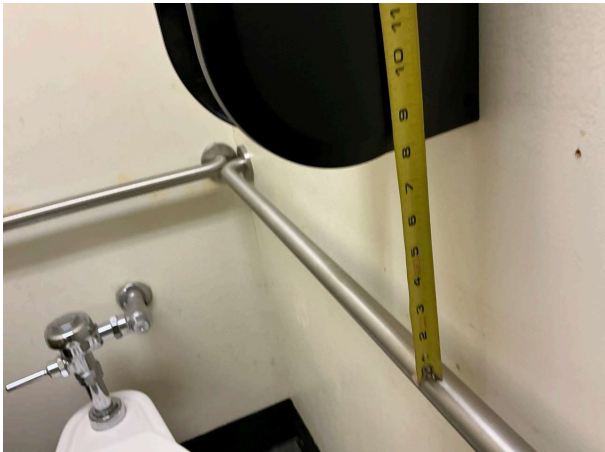
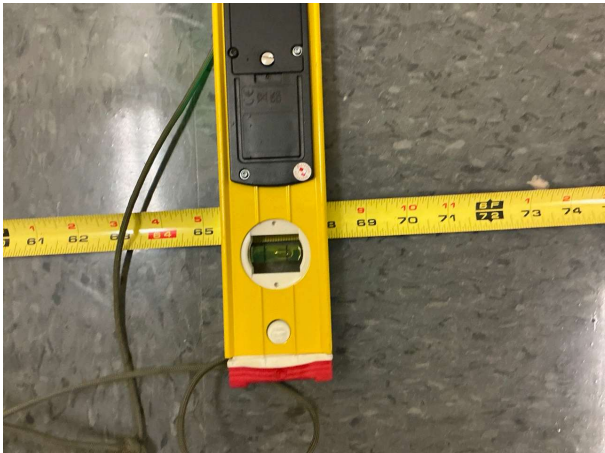
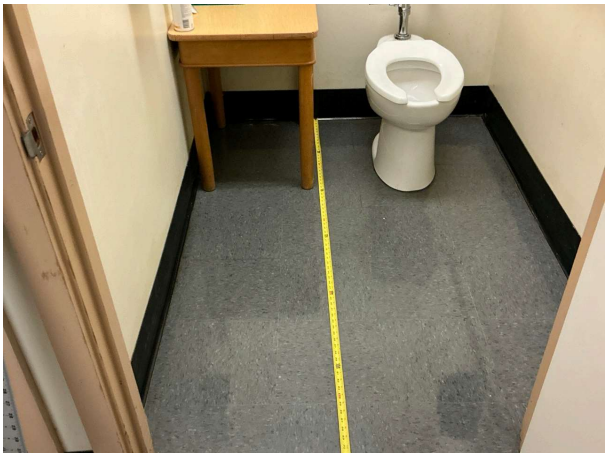
Photos for Barrier ID: AX563784

| Site Conditions | The restroom has a clear width of 52". |

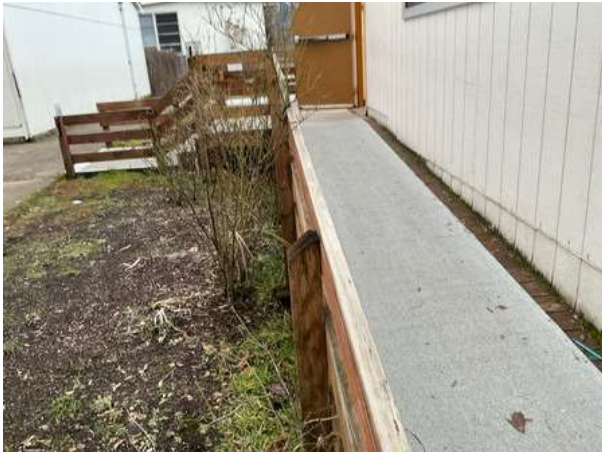
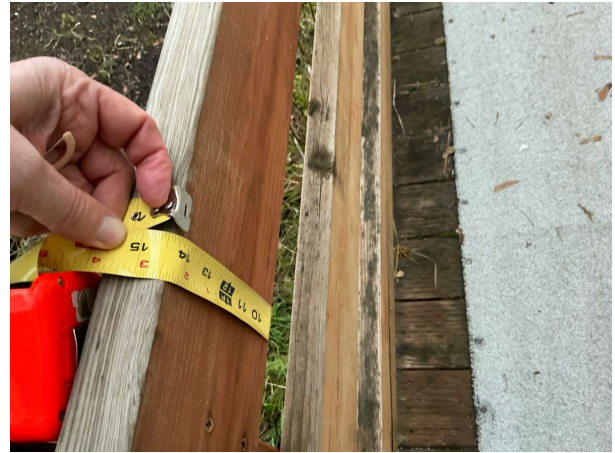
Photos for Barrier ID: AX563812

| <b>Site Conditions</b> | Handrail perimeters are 14-1/2". |

Replace existing handrails on the walkway with compliant handrails. Handrails are not required on walking surfaces with running slopes less than 1:20. However, handrails are required to comply with the following requirements when they are provided on walking surfaces with running slopes less than 1:20. Top of gripping surfaces of handrails shall be 34 inches minimum and 38 inches maximum vertically above walking surfaces. Handrails shall be at a consistent height above walking surfaces, Clearance between handrail gripping surfaces and adjacent surfaces shall be 1-1/2 inches minimum. Handrail gripping surfaces shall be continuous along their length and shall not be obstructed along their tops or sides. The bottoms of handrail gripping surfaces shall not be obstructed for more than 20 percent of their length. Where provided, horizontal projections shall occur 1-1/2 inches minimum below the bottom of the handrail gripping surface. [EXCEPTIONS: 1. Where handrails are provided along walking surfaces with slopes not steeper than 1:20, the bottoms of handrail gripping surfaces shall be permitted to be obstructed along their entire length where they are integral to crash rails or bumper guards. 2. The distance between horizontal projections and the bottom of the gripping surface shall be permitted to be reduced by 1/8 inch for each 1/2 inch of additional handrail perimeter dimension that exceeds 4 inches.] [Advisory 505.6 Gripping Surface. People with disabilities, older people, and others benefit from continuous gripping surfaces that permit users to reach the fingers outward or downward to grasp the handrail, particularly as the user senses a loss of equilibrium or begins to fall.] Handrail gripping surfaces with a circular cross section shall have an outside diameter of 1-1/4 inches minimum and 2 inches maximum. Handrail gripping surfaces with a non-circular cross section shall have a perimeter dimension of 4" minimum and 6-1/4 inches maximum, and a cross-section dimension of 2-1/4 inches maximum. Handrail gripping surfaces and any surfaces adjacent to them shall be free of sharp or abrasive elements and shall have rounded edges. Handrails shall not rotate within their fittings.
