# Walking and Bicycling Audits

San Mateo-Foster City School District

# Bayside S.T.E.M. Academy Walking and Biking Audit

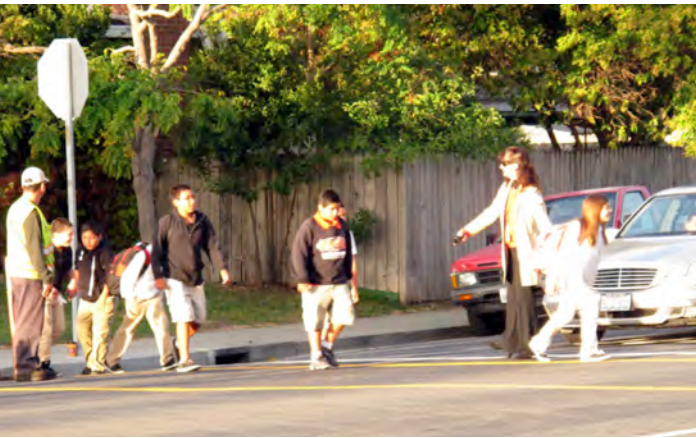
A school staff member assists students crossing at Van Buren / Kehoe.

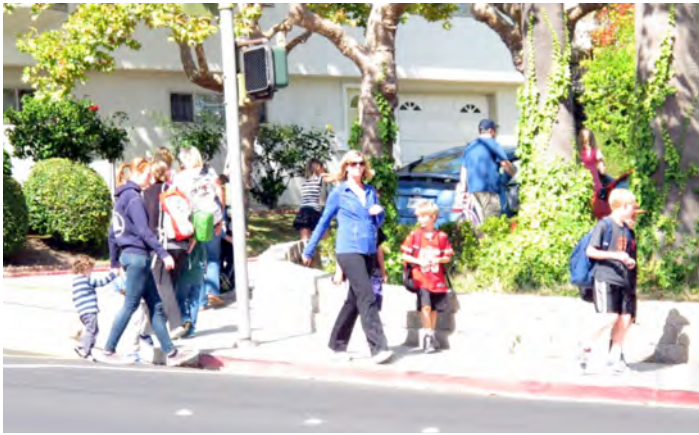
Many parents walk with their children to and from school.

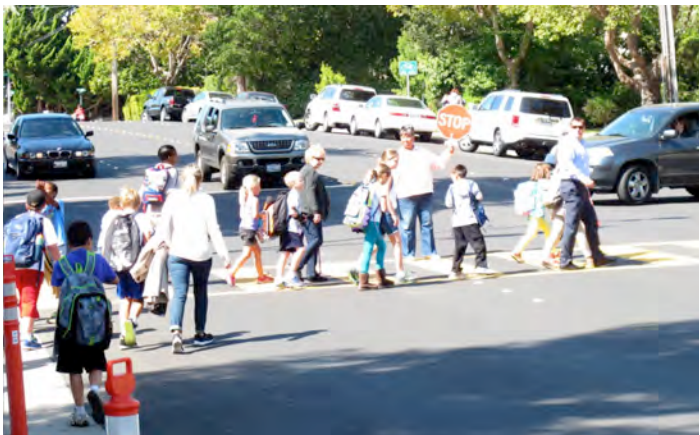
A crossing guard assists students crossing Alameda at Kentucky Ave.

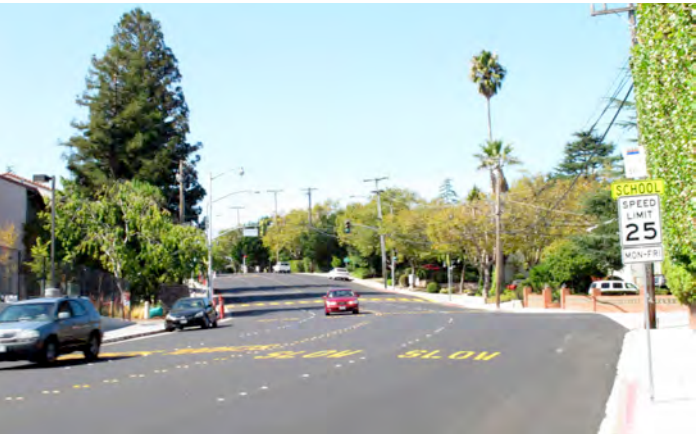
Alameda is wide, lacks edgelines, and encourages high speeds.

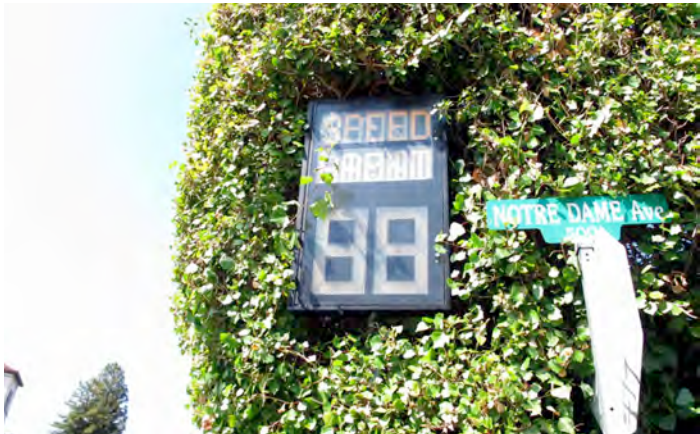
Speed feedback signs advise motorists to slow down.

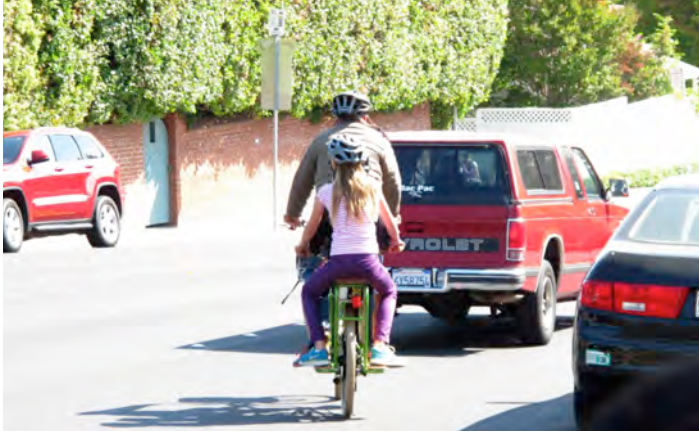
There are no bike lanes on Alameda.

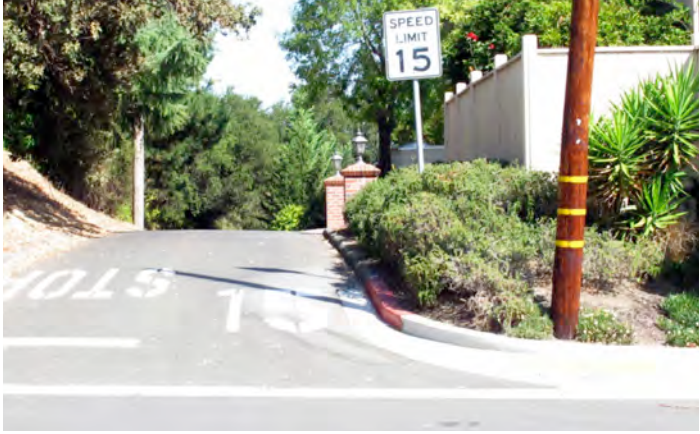
Notre Dame Avenue is a popular alley route for students walking to school.

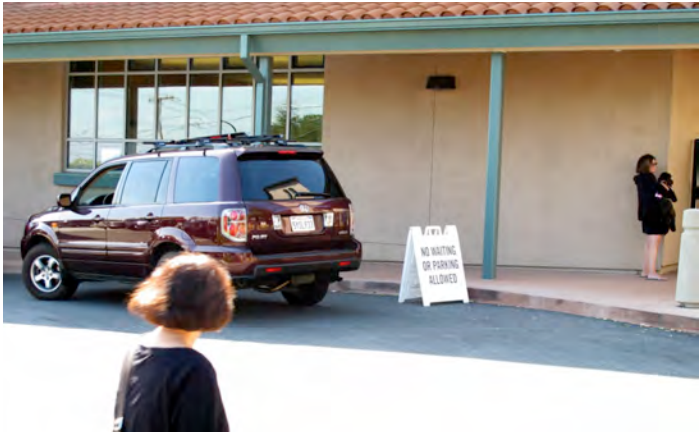
Parents waiting in the drop-off / pick-up zone in the afternoon.

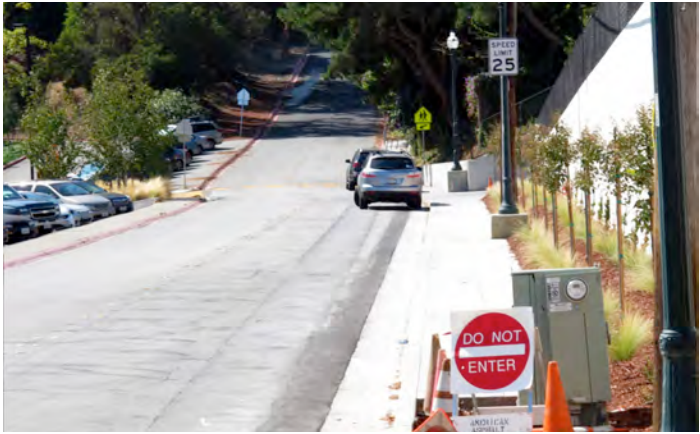
Parents pull out of the loading zone onto Woodland Drive.

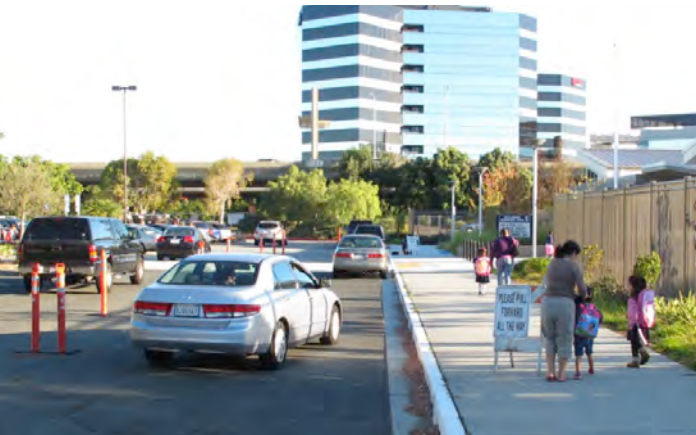
The school parking lot has a designated drop-off and pick-up zone.

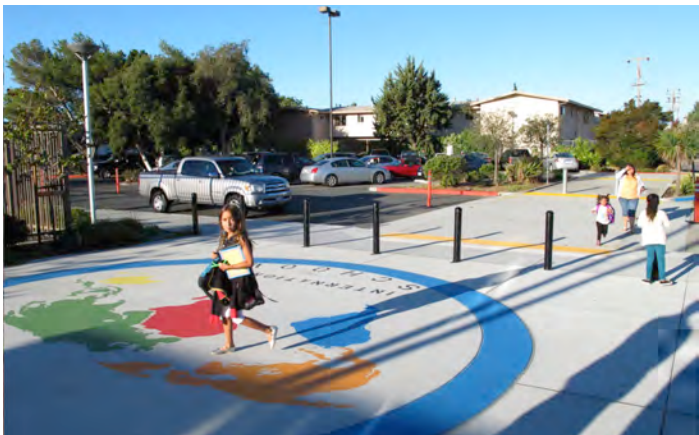
The school parking lot has two sets of raised crosswalks.

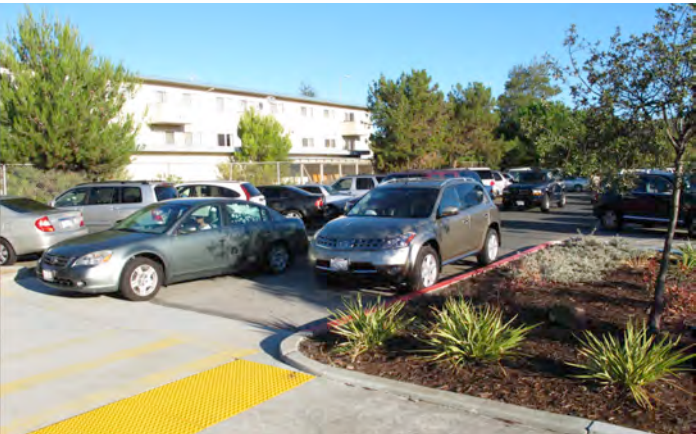
Some parking occurs in red zones.

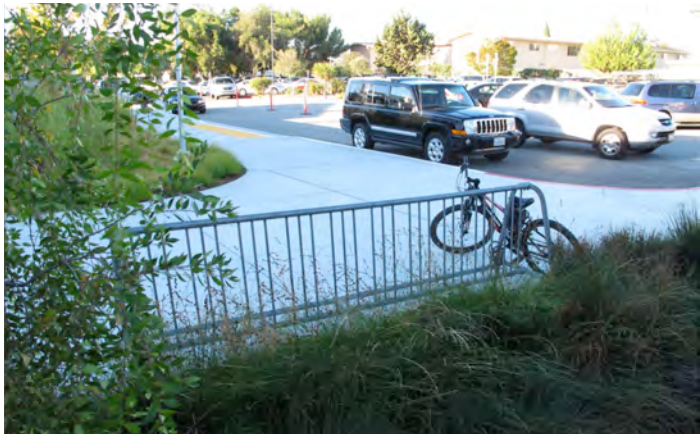
Bicycling to school is infrequent; the school has three rarely used racks.

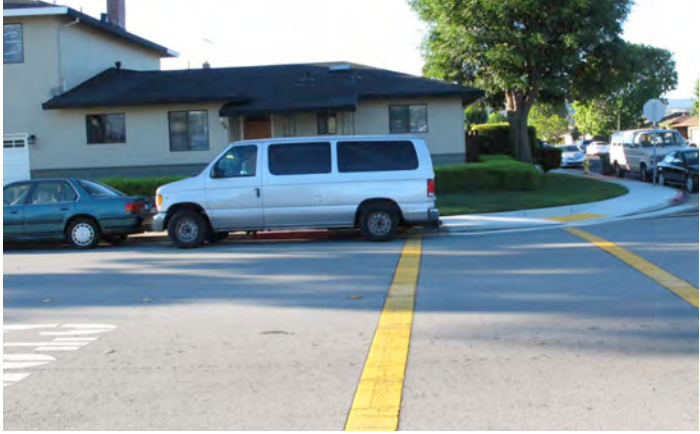
- Parked vehicles were observed encroaching into the crosswalks.

Parked vehicles sometimes encroach into the crosswalk.

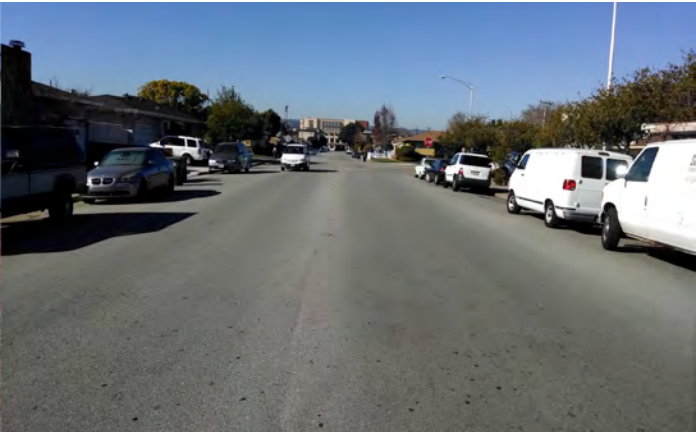
Bermuda and Ginnever are wide streets lacking markings and encouraging higher travel speeds.

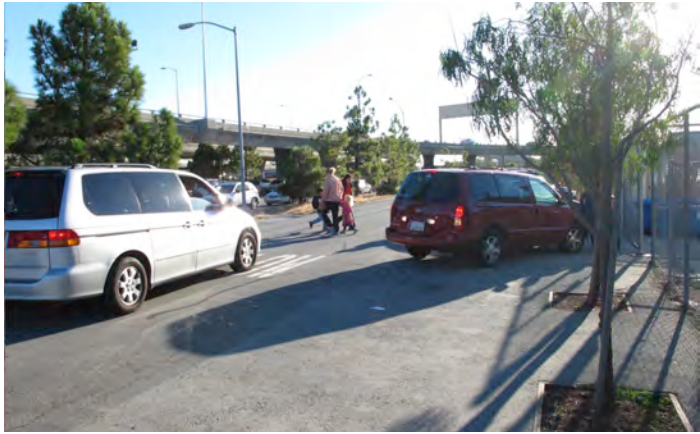
School loading also occurs along 19th Avenue.

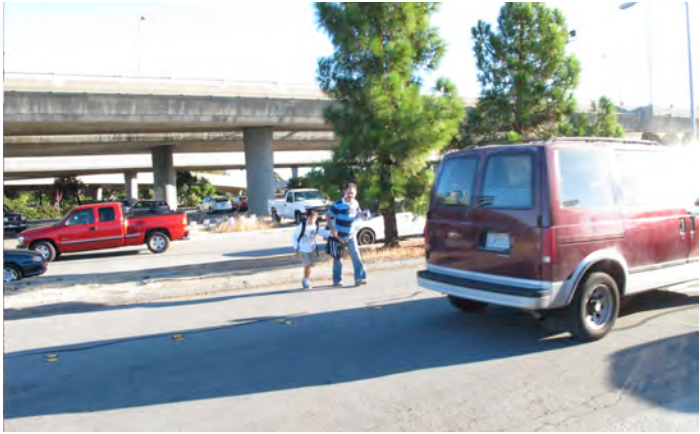
Some parents park in the Park-and-Ride lot and walk their child to school.

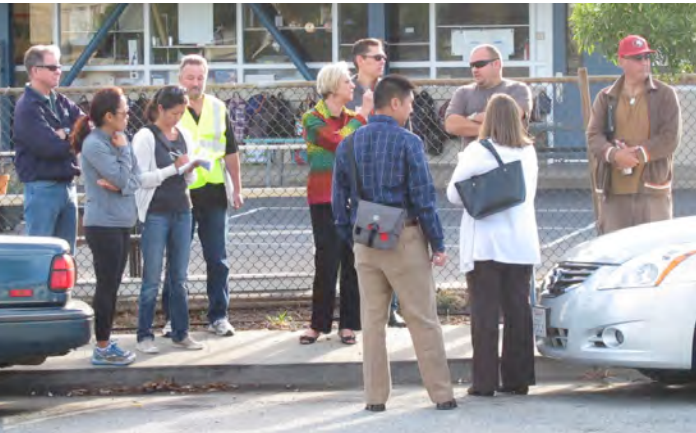
School staff, city staff, and parents participated in the audit.

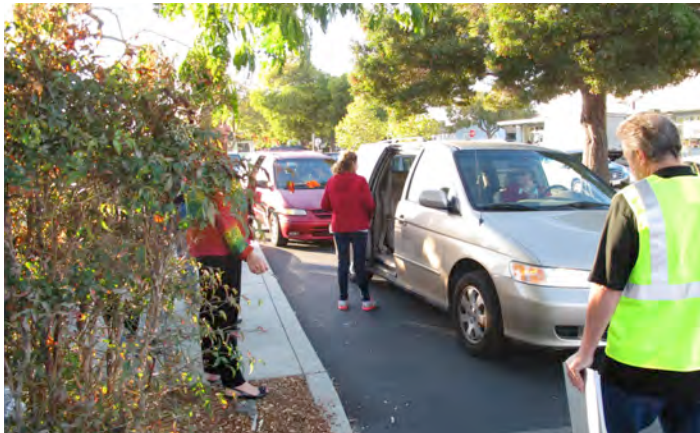
The school parking lot has a designated drop-off and pick-up area.

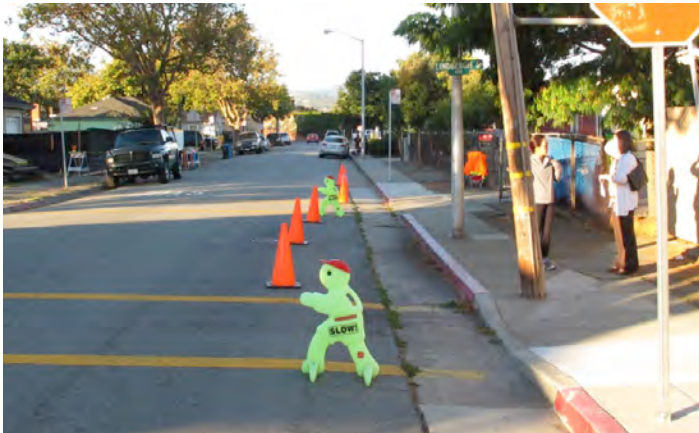
Drop-off and pick-up are also permitted on Lindbergh Street.

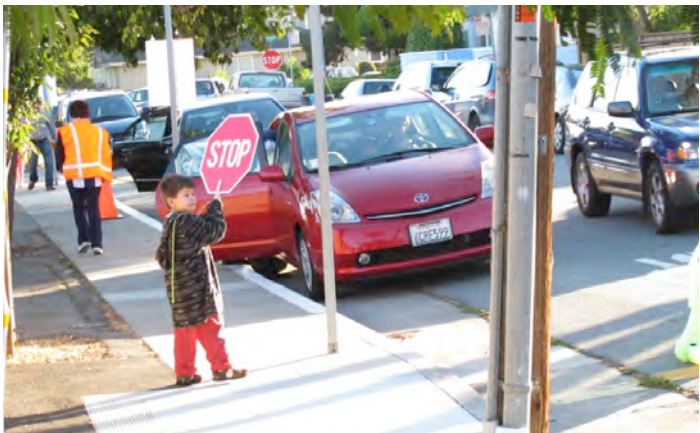
Student helper at the Lindbergh Street drop-off / pick-up zone.

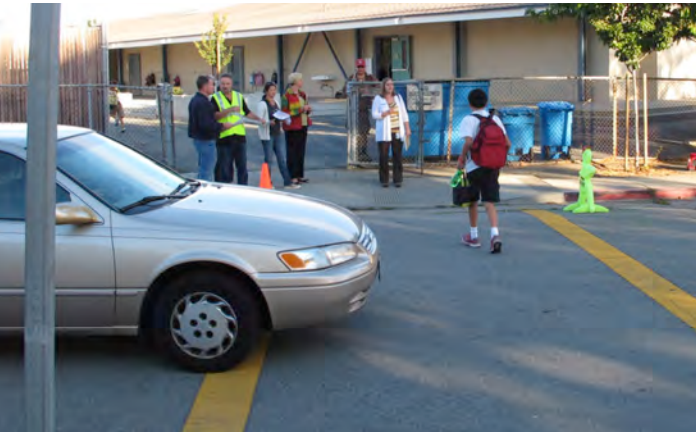
Cars sometimes encroach on the crosswalk while students are crossing.

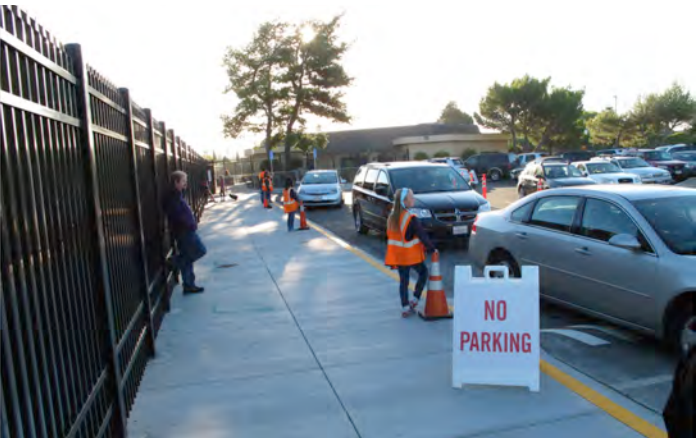
Parkside runs an effective student valet program.

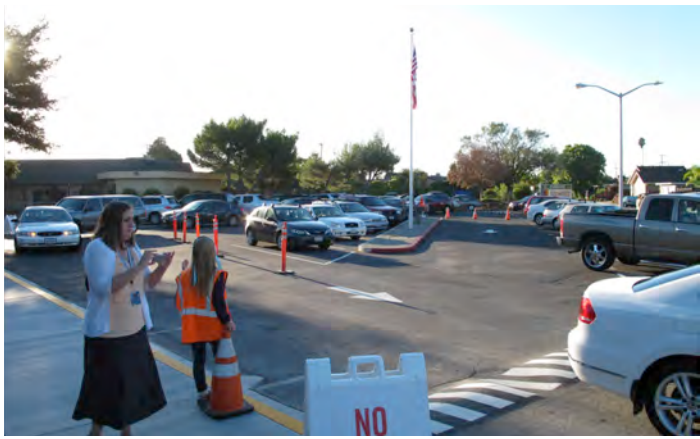
Drop-off / pickup cones, curb striping, signs, and management are effective.

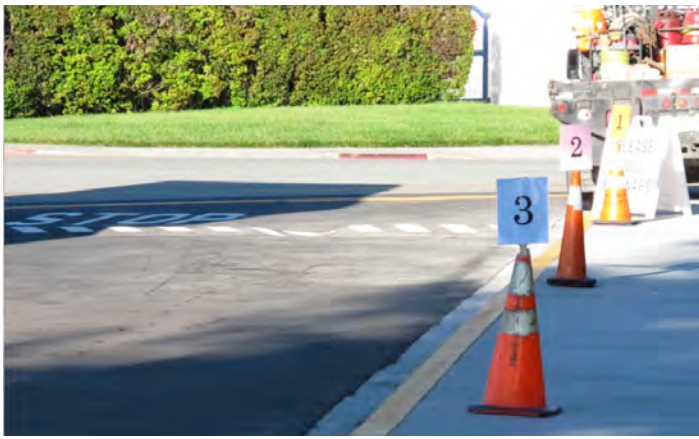
The student valet spaces are well-labelled.

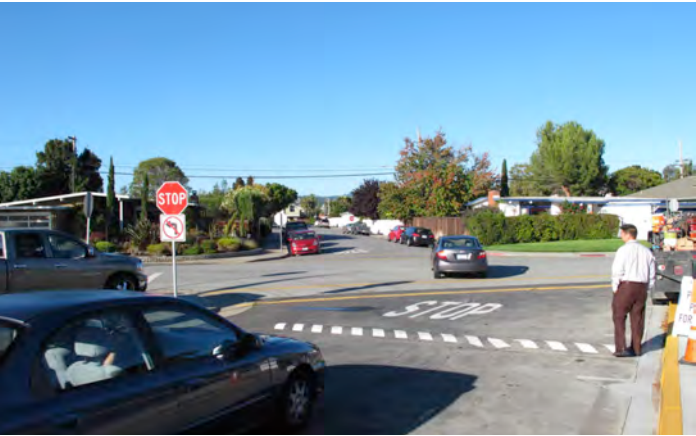
Prohibiting left-turns out of the parking lot improves valet operations.

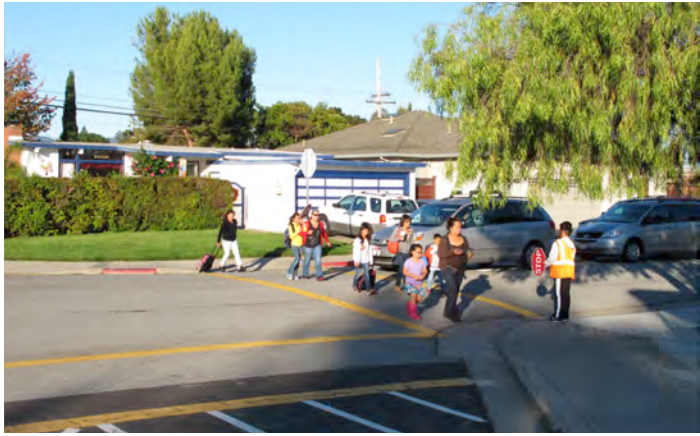
Adult crossing guards should staff school crosswalks (student patrols shown).

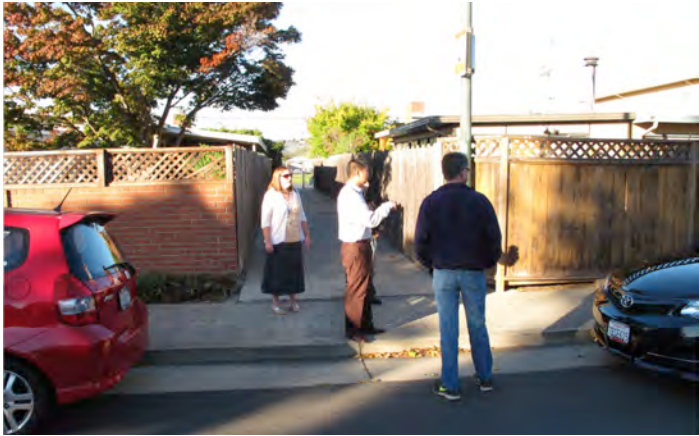
The school has secondary access via a small easement at Borden.
