# BALDWIN SCHOOL

## Facilities Condition Assessment : October 19, 2022

Facilities Condition Assessment, Capacity Analysis and Master Plan for CPS

## 7.2 | BALDWIN SCHOOL BUILDING APPENDIX

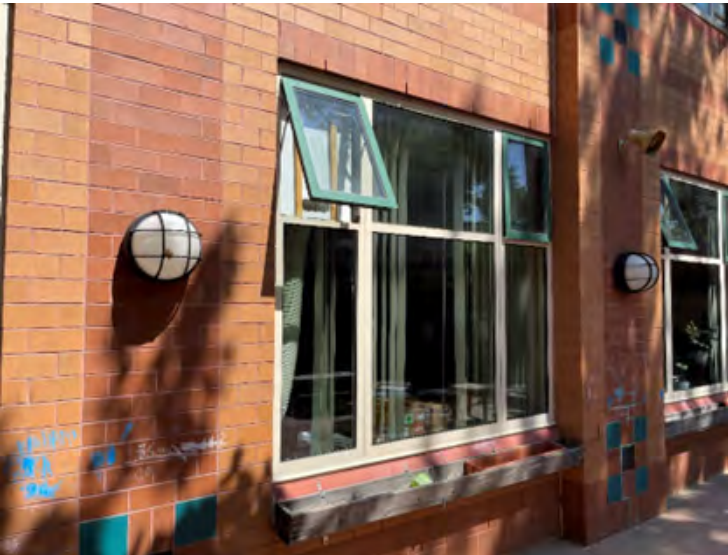
AE-B: Representative fenestration with fixed and operable components

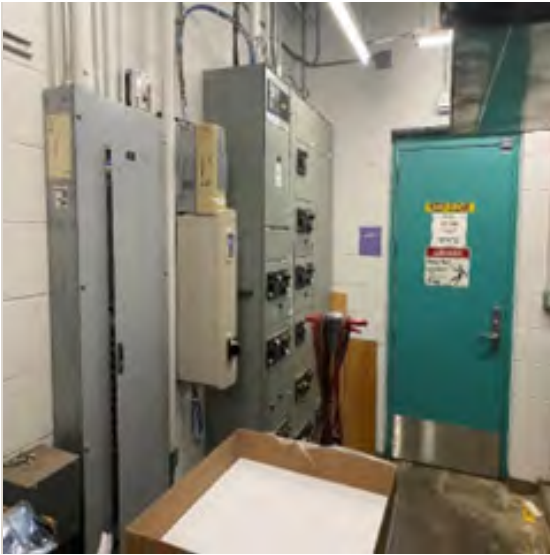
E-2: MCC Panel – General Distribution

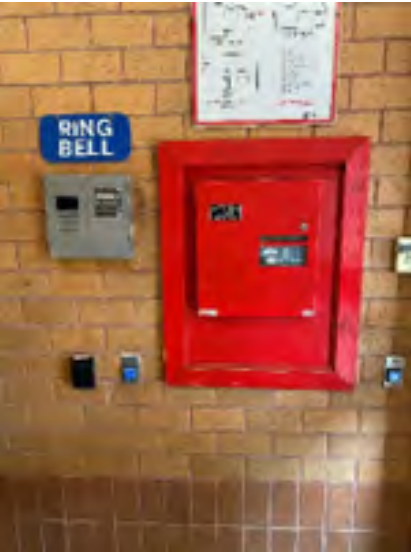
Speakers/lights are installed in corridors and some common spaces to provide alarm notification to occupants. The devices appear in good working order. Overall, the fire alarm is in fair/good condition and with proper maintenance should provide reliable service in the short term.

E-7: Speaker-type system

*Recommendations*  
Provide all required testing and detailed review for a code compliant installation.

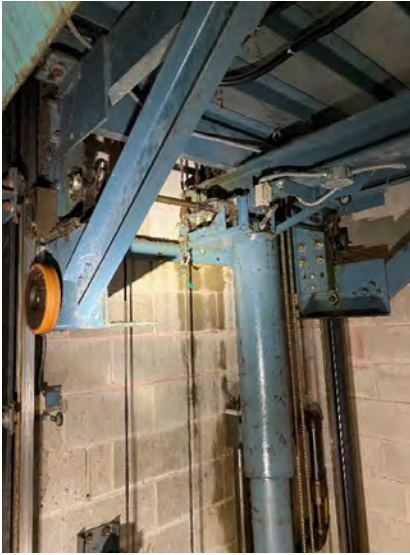
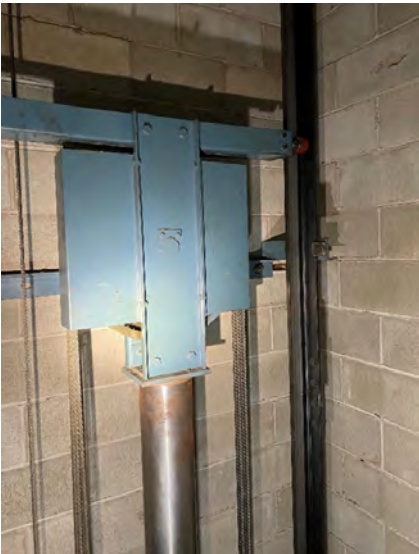
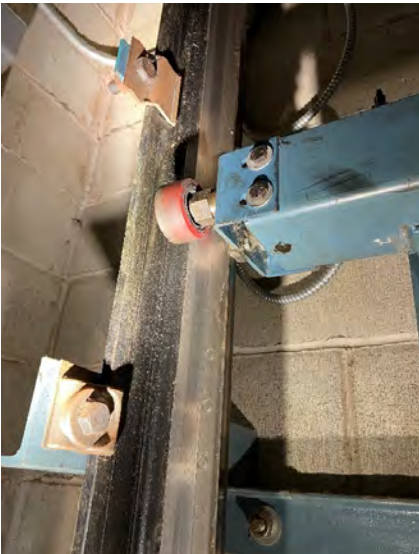
- Maintenance Deficiencies:
- Check oil line in hoistway or jack head for leaks; substantial oil leak on pit floor. Repair, clean, and dry pit of leaked oil.
  - Scrape and clean all car and hall door sills of debris.
  - Clean cartop equipment and car door operators.
  - Tighten loose rear wall handrail in cab.
  - Conduct full hoistway cleandown of all hoistway equipment.

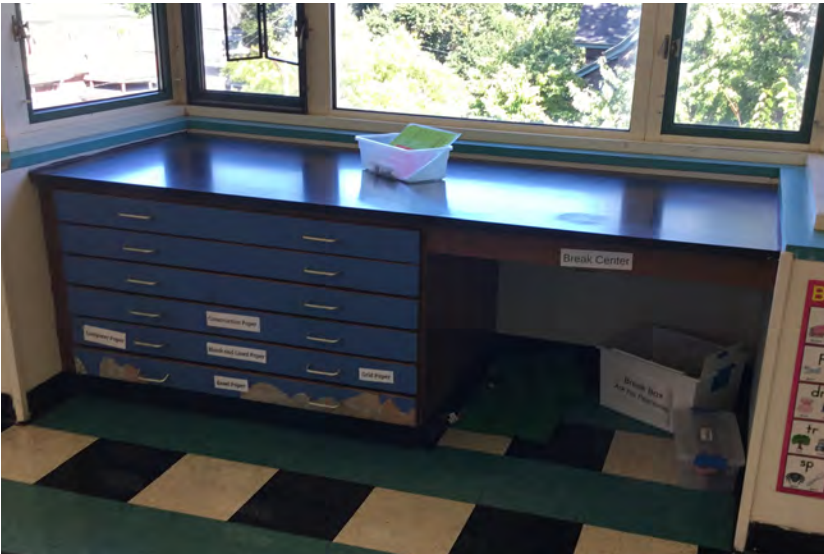
Peeling Millwork

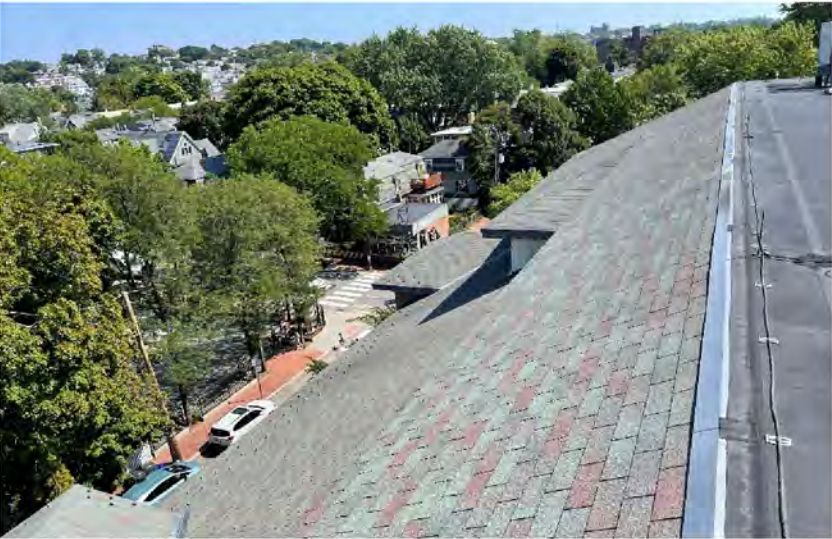
AE-25: Representative asphalt shingled roofing at transition with EPDM

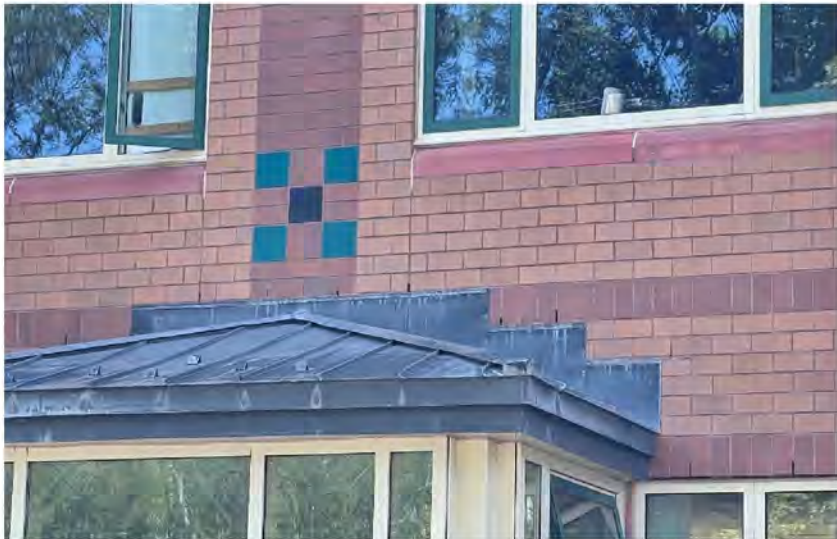
AE-31: Typical standing seam roof over lightwell at North Elevation
