# CAMBRIDGEPORT SCHOOL

## Facilities Condition Assessment : October 19, 2022

Facilities Condition Assessment, Capacity Analysis and Master Plan for CPS

# 7.3 | CAMBRIDGEPORT SCHOOL BUILDING APPENDIX

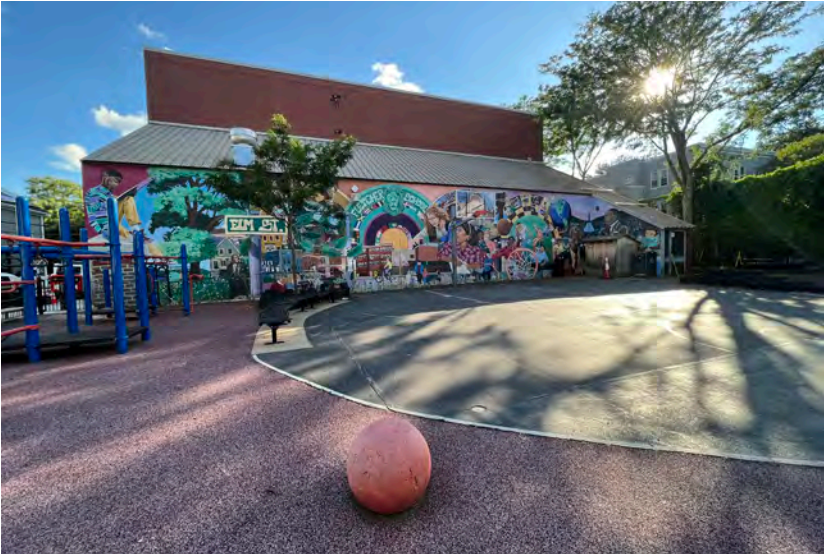
North Side of Site

The north side of the site features a large play area, fenced in from the sidewalk with two entry points. There are a series of play structures and free-standing play elements as well as benches surrounding a half court for basketball. The floor on this side is rubber except for the court which is paved with asphalt. The north side of the site is in good condition.

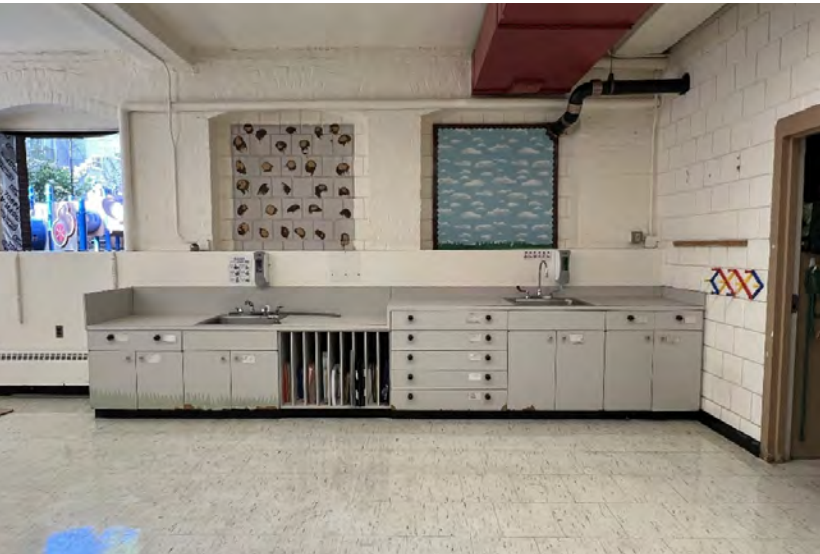
Typical Room – Basement Level

Walls:  
Basement walls are a mix of CMU, brick, and SGFT/ glazed block. These create an incohesive look to the basement level rooms. The upper-level classroom walls are composed primarily of gypsum board with exposed CMU in some locations. These walls are in moderate condition in the main classroom areas but are marginal in the entry/cubby areas of the rooms. The corridor walls have a gypsum finish however the quality is marginal and the trim is poorly executed. CMU walls have deep struck joints, sometimes with accent colors painted in the joints, but these give shadows that tend to make the overall appearance look dingy. Areas with exposed, painted brick walls look unfinished due to the rough-laid nature of the masonry in this lower level.

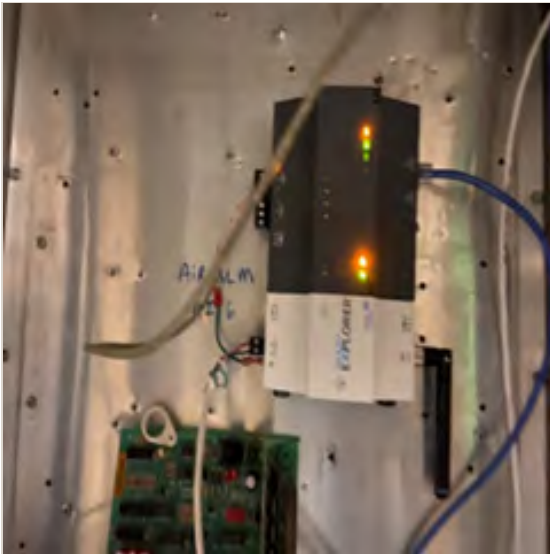
M-6: Updated Network Controller

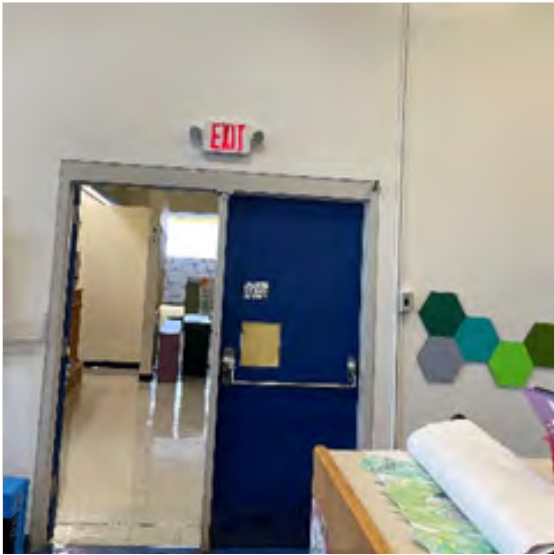
The light level at the stairwells in subject should be reviewed. Emergency exit signs were provided and appeared to be properly located for emergency access.

E-4: Emergency Egress Lighting

Emergency lighting should be upgraded by providing additional fixtures in areas that lack sufficient levels of emergency lighting (stairways). Exit lighting should be upgraded to cover all means of egress corridors and exit doors, where required.

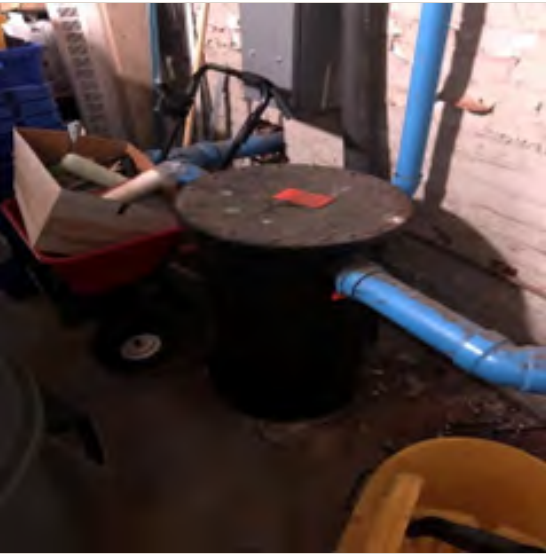
PL-3: Abandoned Neutralization Basin

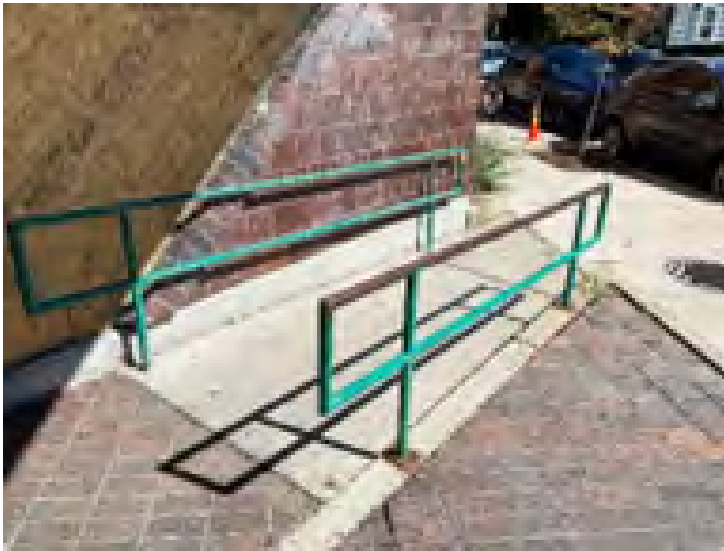
Entrance

The building has an accessible entrance, drinking fountain and toilet room. However, the exterior ramp at the front entrance does not include compliant handrails (i.e. bottom rail is not continuous, etc.). Therefore, if the cost of future renovations exceeds \$100,000 new exterior ramp handrails would be required.

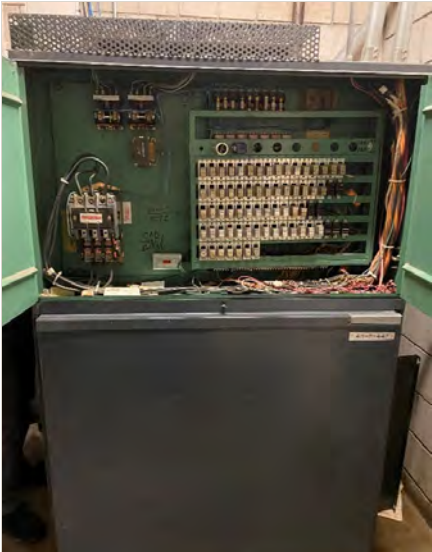
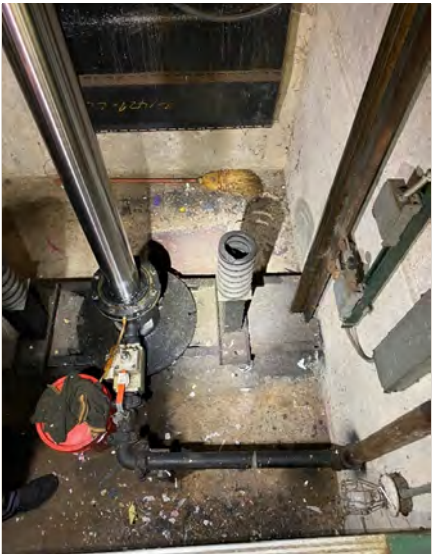
CONDITION: D

PRIORITY: 1

We also recommend adding air conditioning or an oil cooler unit to the machine room. The machine room was observed to be substantially warm. Temperature fluctuations in either direction, heat or cold, have implications on the oil viscosity in the elevator system. As an elevator is used, the friction created by the flow of oil greatly increases the temperature, changing the viscosity. This change in oil viscosity can negatively impact the ride quality and movement of the elevator.

Budget: \$130,000 - \$160,000 (Budget estimates are based on commencement of work in 2023)

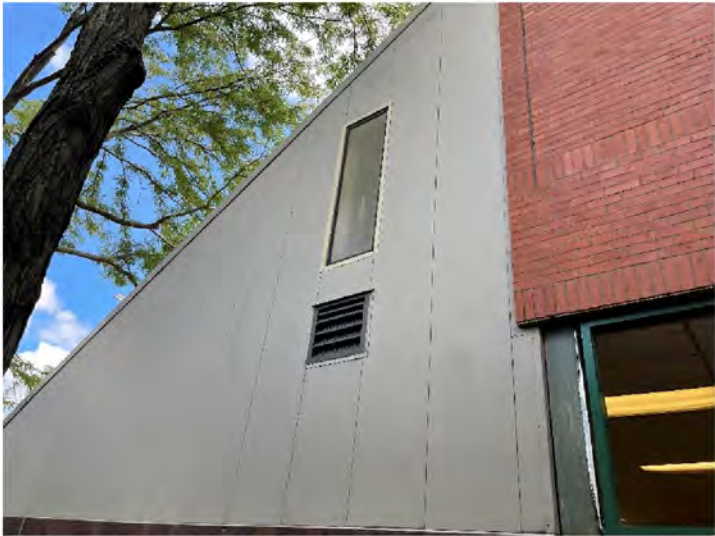
AE-21: Typical insulated metal panel at West Elevation of North wing
