# HAGGERTY SCHOOL

110 Cushing Street  
Cambridge, MA 02138

## Facilities Condition Assessment : October 14, 2022

# 7.6 | HAGGERTY SCHOOL BUILDING APPENDIX

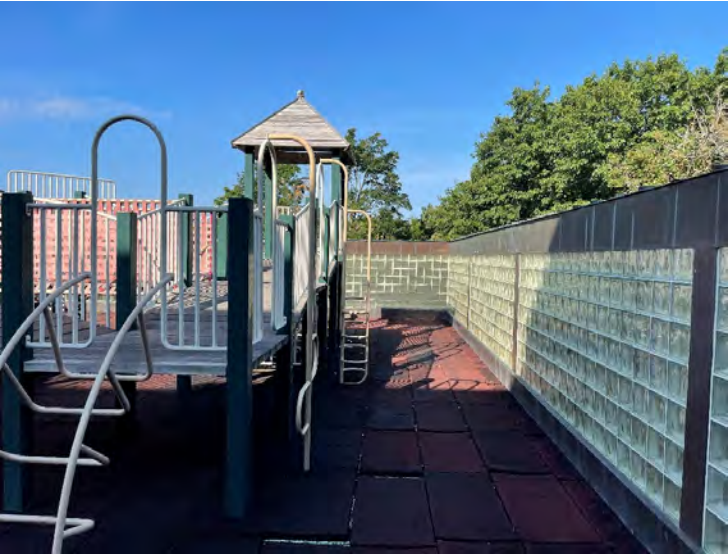
Windows and Doors:  
Glass block forms a clerestory façade around the play roof above the Gymnasium at the West Wing. Facilities personnel did not indicate any water penetration issues with the glass block, however there is water staining and discoloration within the mortar surrounding the glass block in most locations. There is some condensation within the glass block in this area. (Ref: Photo AE-19-20)

AE-D: Playroof over the West Wing

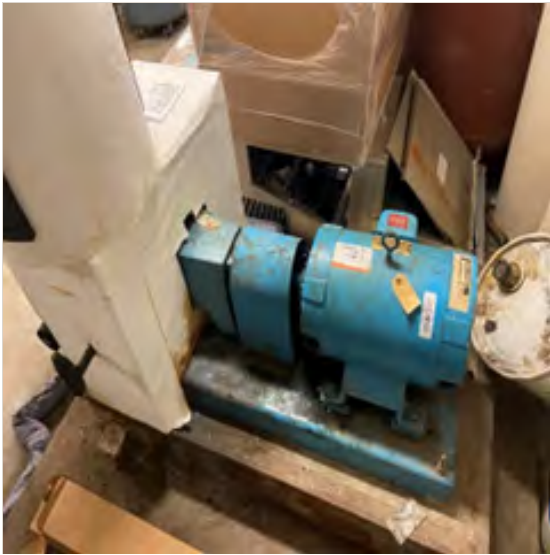
M-2: Original Dual-Temperature Pump

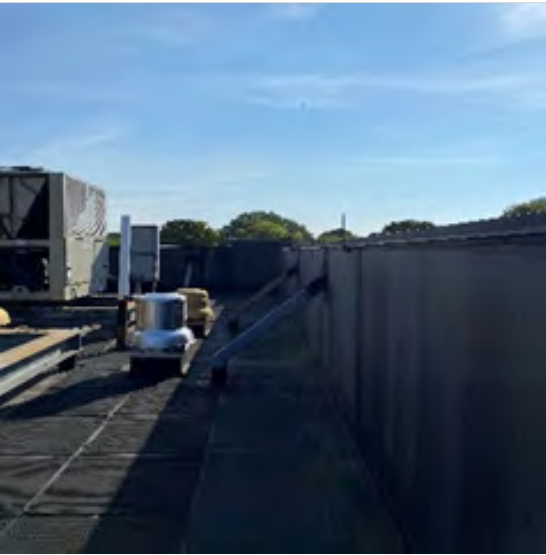
The lightning protection system appears in fair to good condition. It was noted that the new mechanical system on the roof was not integrated into the lightning protection system.

E-4: Lightning Protection

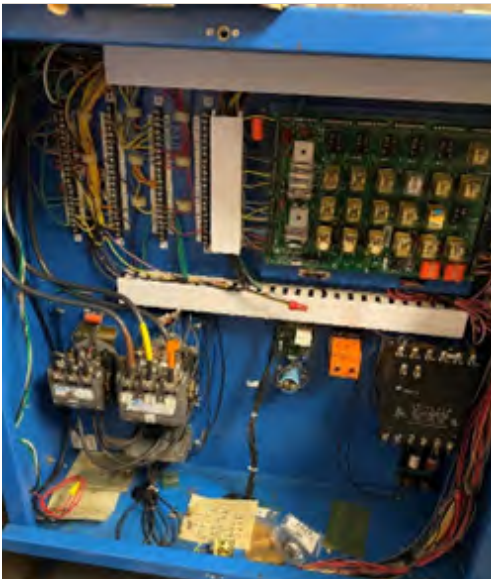
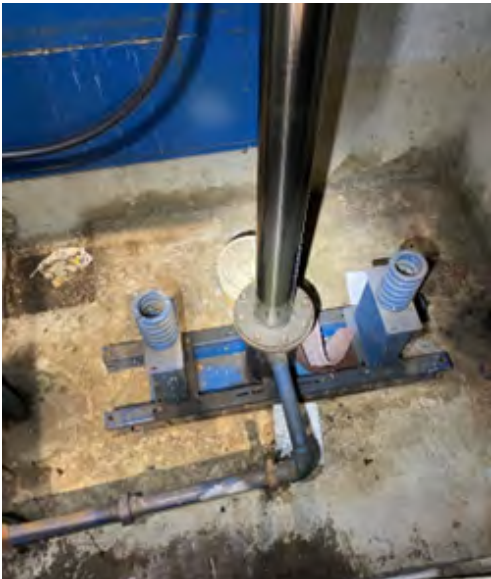
- Repair leaking oil line; replace any fittings and seals as needed.
- Scrape and clean debris from hall and car door sills.
- Replace missing pickup roller at Floor 2.
- Adjust car door hangers or rollers to eliminate front entrance car door from dragging in the sill.
- Repair car position indicator – not functioning.
- Replace light bulb for Floor 1 COP button.
- Recommend building cleaning staff cease pushing water and/or floor cleaning agents into the hoistway. Evidence of water or cleaning supply corrosion present inside the hall door sills and hall door equipment below the landing(s).
- Machine room air conditioning does not appear to be functioning. Check and verify proper operation of HVAC.

We recommend budgeting for a modernization of the elevator within the next 3-5 years. As part of the modernization, we recommend the scope include replacement of the controls, power unit, signal fixtures, machine room and hoistway wiring, car and hoistway door equipment, including door panels, and car enclosure and finishes. Further discussion may be held pertaining to the jack. Based on the original installation date, the jack could have been installed with a PVC containment liner and may be suitable for continued use. Decision pertaining to the replacement of the jack should be based on budget.

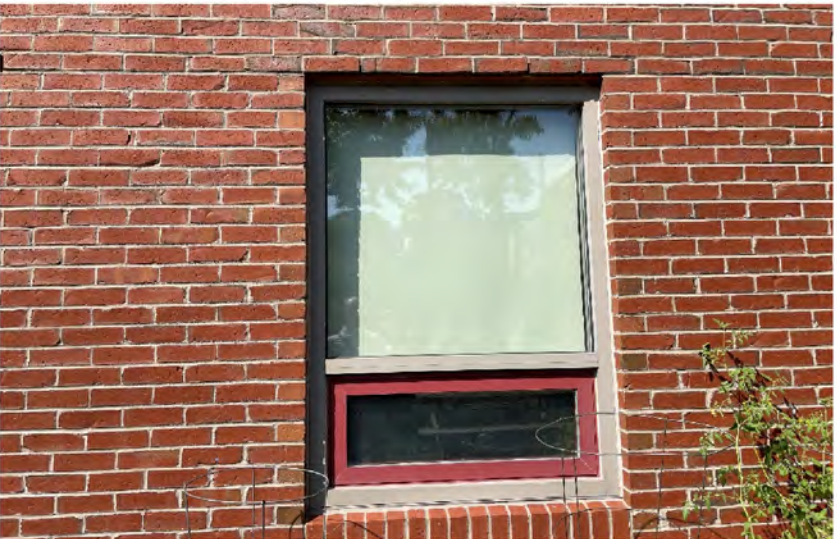
AE-24: Representative aluminum window assembly with fixed and operable components

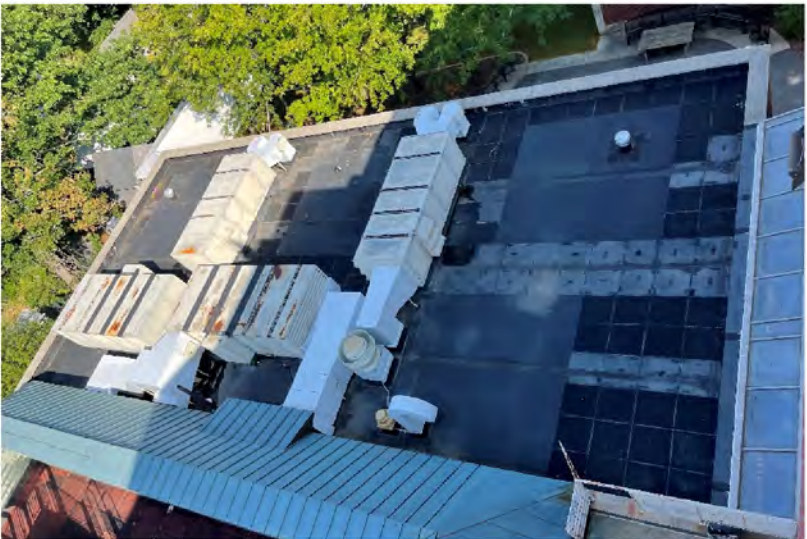
AE-40: General view at North portion of West Wing Roof
