# KENNEDY-LONGFELLOW BUILDING

158 Spring Street  
Cambridge, MA 02141

## Facilities Condition Assessment : October 14, 2022

# 7.7 | KENNEDY-LONGFELLOW SCHOOL BUILDING APPENDIX

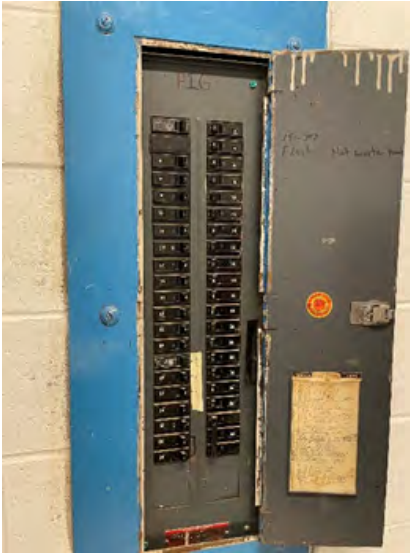
E-4: Dated Subpanel

Due to the age of the existing electrical distribution system, it is recommended that the existing systems be scanned with an infrared camera to identify any loose or weak electrical connections. The generator should be tested, and a testing regime should be established.

The electrical distribution system should be replaced completely with the next renovation or large-scale mechanical upgrade. It is now approaching 53 years old and is significantly past its useful life.

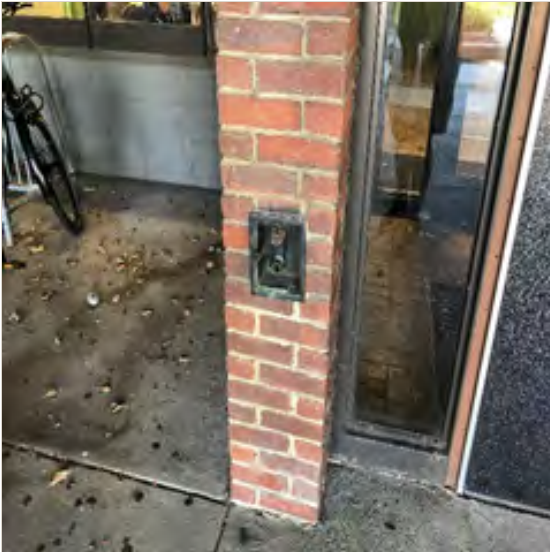
Image P4: Exterior Hose Bibb

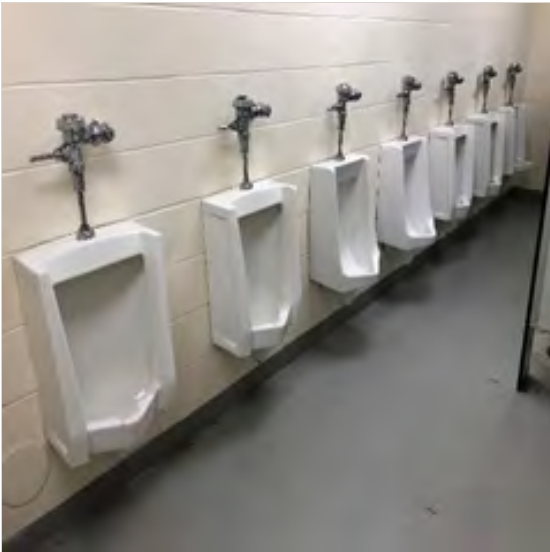
PL-7: Privacy Shields Should Be Provided

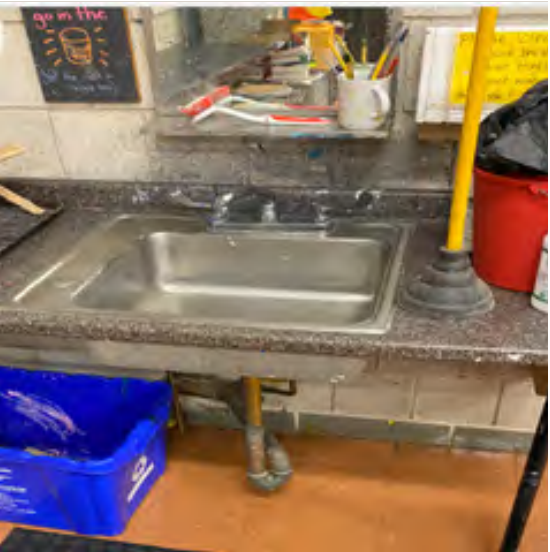
PL-8: Industrial Art Sink Clogging

*Recommendations*  
Provide clay trap to serve existing industrial arts sinks.

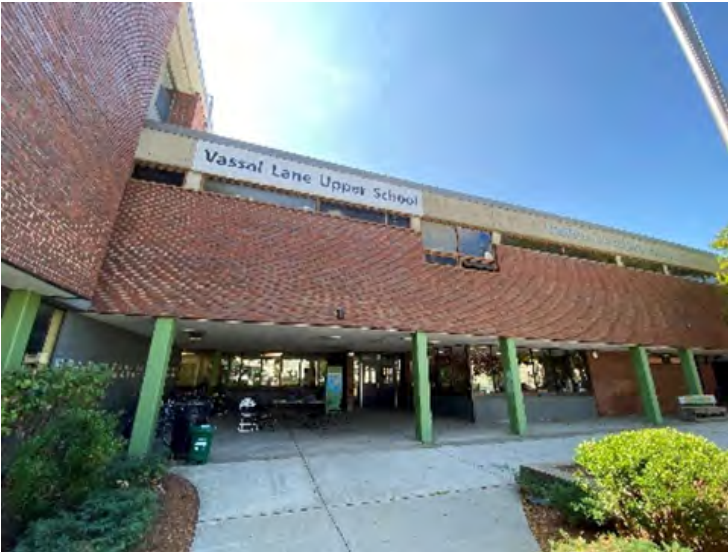
Entrance

Accessibility for Persons with Disabilities  
The building has an accessible entrance, toilet room, and drinking fountain. Therefore, if the cost of future renovations exceeds \$100,000 additional modifications would not be required.

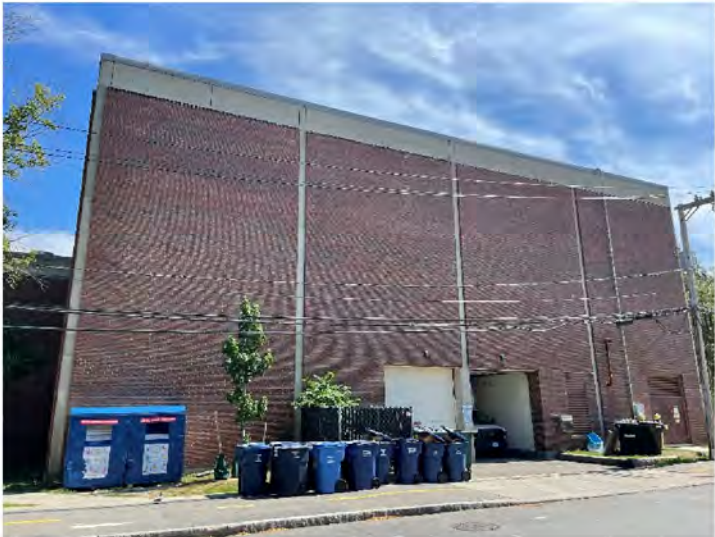
AE-5: Partial West Elevation

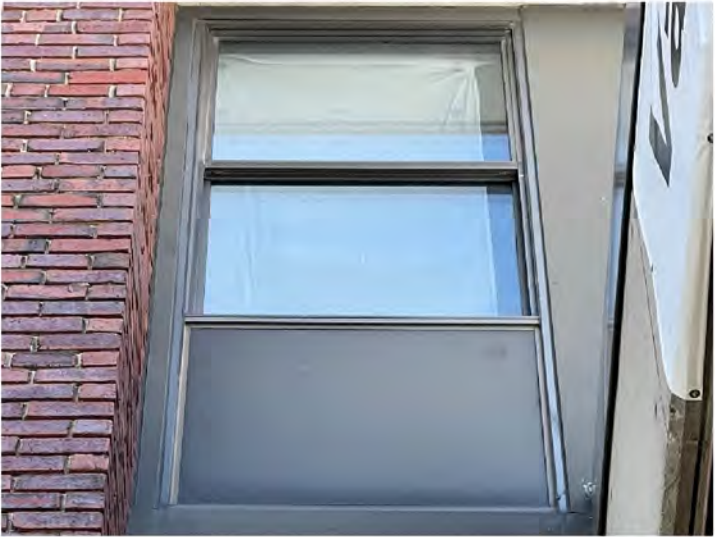
AE-24: Representative hung aluminum window assembly with spandrel panel

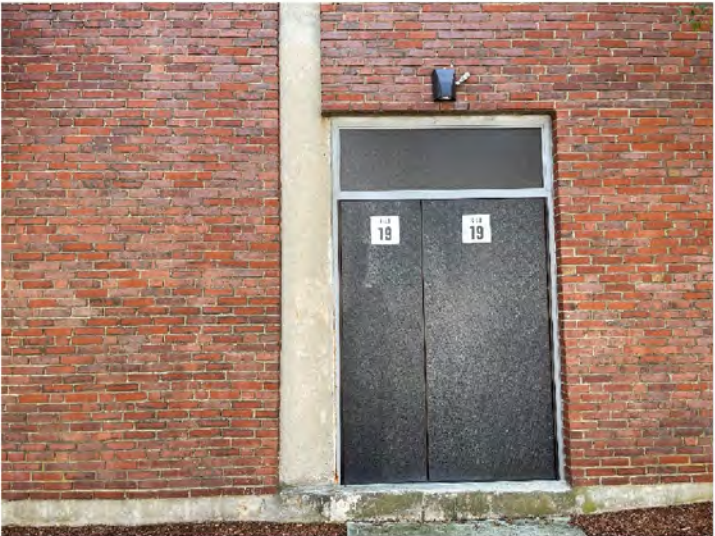
AE-38: Typical metal door assembly at exterior

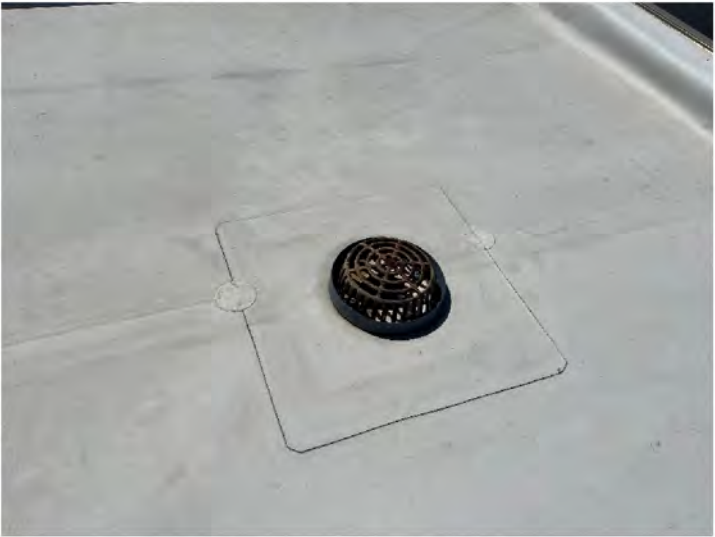
AE-54: Typical roof drain assembly

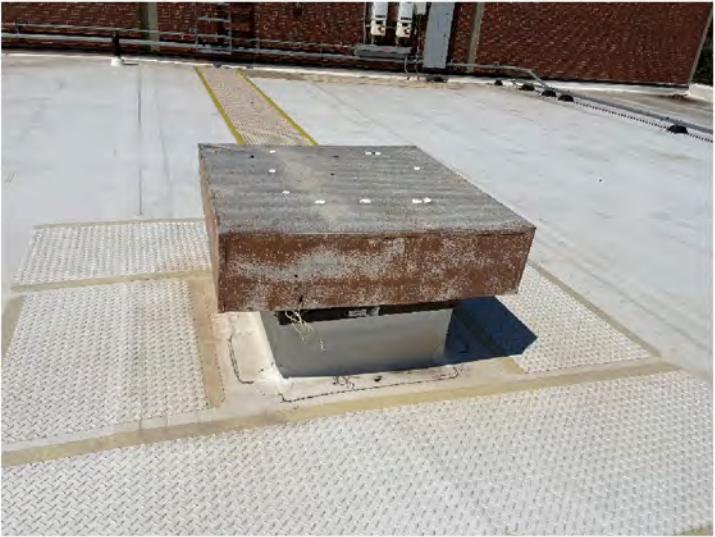
AE-56: Typical vent curb with walkway pads
