# LONGFELLOW BUILDING

359 Broadway  
Cambridge, MA 02139

**Facilities Condition Assessment : October 19, 2022**

## 7.8 | LONGFELLOW BUILDING BUILDING APPENDIX

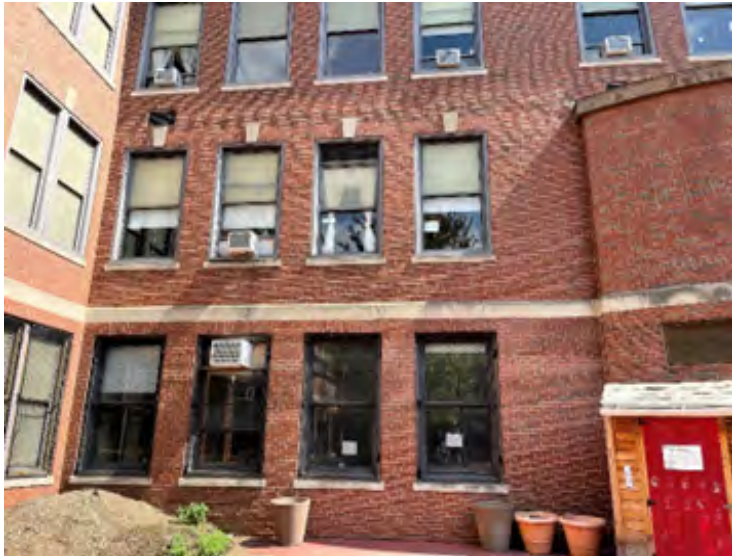
AE-A: Representative façade within Courtyard

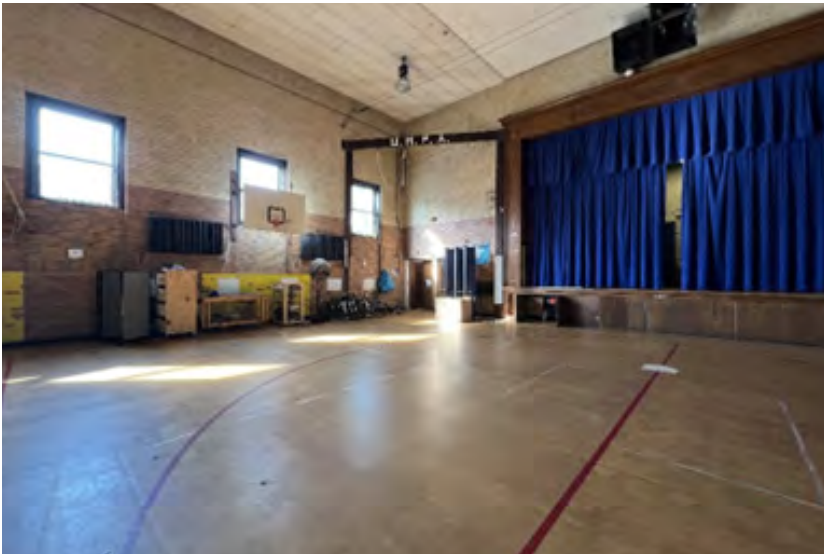
Gym and Stage

floor at the stage are both in adequate condition. The gym floor appears to be a rubber or linoleum sheet floor; it is well past its useful life.

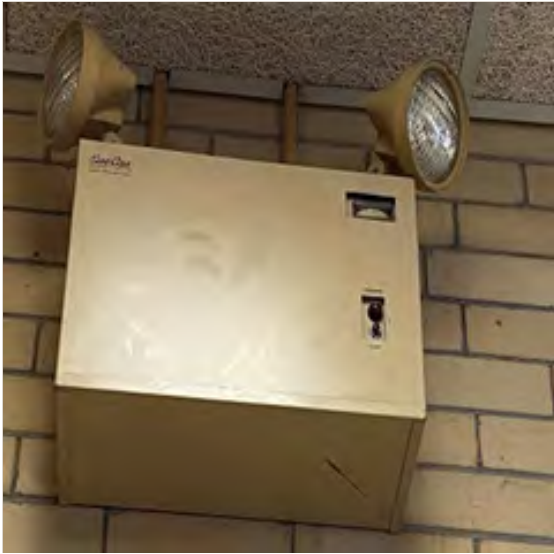
E-4: Egress Lighting

Emergency lighting should be upgraded by providing additional fixtures in areas that lack sufficient levels of emergency lighting (stairways). Exit lighting should be upgraded to cover all means of egress corridors and exit doors, where required. It is recommended that all devices be replaced with the next major renovation, as ceilings will need to be removed for MEP work.

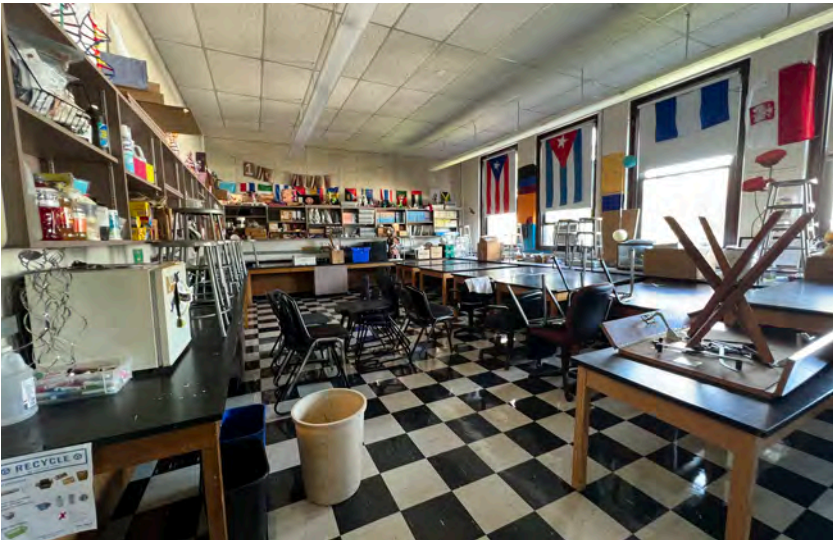
Science Classroom

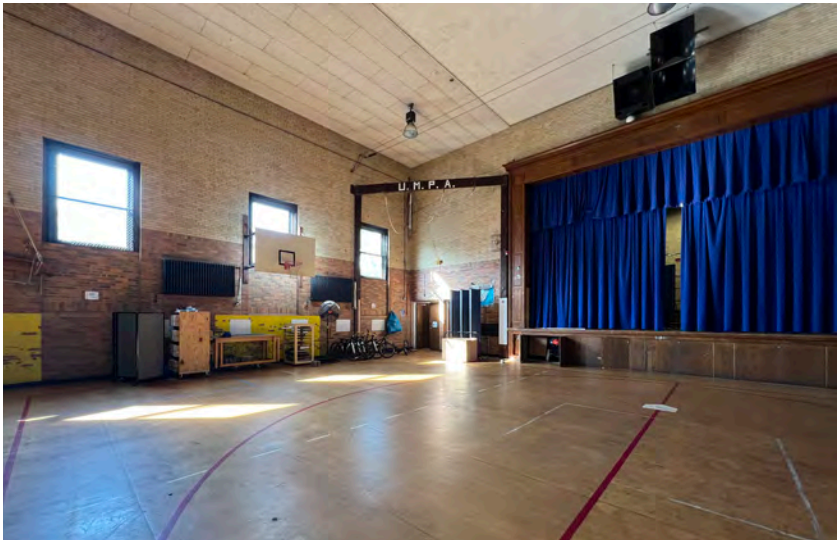
Gym

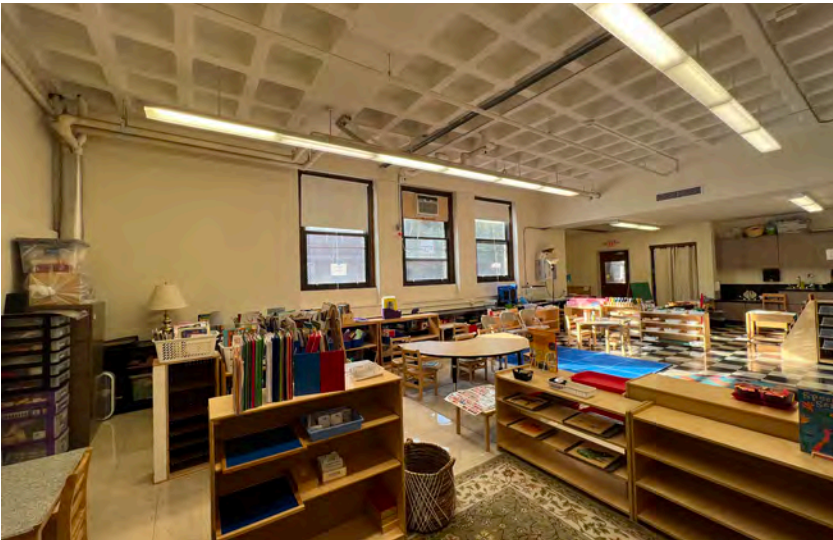
Basement classroom

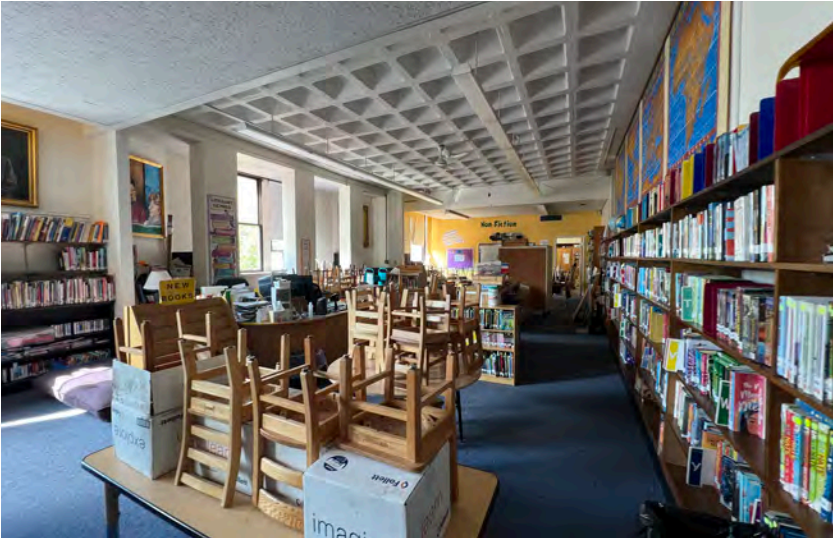
Library

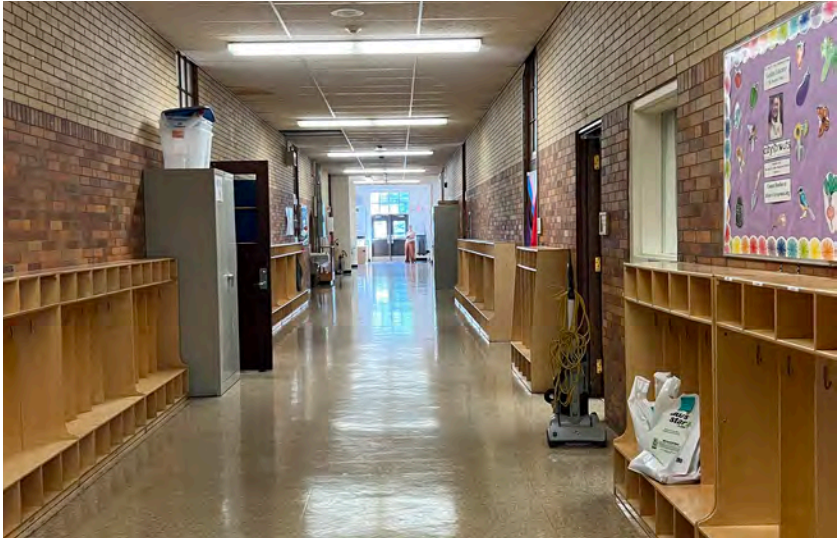
Hallway

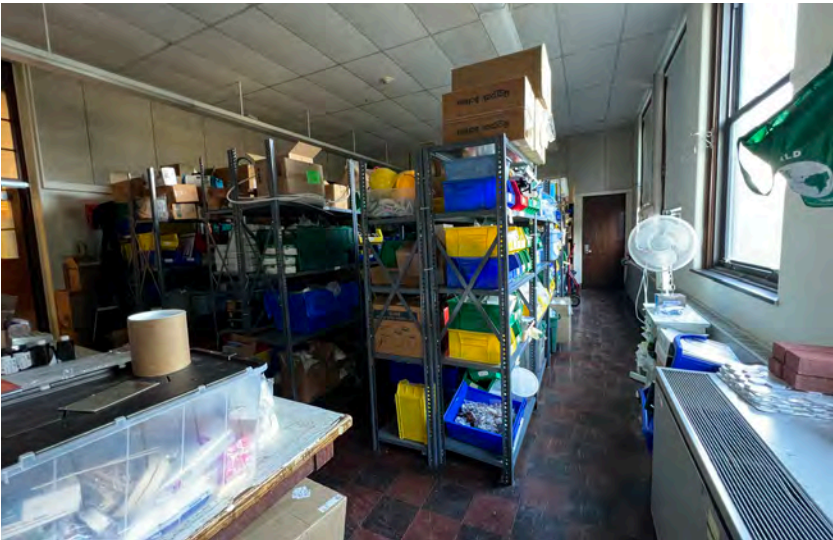
Classroom used as storage

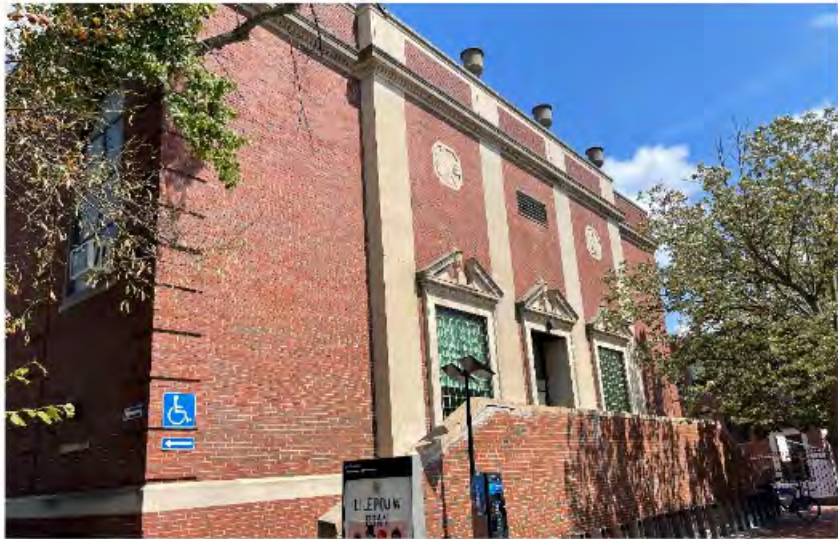
AE-1: South Elevation, West Wing

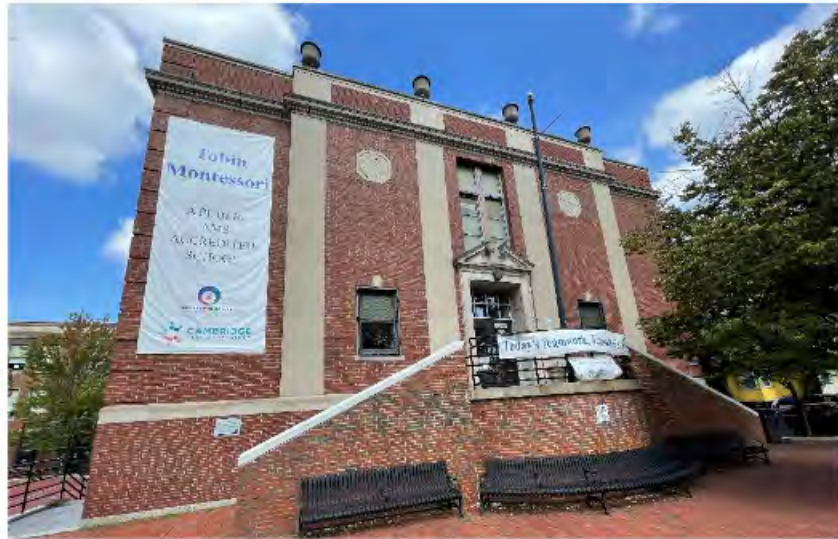
AE-2: South Elevation, East Wing

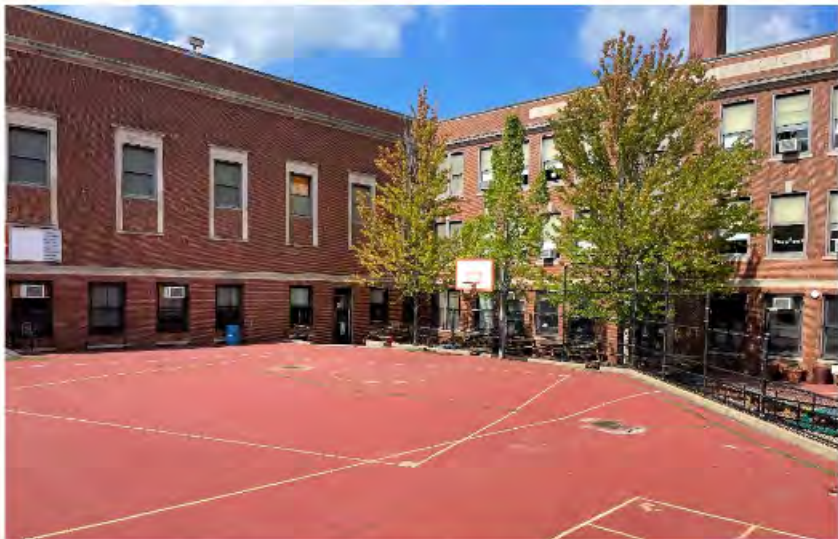
AE-3: South and East Elevations within Courtyard

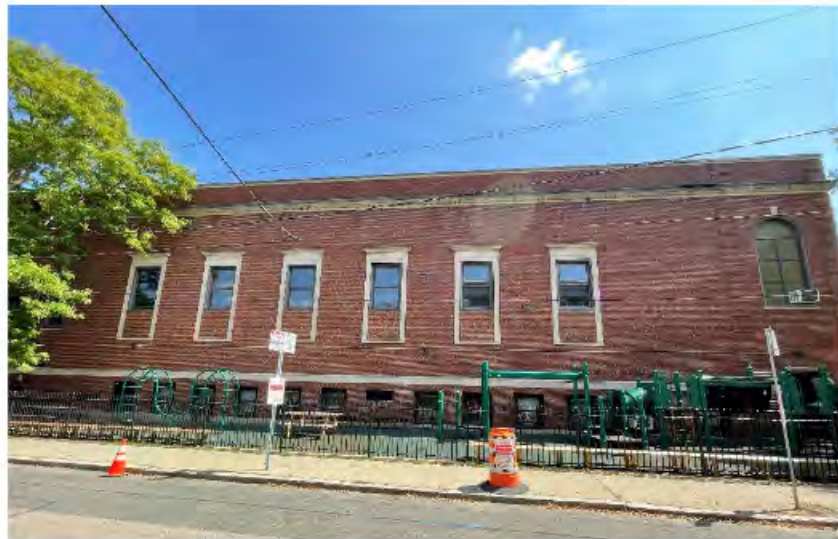
AE-4: West Elevation

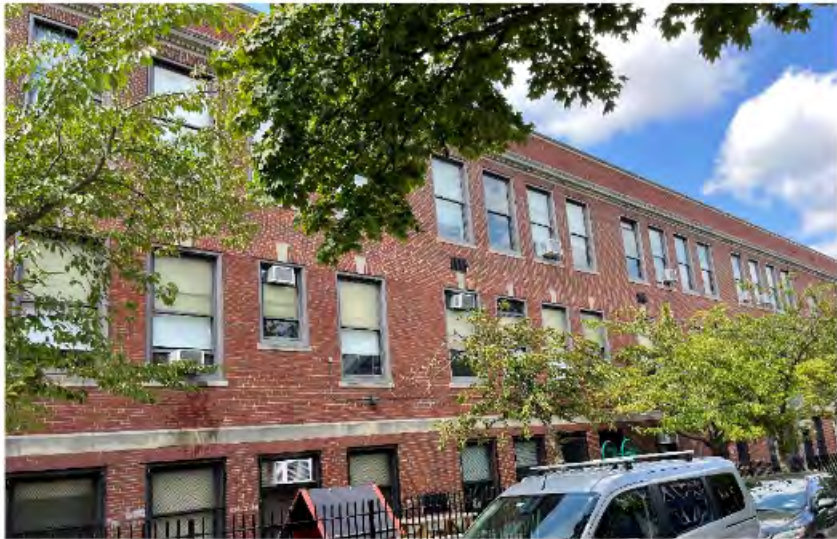
AE-5: East Elevation

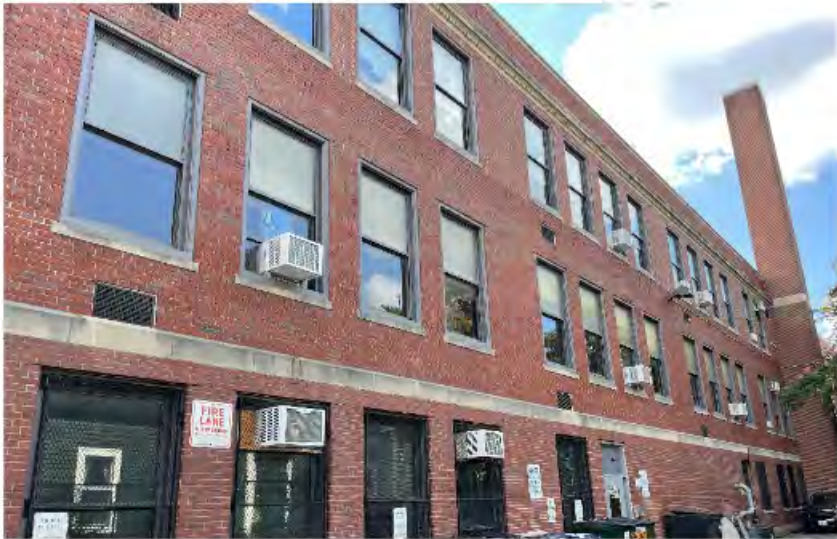
AE-6: North Elevation

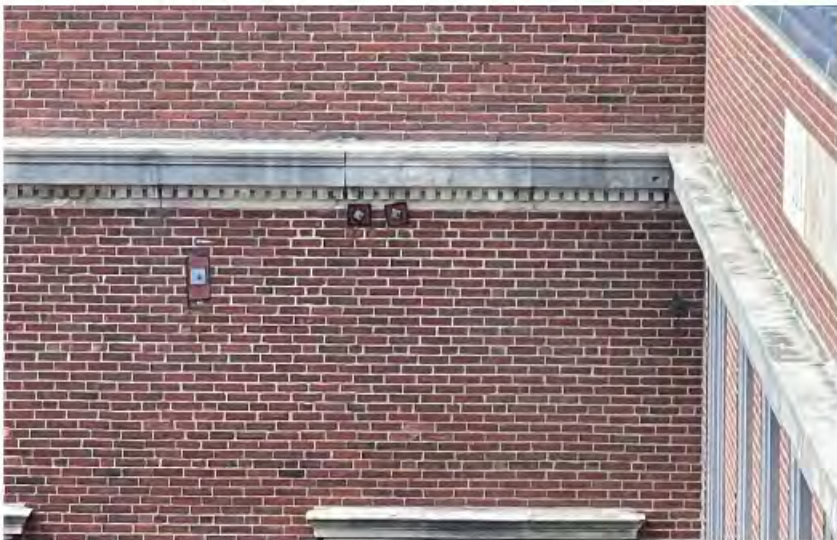
AE-8: Representative façade with tie backs
