# MORSE ELEMENTARY SCHOOL

## Facilities Condition Assessment : October 19, 2022

Facilities Condition Assessment, Capacity Analysis and Master Plan for CPS

# 7.9 | MORSE SCHOOL BUILDING APPENDIX

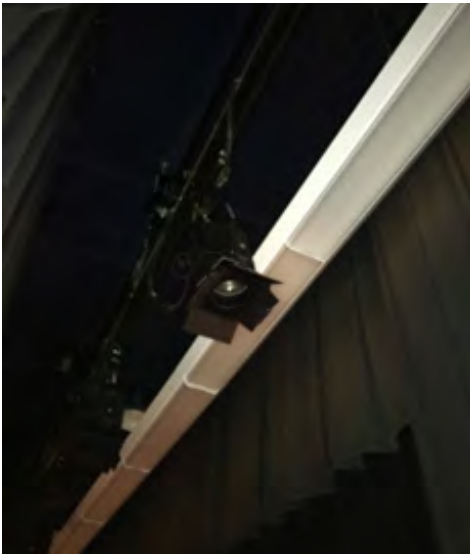
Incandescent Theatrical Lighting Fixtures

Theatrical Lighting:  
This system should be upgraded. Panelboards and/or dimmer racks serving theatrical lighting should be replaced with relay panels. Fixtures should be upgraded to LED spot and wash fixtures. Existing power infrastructure is likely to be able to be reused. Low-voltage control wiring (category cable) must be added to serve each lighting position.

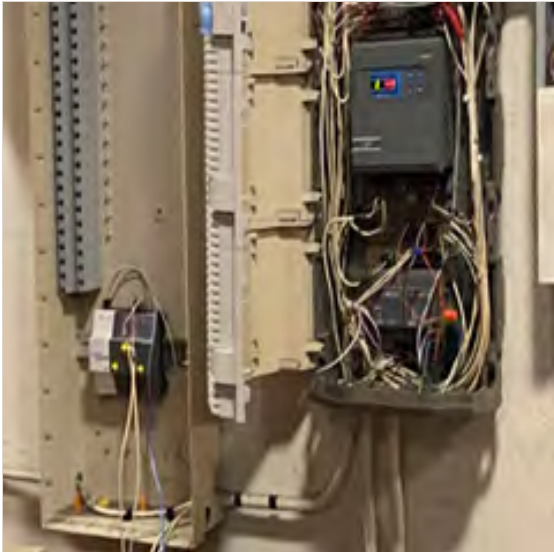
*Existing Condition*  
The whole building was upgraded onto the JCI Metasys network during the 1995 renovation. Controls are tied to the unit ventilators, chiller, and air handlers to provide local controls to the rooms via thermostats. They control fan speed in the unit ventilator to which the hot water/chilled water serves the rooms accordingly. All information is tied to the Cambridge BAS network via JCI Facility Explorer.

M-5: JCI Controls

*Recommendations*  
Most of the Cambridge School system BAS network resides on a more modern Tridium Niagara platform and ultimately a plan should be developed to transition to this newer platform as the older Metasys system is no longer supported and reaching the end of its expected median service life of 20-years. Control system upgrades should include a complete system of DDC controllers, sensors, actuators, and head-end graphics.

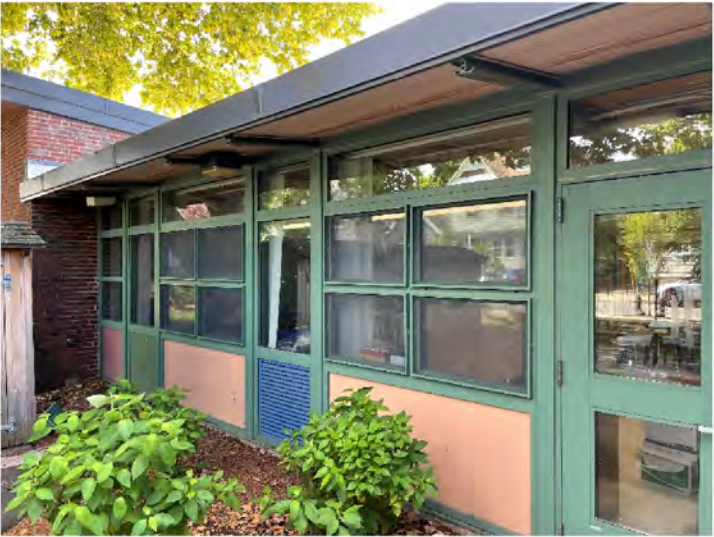
AE-9: Representative East Elevation condition at E Wing

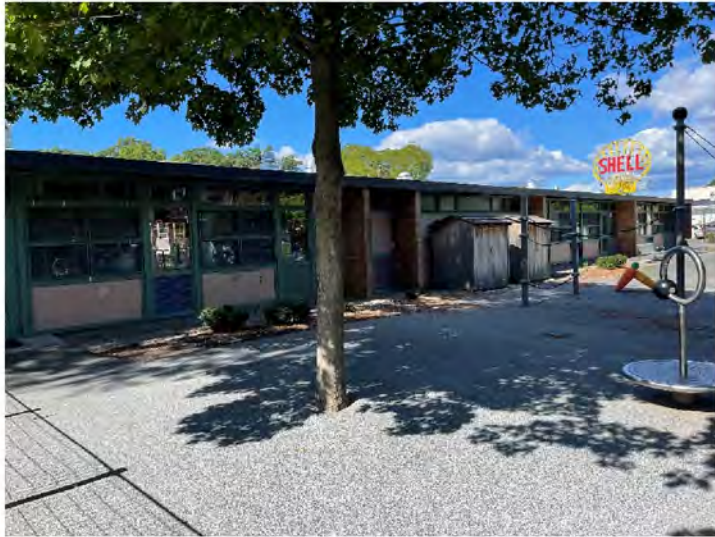
AE-8: Representative East Elevation at E Wing

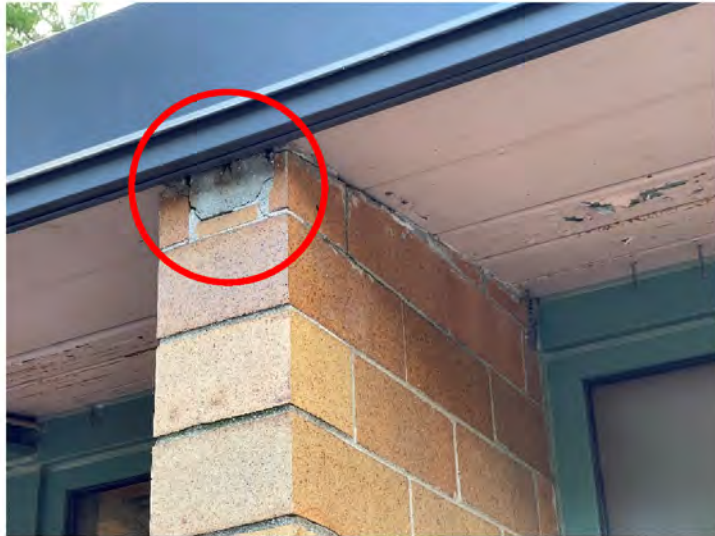
AE-21: Typical exposed metal roof truss end at exterior of facade

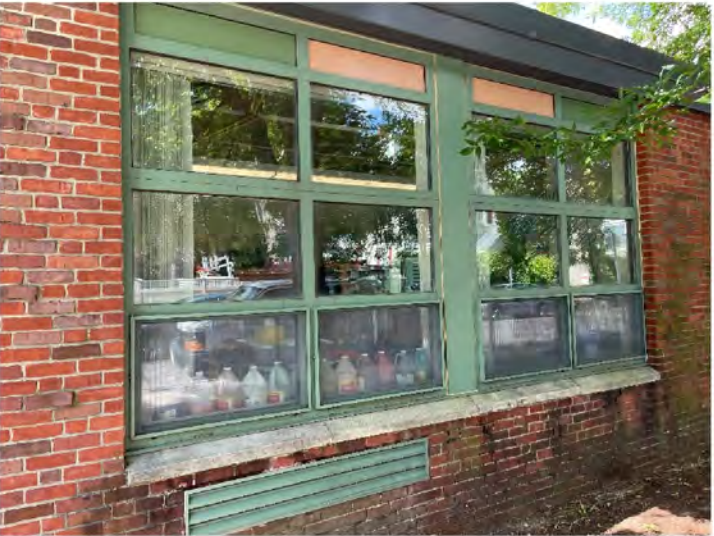
AE-26: Typical aluminum storefront assembly with fixed, operable and spandrel components within punched opening

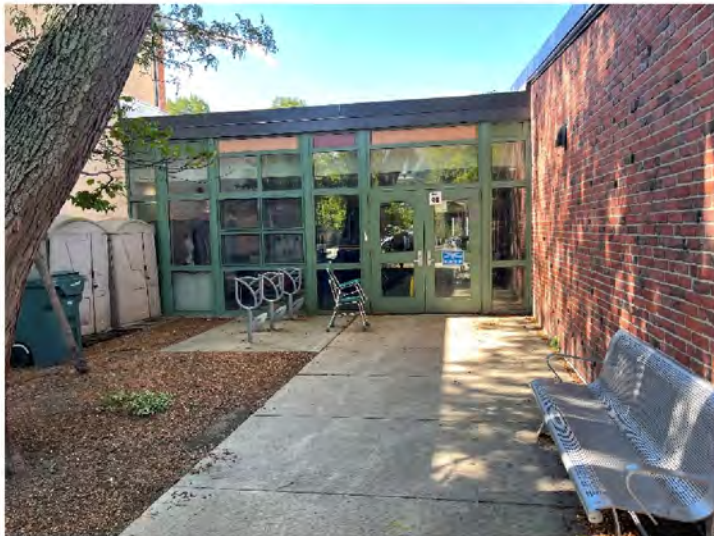
AE-27: Typical aluminum storefront assembly with fixed, operable and spandrel components at building entrance condition

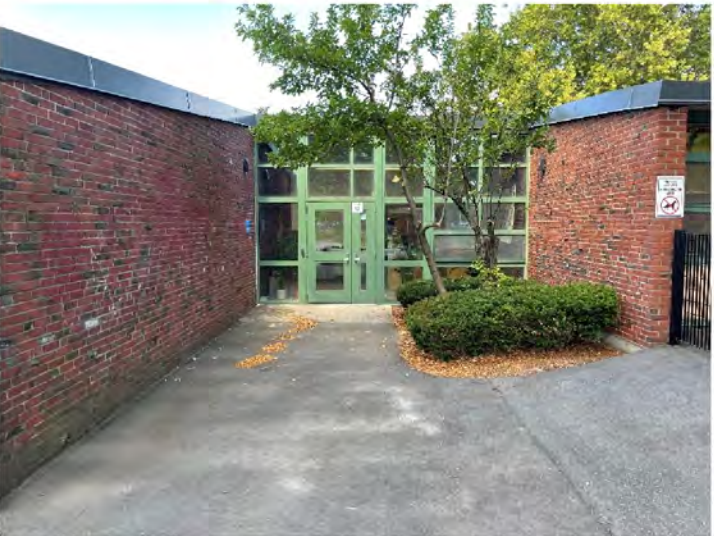
AE-28: Typical storefront entrance with operable and fixed components

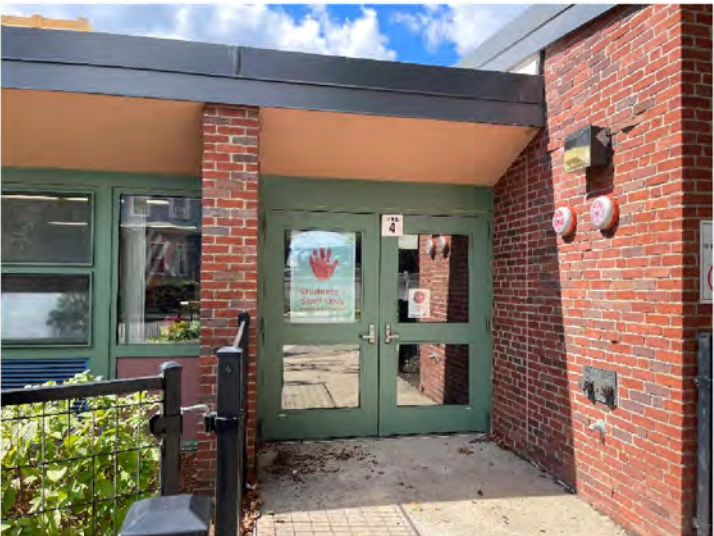
AE-43: Typical entrance doors

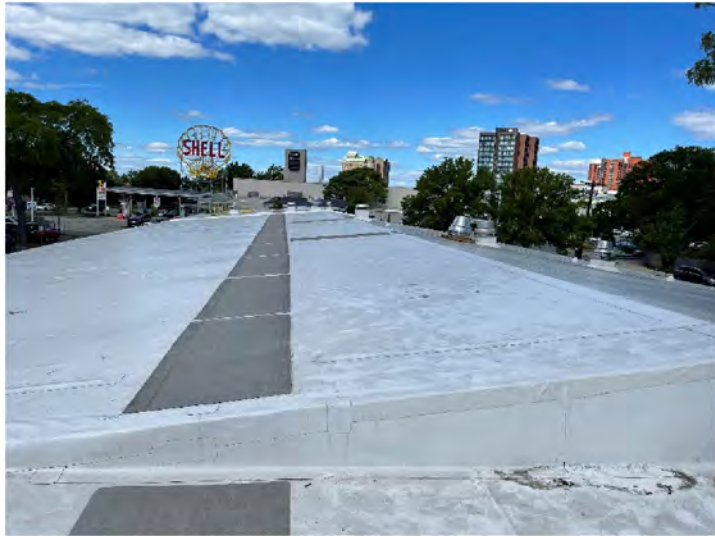
AE-54: Representative PVC roofing assembly

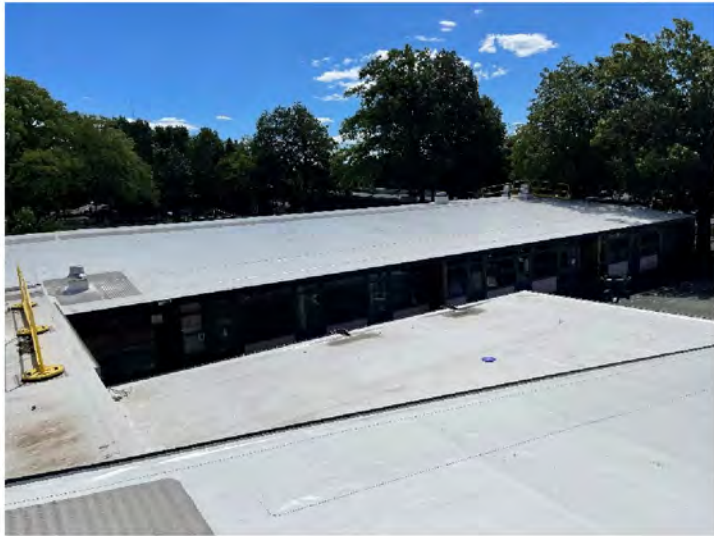
AE-57: Representative PVC roofing assembly

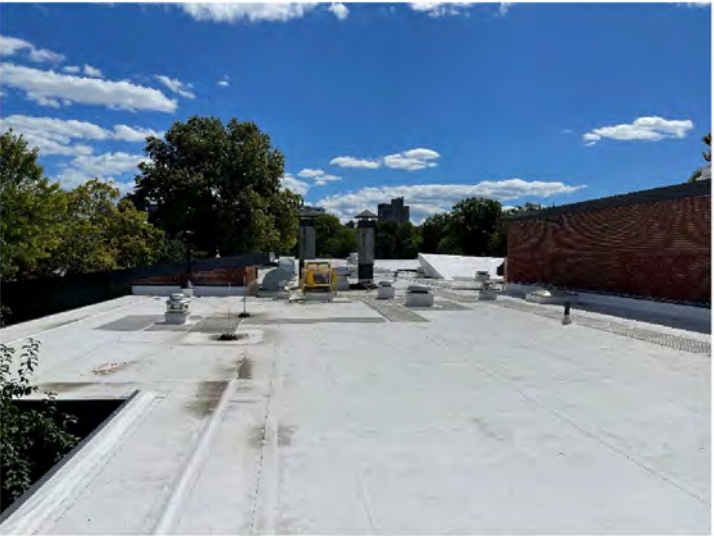
AE-58: Representative PVC roofing assembly

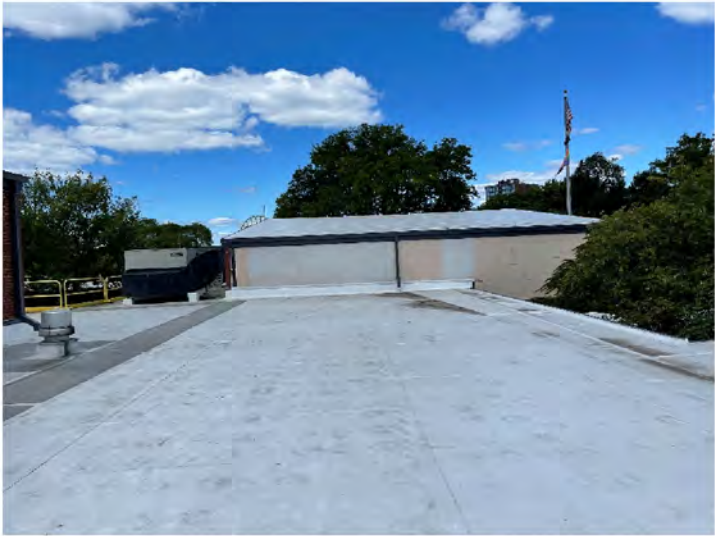
AE-55: Representative PVC roofing assembly

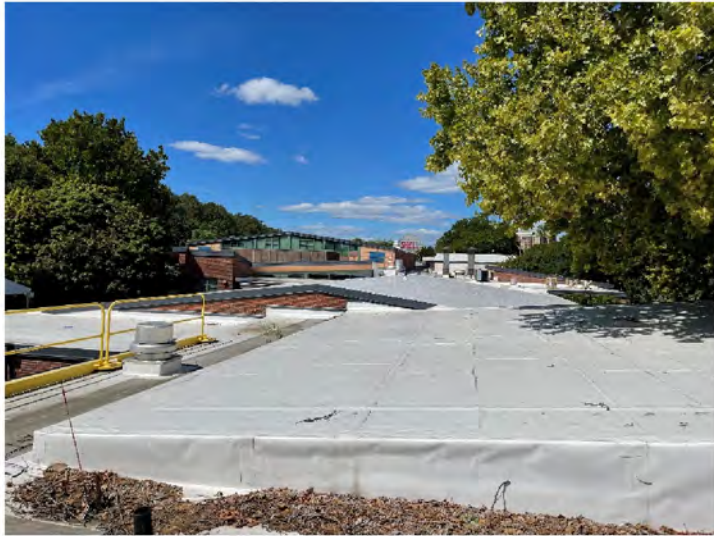
AE-59: Representative PVC roofing assembly
