# PEABODY SCHOOL

## Facilities Condition Assessment : October 14, 2022

Facilities Condition Assessment, Capacity Analysis and Master Plan for CPS

## 7.10 | PEABODY SCHOOL BUILDING APPENDIX

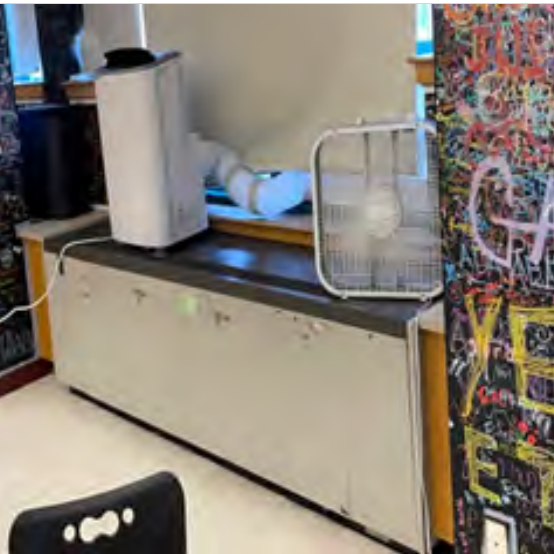
*Existing Condition*  
The building is run on a 2-pipe hot water/chilled water system. The chiller was installed during the 1995 renovation and is in poor condition. The chiller is in the process of being replaced and is completely down. The whole building is retrofitted with portable air conditioners until the new chiller is installed.

M-3: Portable AC

*Recommendations*  
The current chiller is in poor condition and does not function. Replacing the chiller is necessary. The exterior piping should also be replaced by the chiller as it is considerably weathered and damaged. The unit ventilators need to be replaced immediately as there is no condensate collection causing condensate to drip into the unit ventilators and fin tube. They are on year 22 of their 20 year service life.

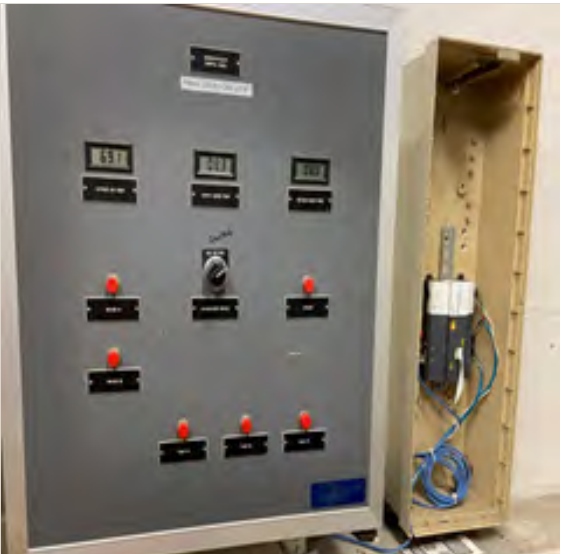
*Existing Condition*  
The whole building was upgraded onto the JCI Metasys network during the 1995 renovation. Controls are tied to the boilers, unit ventilators, chiller, and air handlers to provide local controls to the rooms via thermostats. They control fan speed in the unit ventilator to which the hot water/chilled water serves the rooms accordingly. All information is tied to the Cambridge BAS network via JCI Facility Explorer.

M-7: JCI Controls

*Recommendations*  
Most of the Cambridge School system BAS network resides on a more modern Tridium Niagara platform and ultimately a plan should be developed to transition to this newer platform as the older Metasys system is no longer supported and reaching the end of its expected median service life of 20-years. Control system upgrades should include a complete system of DDC controllers, sensors, actuators, and head-end graphics.

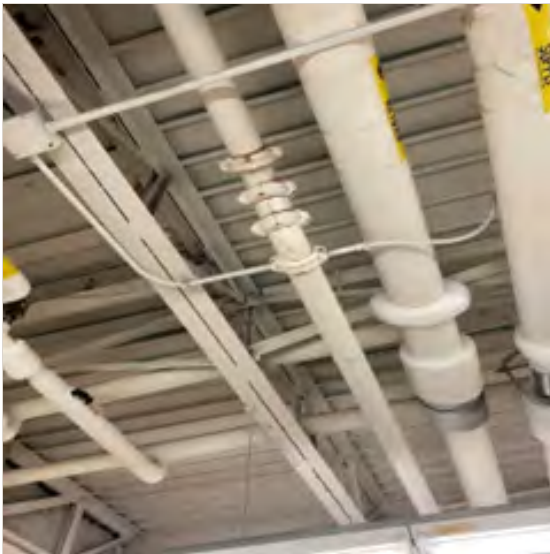
FP-1: Failing Fittings

Replace corroded sections of pipe and fittings as required.

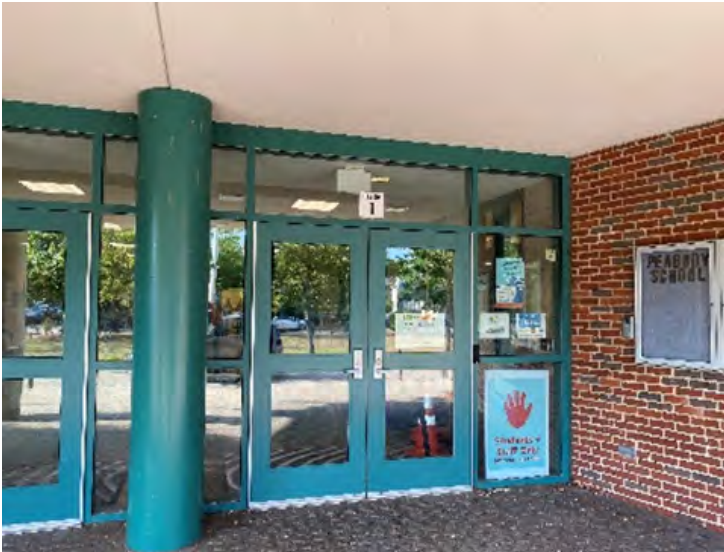
Entrance

Accessibility for Persons with Disabilities  
The building has an accessible entrance, drinking fountain and toilet room. Therefore, if the cost of future renovations exceeds \$100,000 no additional accessibility improvements are required.

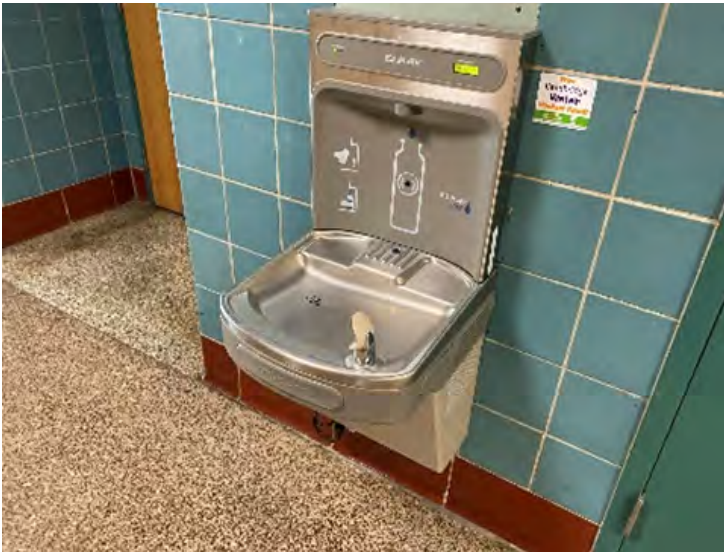
Drinking Fountain

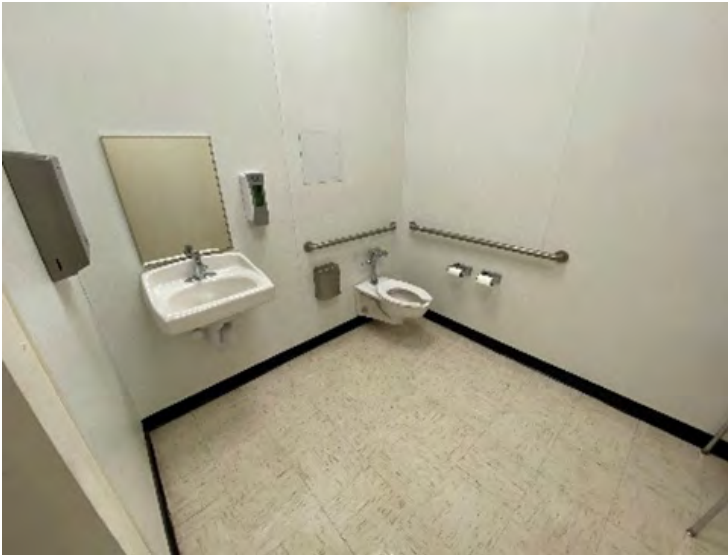
Toilet Room

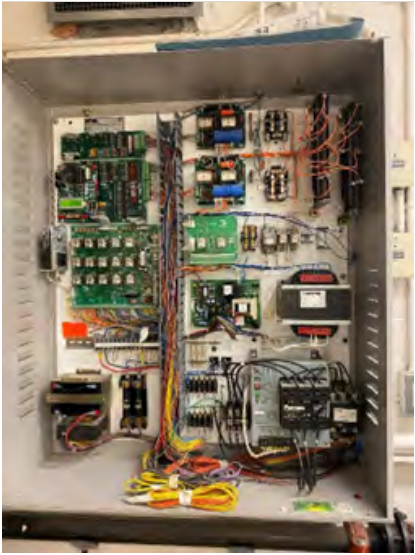
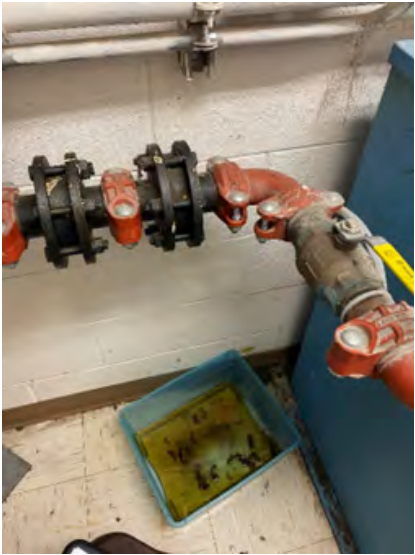
The elevator was installed in 2000 by Embree Elevator. The controls were manufactured by MCE and the hydraulic power unit and jack assemblies were manufactured by Canton Elevator.

- Maintenance Deficiencies:
- Scrape and clean all hall and car sills of debris.
  - Repair leaking oil line in machine room – Replace any victaulic seals and fittings as needed.
  - Replace worn hall door pickup rollers.
  - Recommend building cleaning staff cease pushing water and/or floor cleaning agents into the hoistway. Evidence of water or cleaning supply corrosion present inside the hall door sills and hall door equipment below the landing(s).
  - An unknown solution is also being used on the cab interior finishes that is leaving a residue on the stainless steel and button surfaces. Cleaning agents should never be used or sprayed on elevator buttons, as this may cause corrosion and malfunction to the button electronics.

We recommend budgeting for a modernization of the elevator within the next 5-7 years. As part of the modernization, we recommend the scope include replacement of the controls, power unit, signal fixtures, machine room and hoistway wiring, car door equipment, including door panels, and car enclosure and finishes.

Budget: \$120,000 - \$150,000 (Budget estimates are based on commencement of work in 2023)

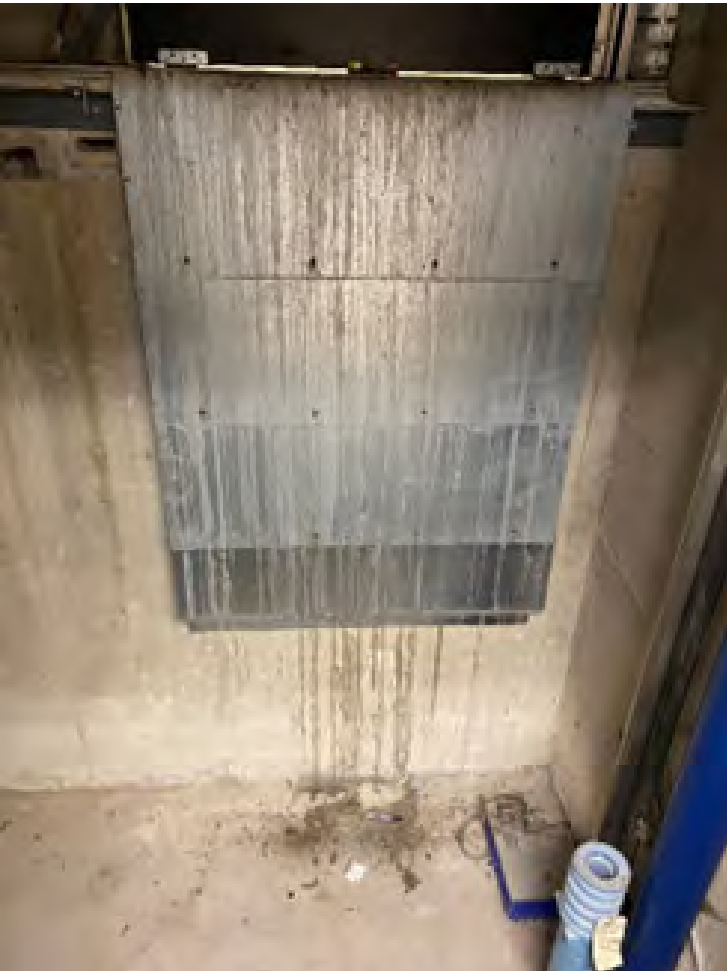
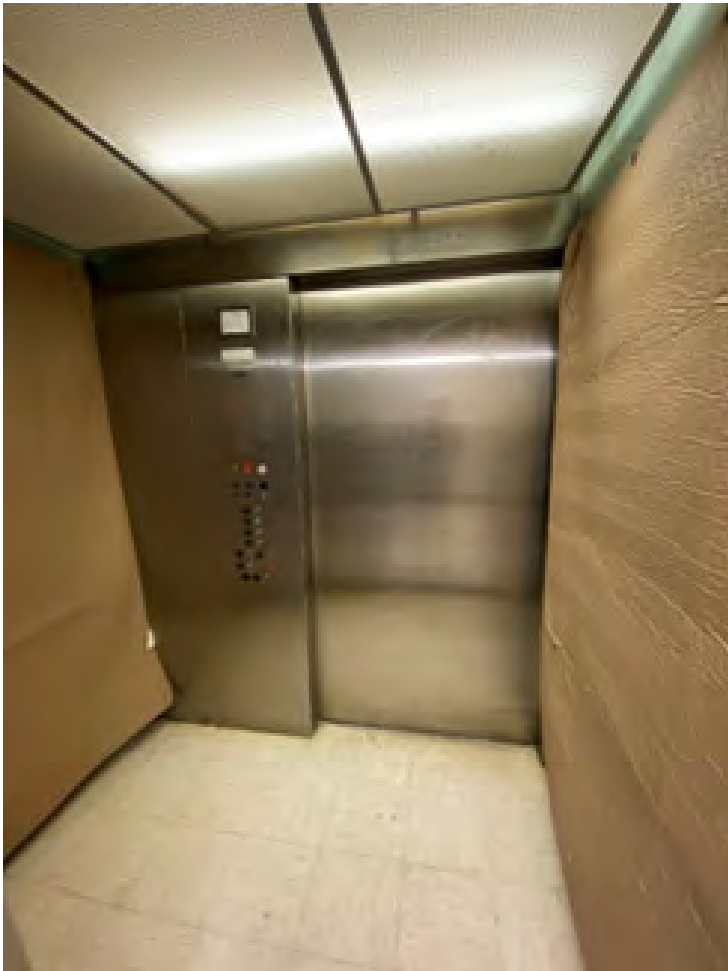
Door Hardware

Site survey showed the majority of doors are in good shape. All exterior and corridor doors look to meet egress requirements. Survey also included Youth Center doors, these doors are in slightly worse condition than the rest of the school. Exterior doors are beginning to show slight deterioration.

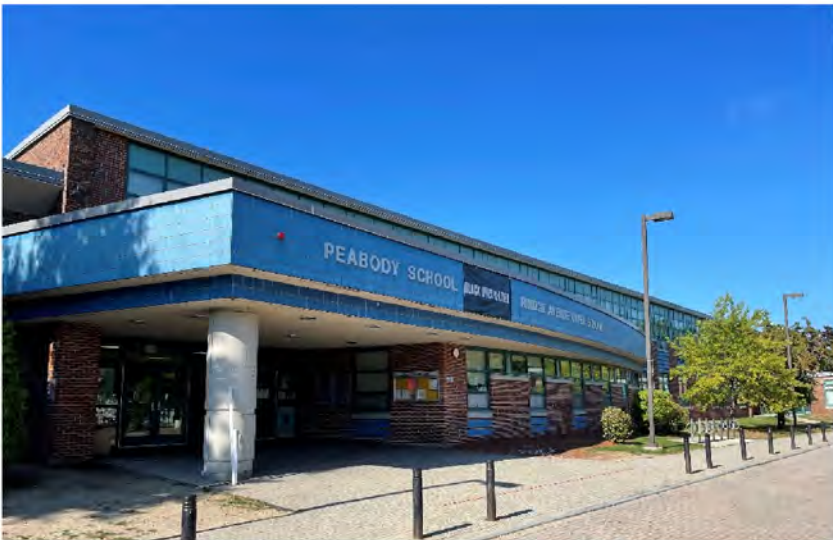
AE-1: North Elevation at Main Entrance

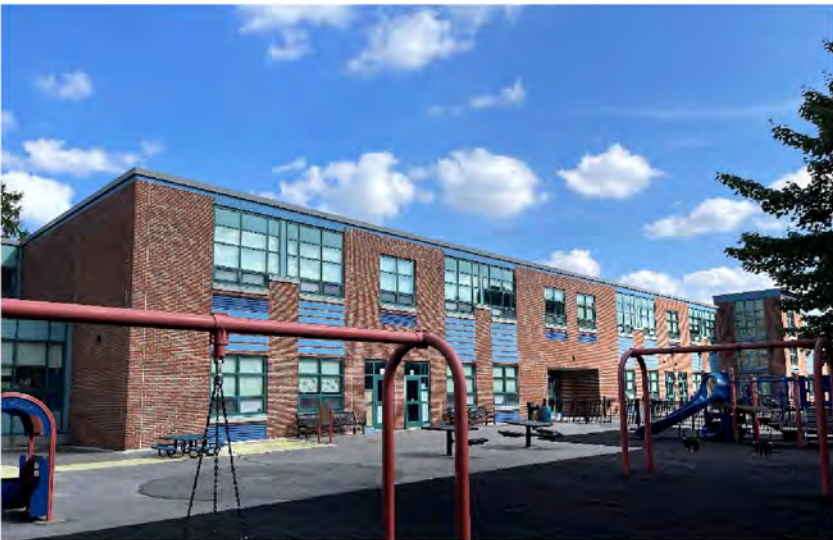
AE-2: West Elevation

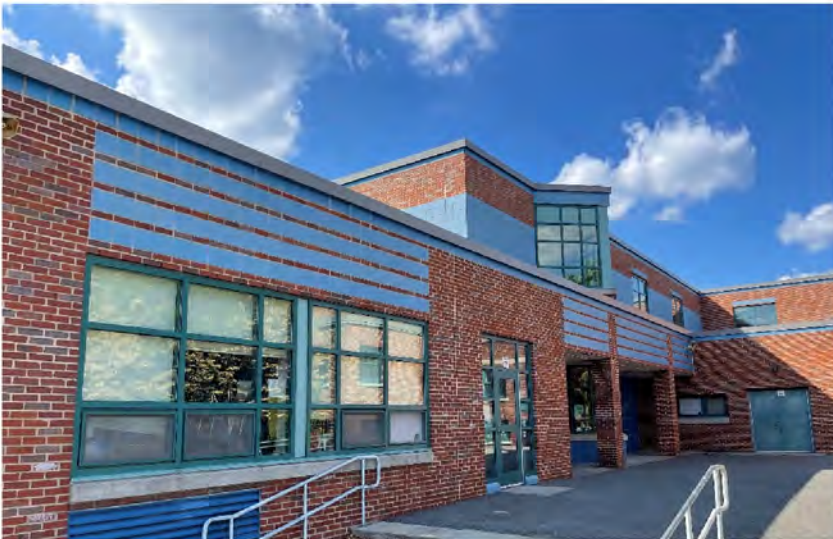
AE-3: South Elevation

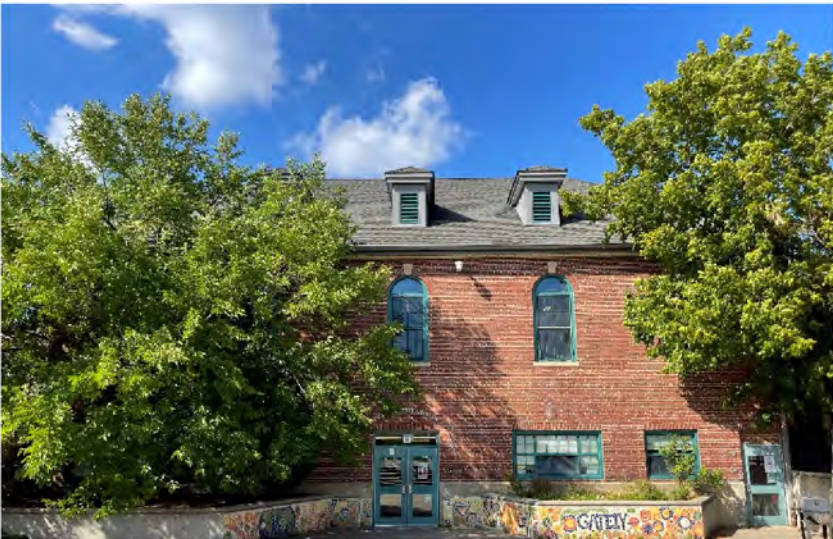
AE-4: Partial South Elevation

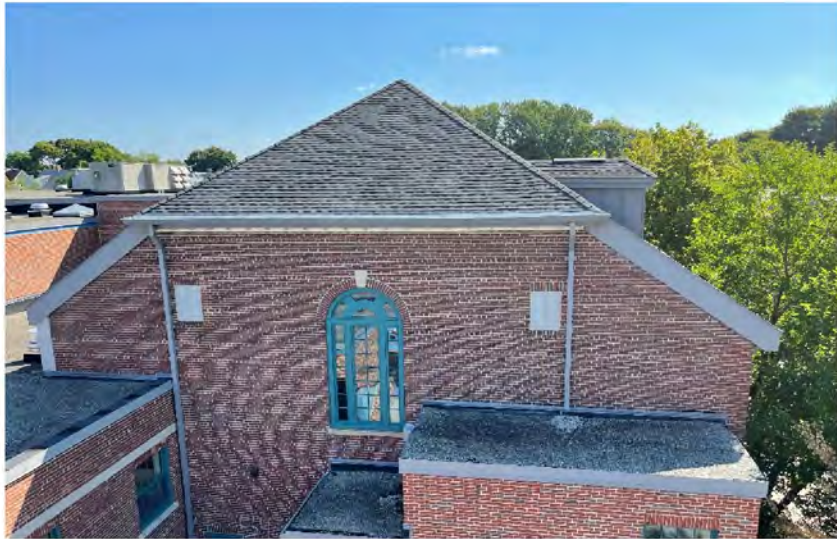
AE-5: Partial West Elevation

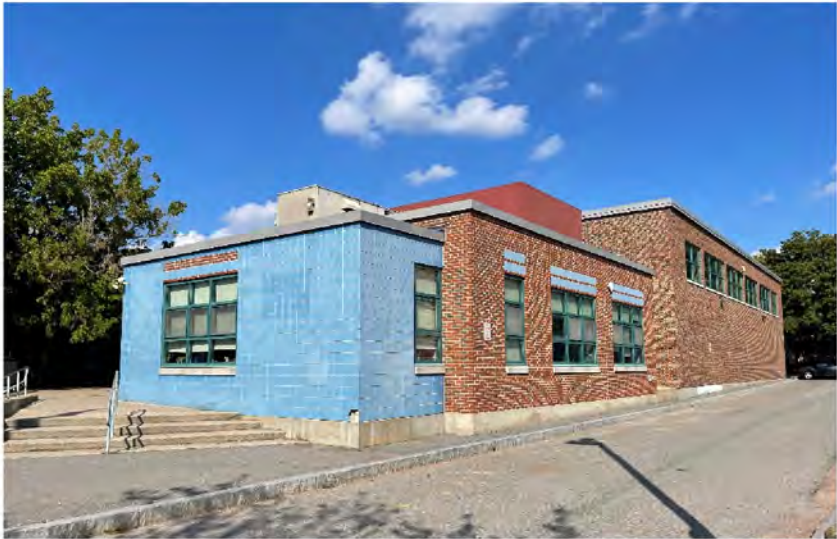
AE-6: Partial South Elevation

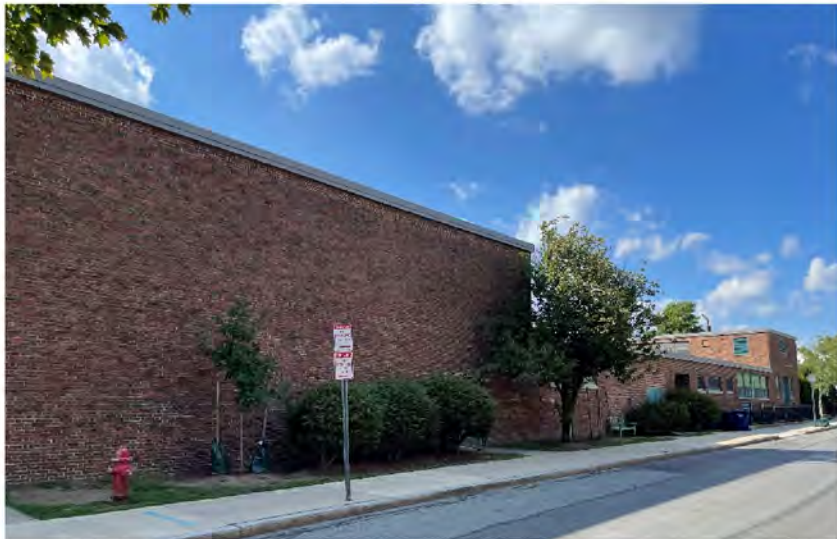
AE-7: East Elevation

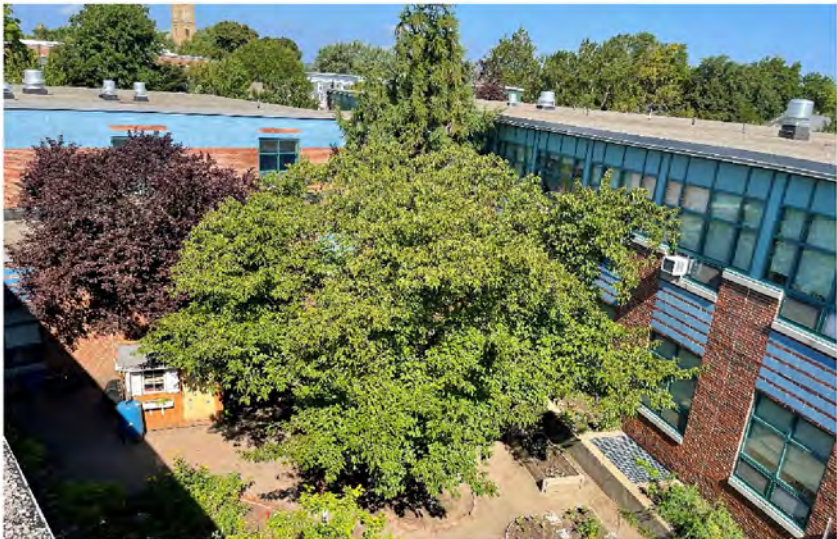
AE-8: Courtyard Elevations

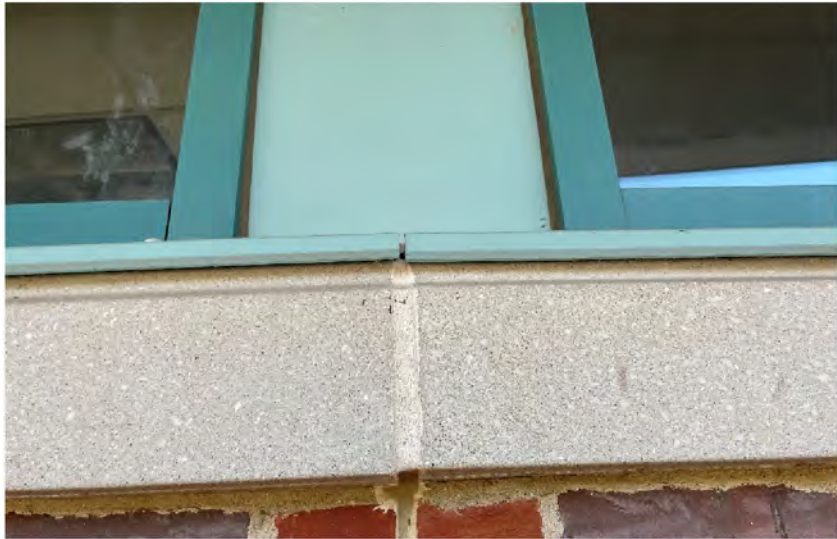
AE-13: Typical precast sill with aluminum windows above

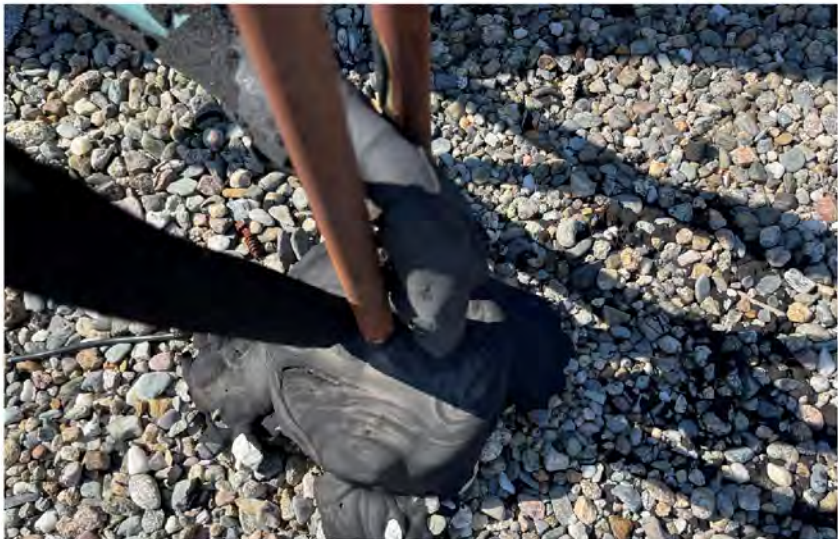
AE-51: Typical pitch pocket with pourable sealer.
