# TOWN OF SUFFIELD

## CONDITIONS ASSESSMENT & MASTER PLAN

**EXISTING CONDITIONS NARRATIVE .....C**

## FIRE DEPARTMENT 1 (HQ) - 73 MOUNTAIN RD, SUFFIELD, CT

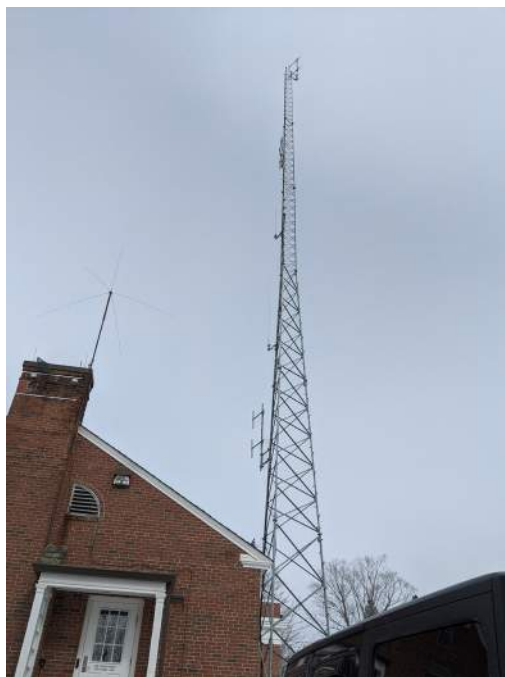
● D1. 5: Radio tower

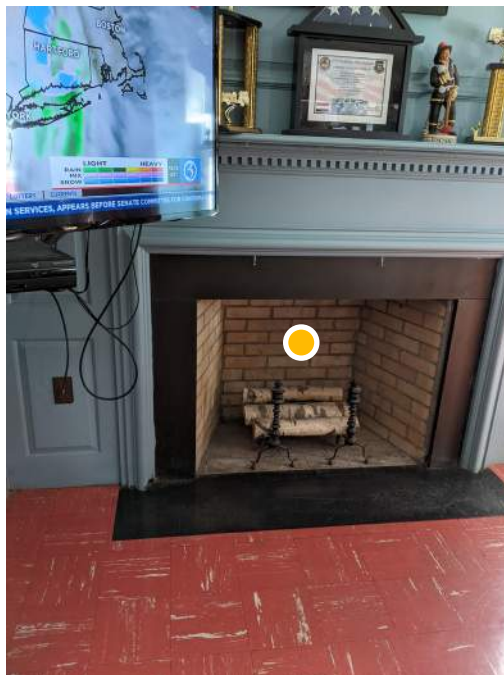
● D1. 10: Fireplace in Day Room

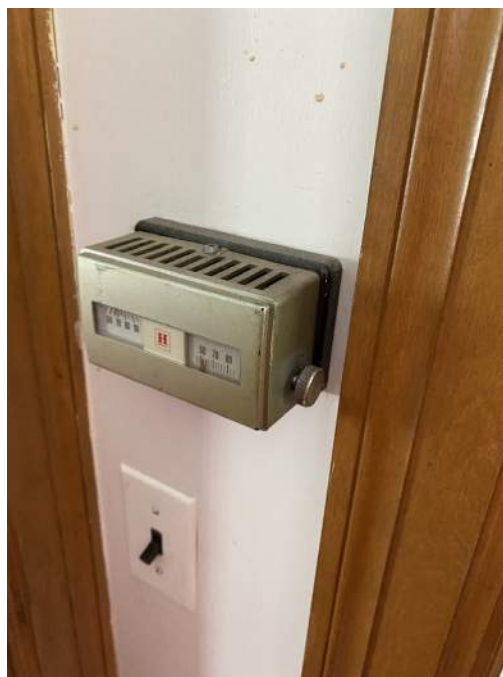
● D2. 32: Old Thermostat

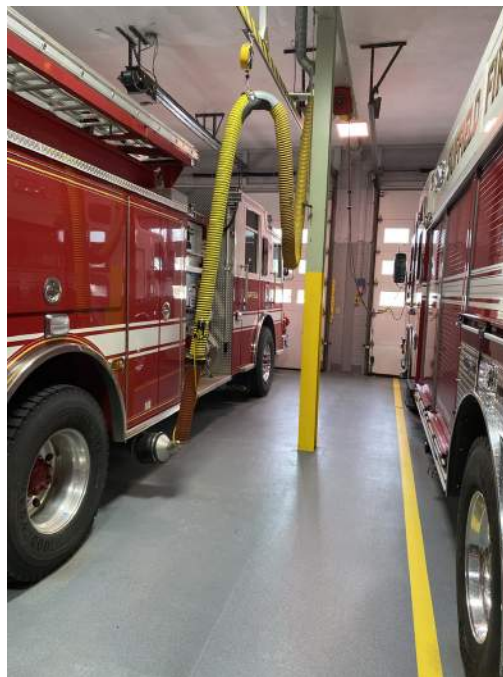
● D2. 36: Plymovent Exhaust

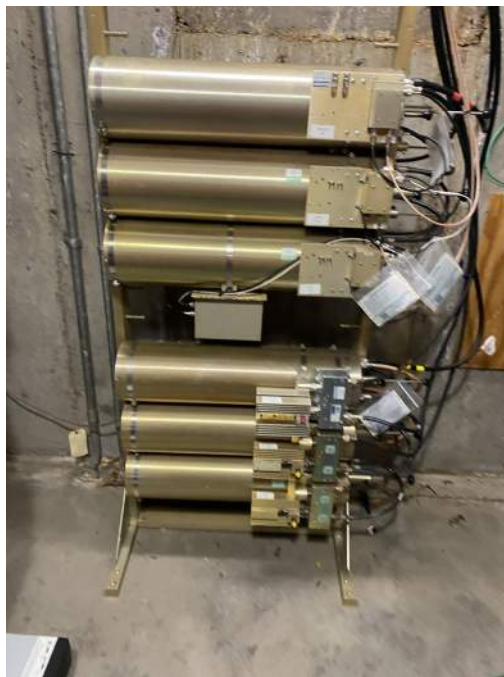
● D2. 38: Radio Equipment

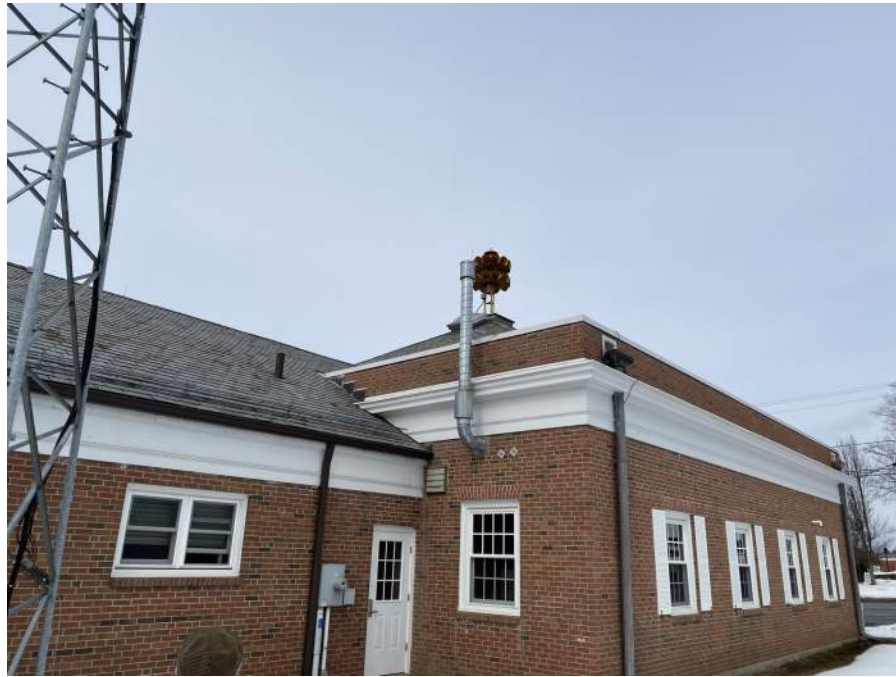
● D2. 39: Roof Drain Gutters and App Bay Exhaust

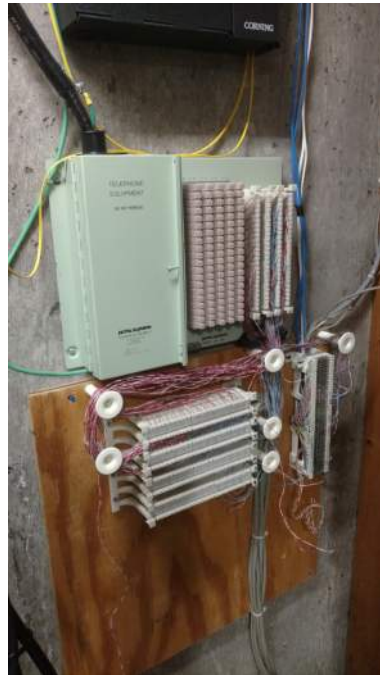
● D2. 41: Telephone Demarc

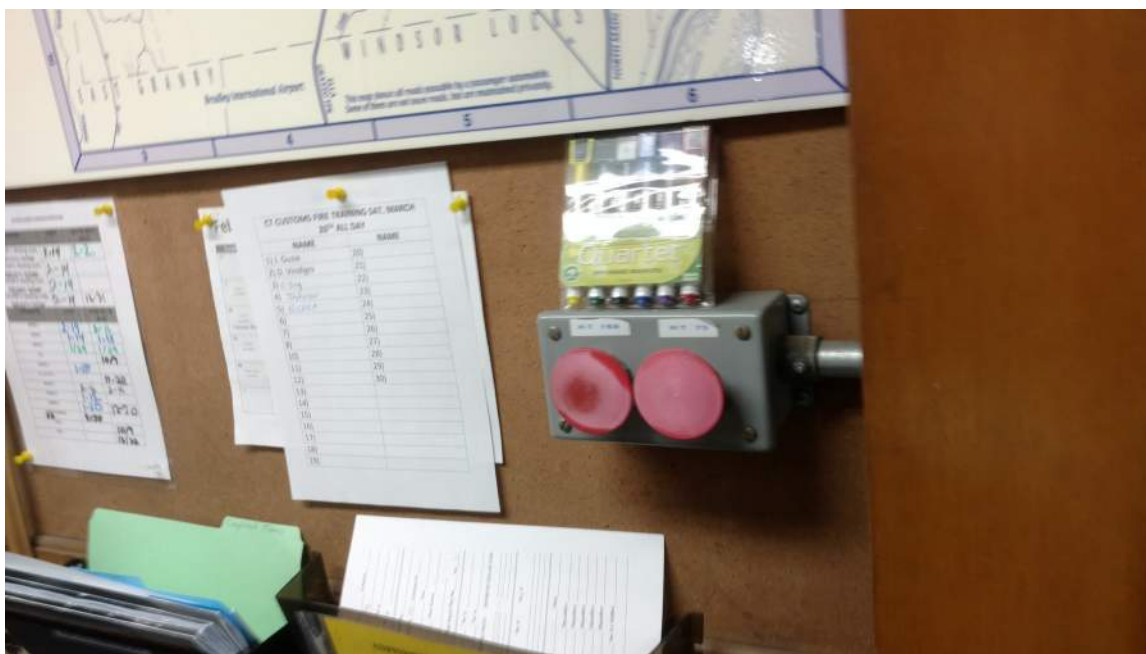
● D2. 43: Traffic Signal Control Buttons (1)

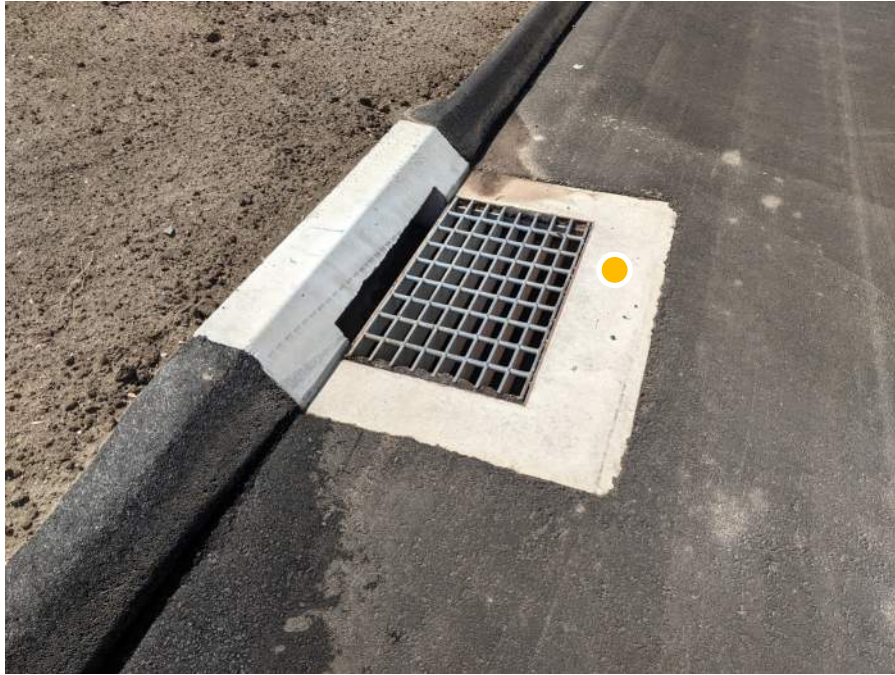
● D3. 5: New catch basins and tops were recently installed

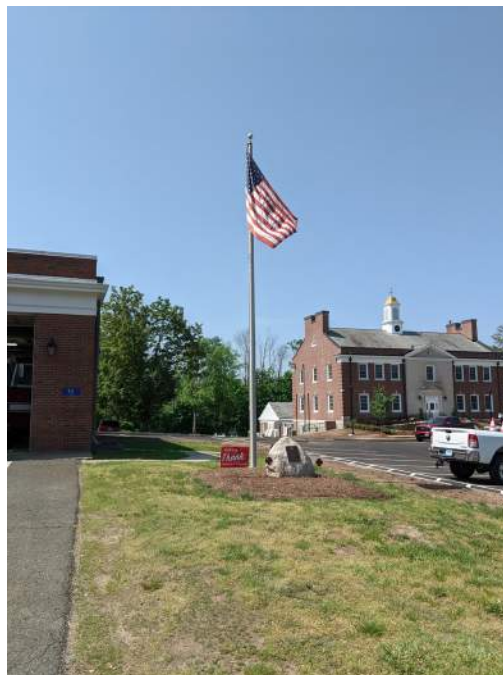
- D3. 8: Flag pole and plaque at Mountain Road

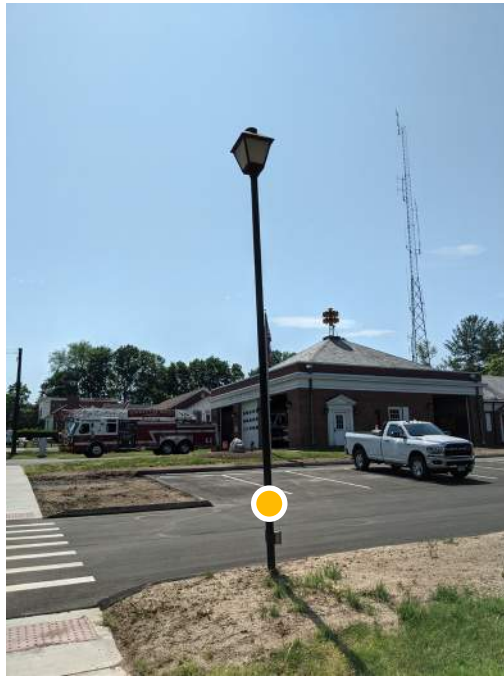
● D3. 9: Site lighting at lot line between Fire Station and Town Hall
