# TOWN OF SUFFIELD

## CONDITIONS ASSESSMENT & MASTER PLAN

## SUFFIELD MIDDLE SCHOOL - 350 MOUNTAIN RD, SUFFIELD, CT

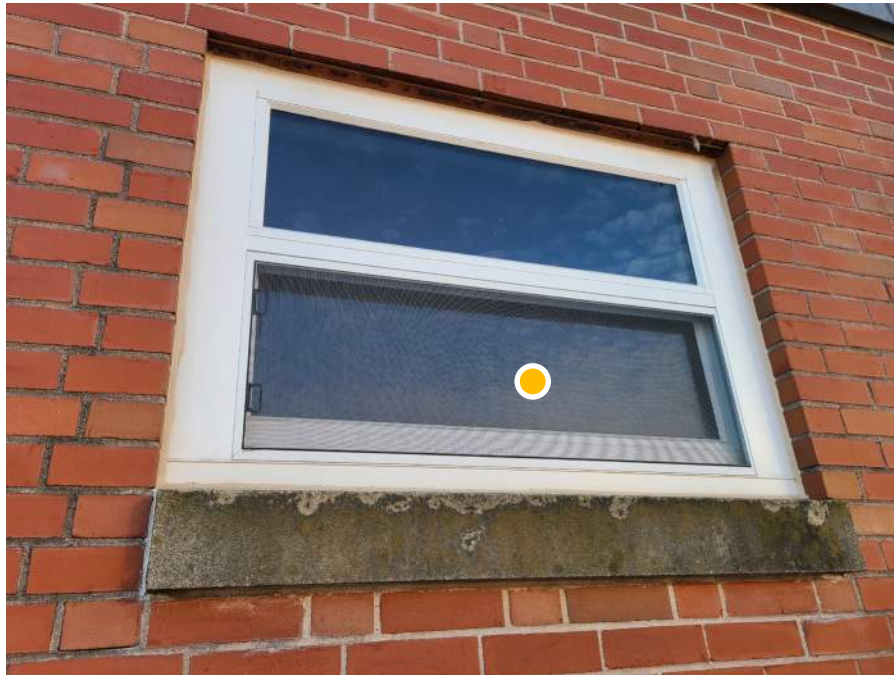
● D1. 1: Detail view of window opening in original 1964 building.

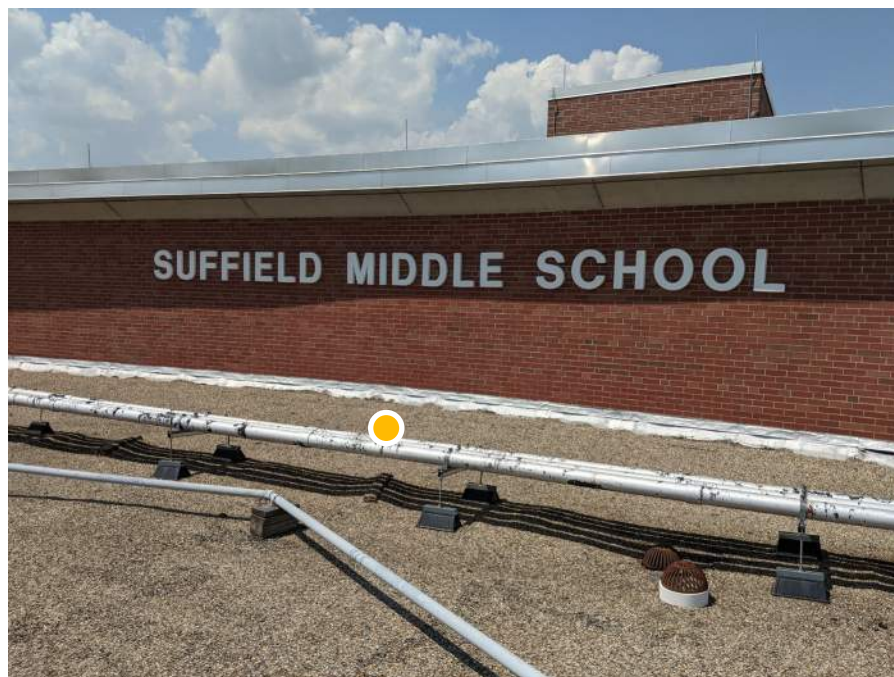
● D1. 12: Detail view of original 1964 construction, two story portion, with surface mounted electrical conduits, roof mounted, into original electrical room.

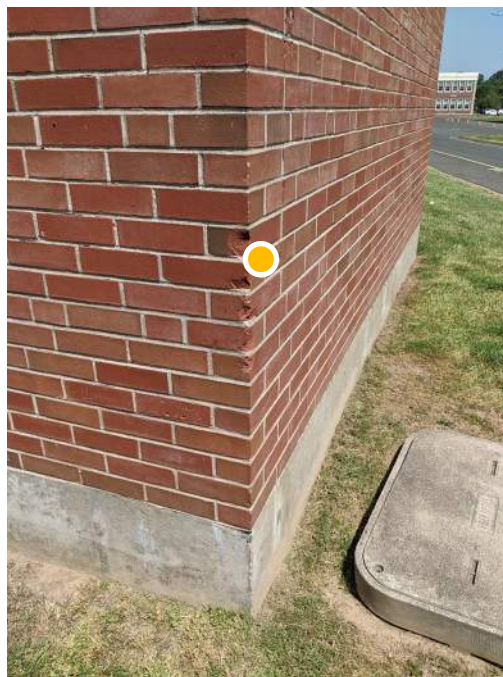
● D1. 16: Detail view of the overall condition of the composite masonry wall, part of the original 1964 building.

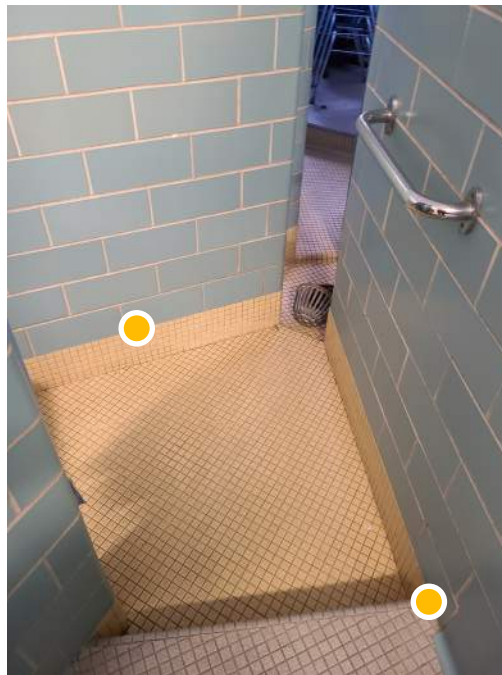
D1. 34: View of girls shower stall in original building, no longer utilized and does not meet current accessibility codes.

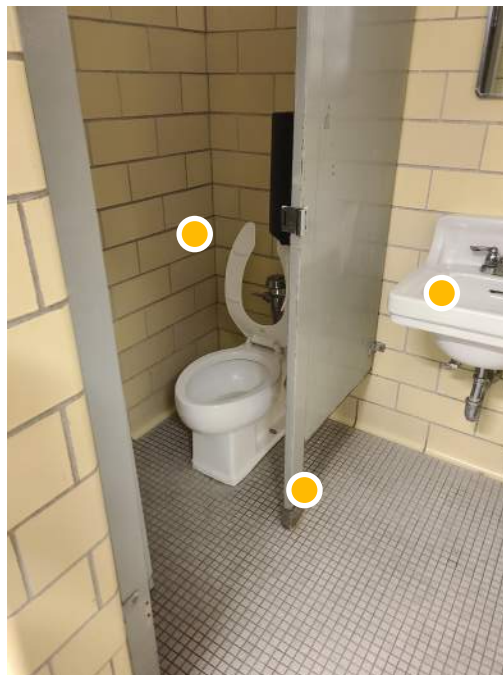
● D1. 36: Detail view of toilet configuration adjacent to girls locker room, does not meet current accessibility codes.

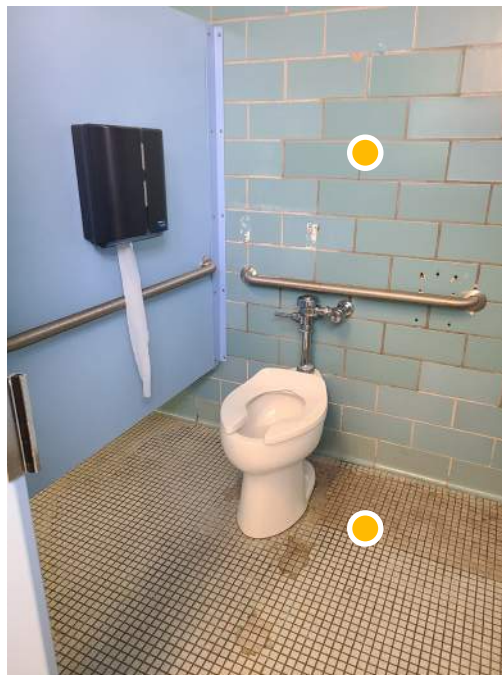
- D1. 38: Detail view of existing toilet reconfiguration in toilet rooms adjacent to gymnasium, note condition and repairs/patches on floors and walls.

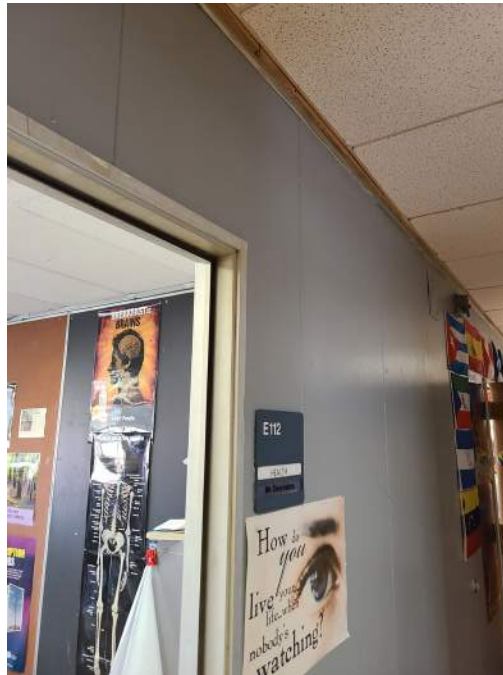
● D1. 43: Detail view of modular wall construction in the 1972 addition

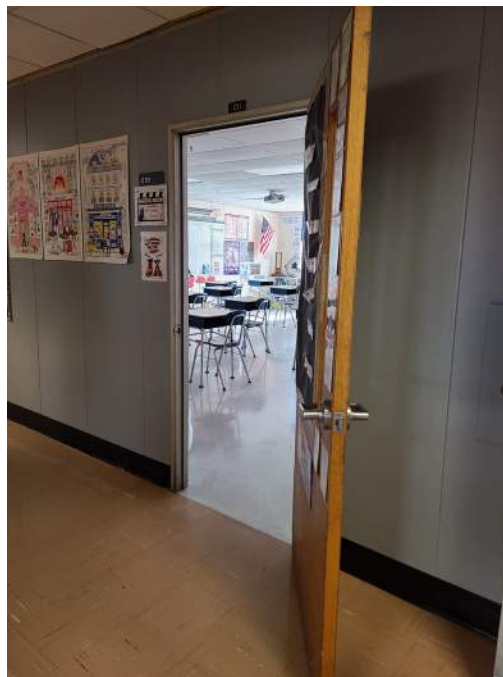
● D1. 44: View of typical door into classroom as a part of the modular wall construction (1972 addition).

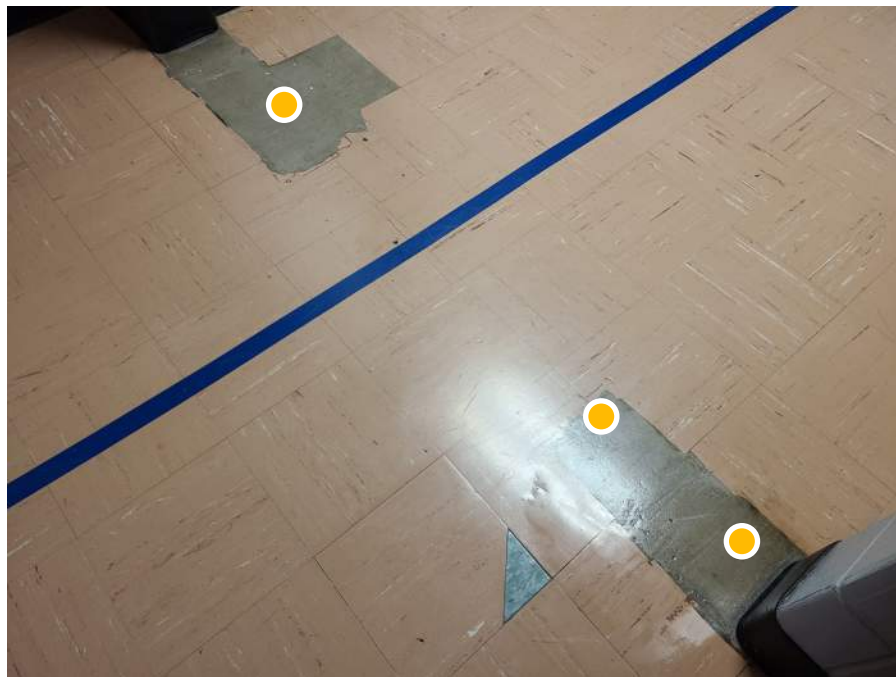
● D1. 48: Detail view of flooring patch/retrofit, possible vinyl asbestos tile original to building.

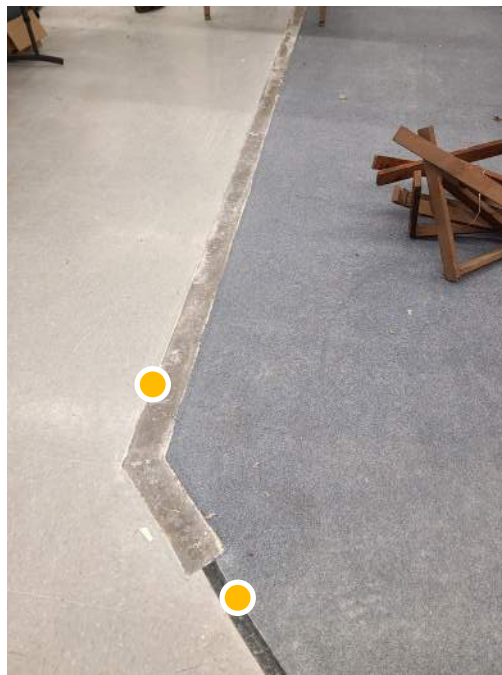
- D1. 50: Flooring transition retrofit and/or removal of transition altogether.

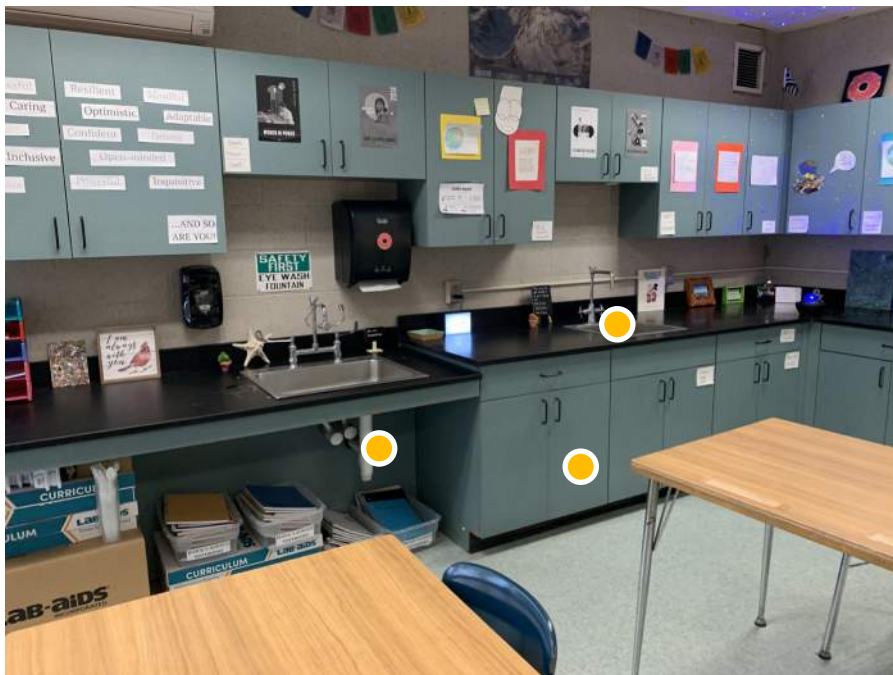
- D1. 70: View of science classroom modifications and upgrades 2002

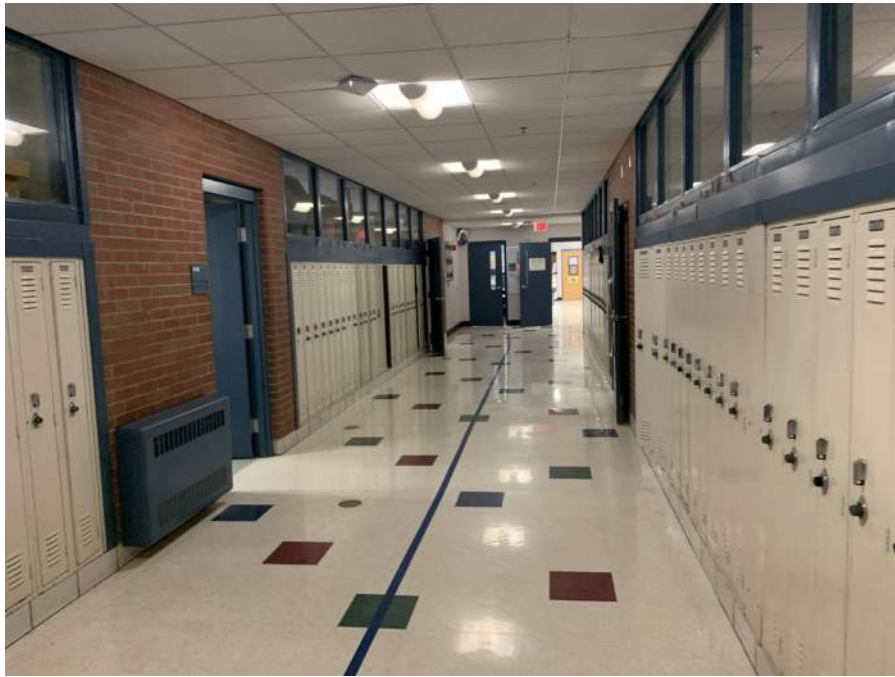
● D1. 77: View of corridor in original 1964 building.

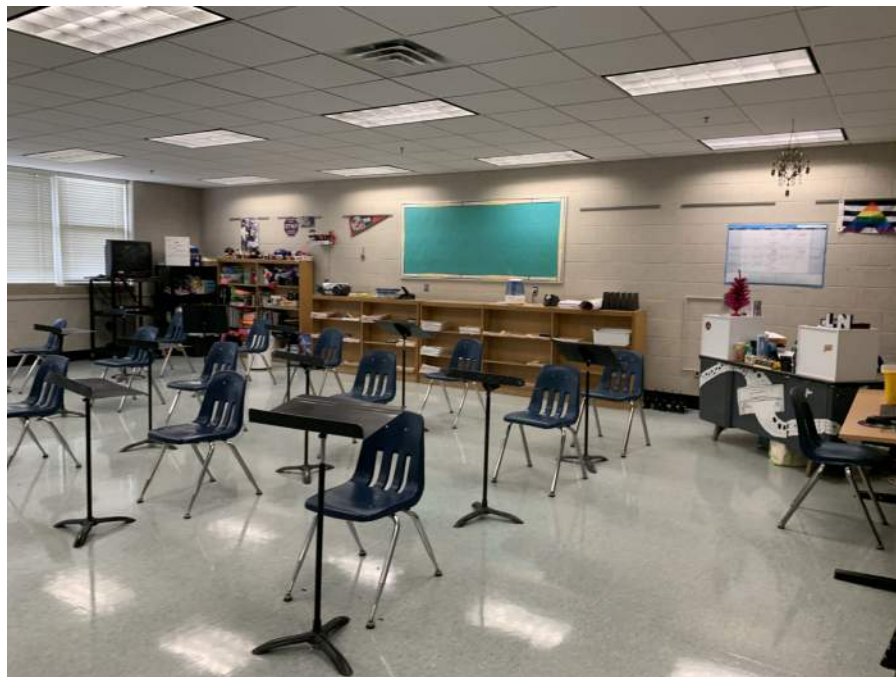
● D1. 80: View of existing band/chorus room.

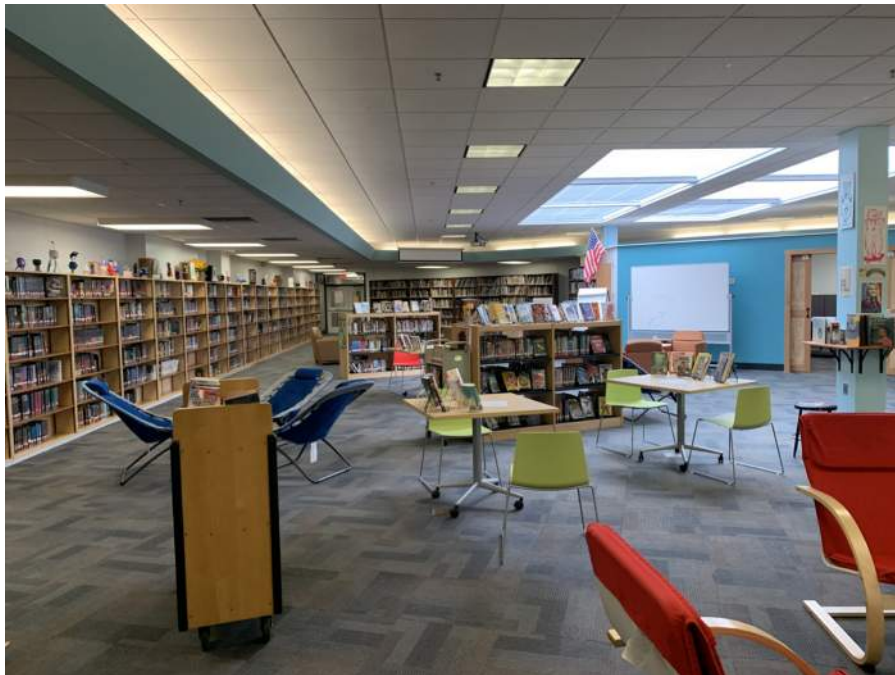
● D1. 82: View of the media center, infill addition 1972.

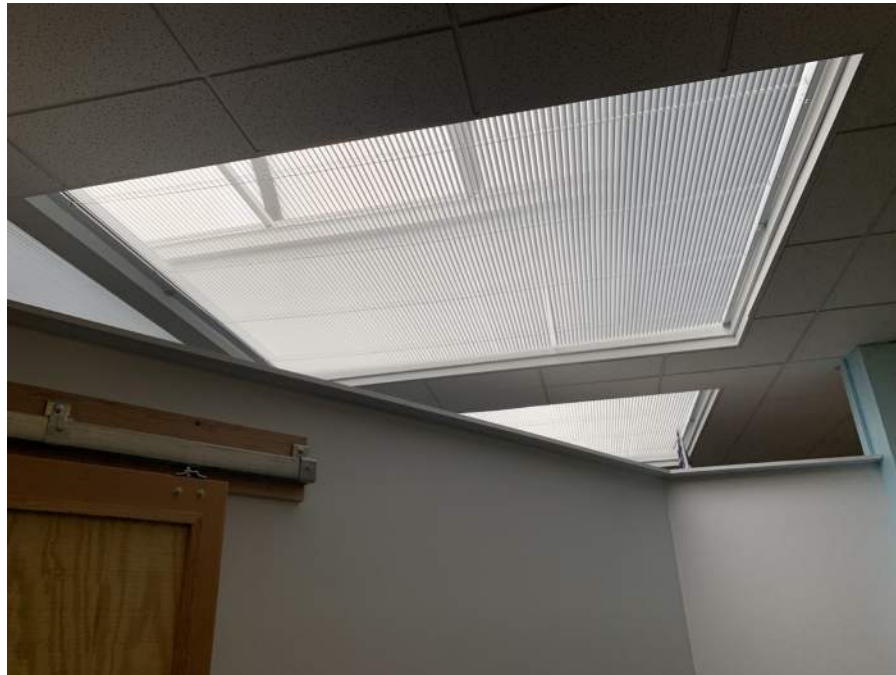
- D1. 83: Detailed view of blind system under the existing barrel vault skylight, 1972 infill addition

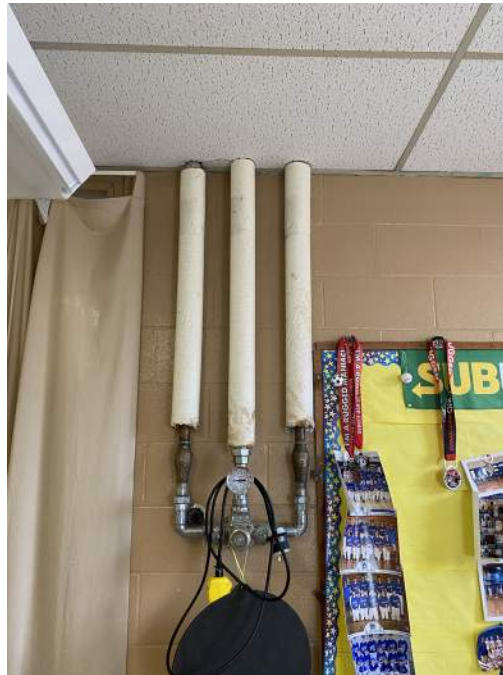
● D2. 11: Domestic Water Thermostatic Mixing Valve.

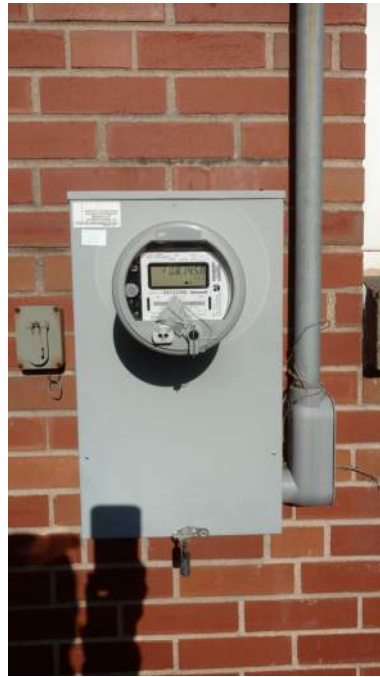
● D2. 17: Electrical Meter.

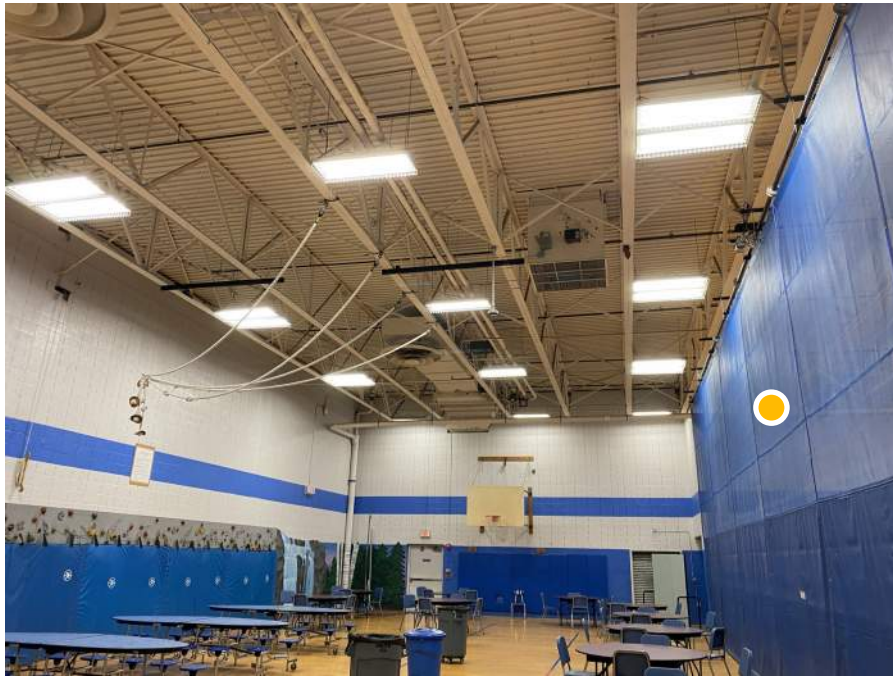
● D2. 29: View of auxillary gym 1972 (center/left) and roll up curtain (right)

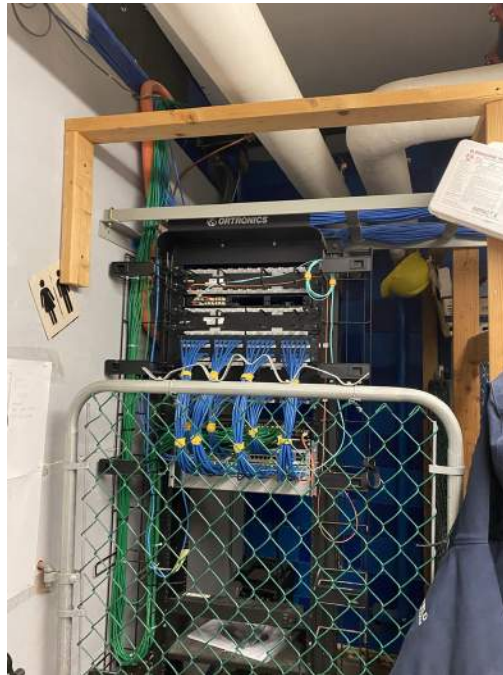
● D2. 39: IDF Data Rack #2.

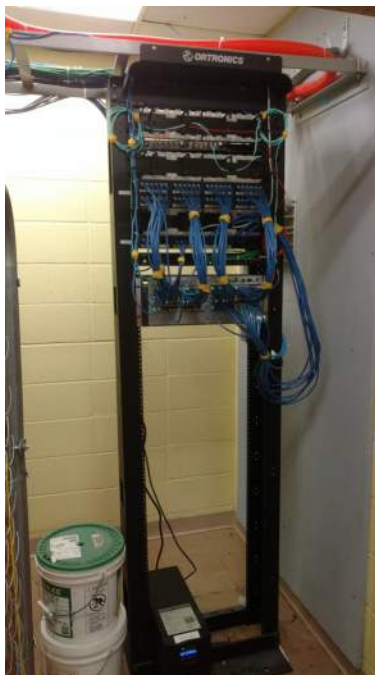
● D2. 40: IDF Data Rack #2.

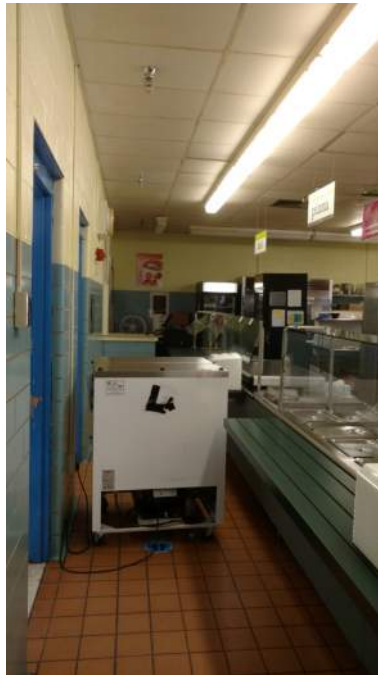
- D2. 45: Detail view of the kitchen / server line. Kitchen Lighting with Linear Fluorescent.

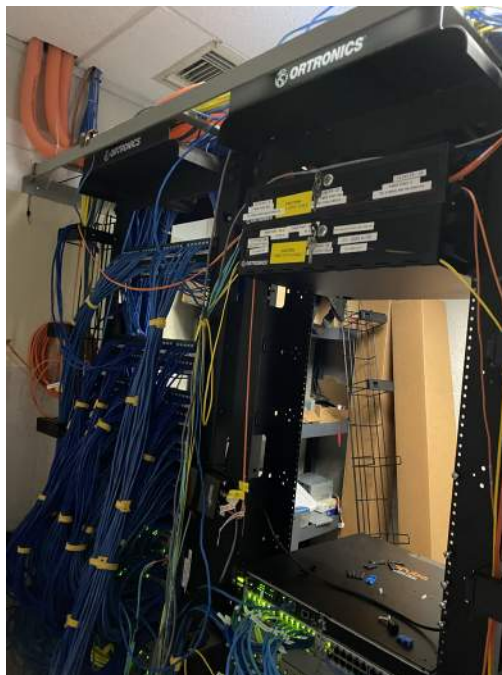
- D2. 46: MDF Data Rack.

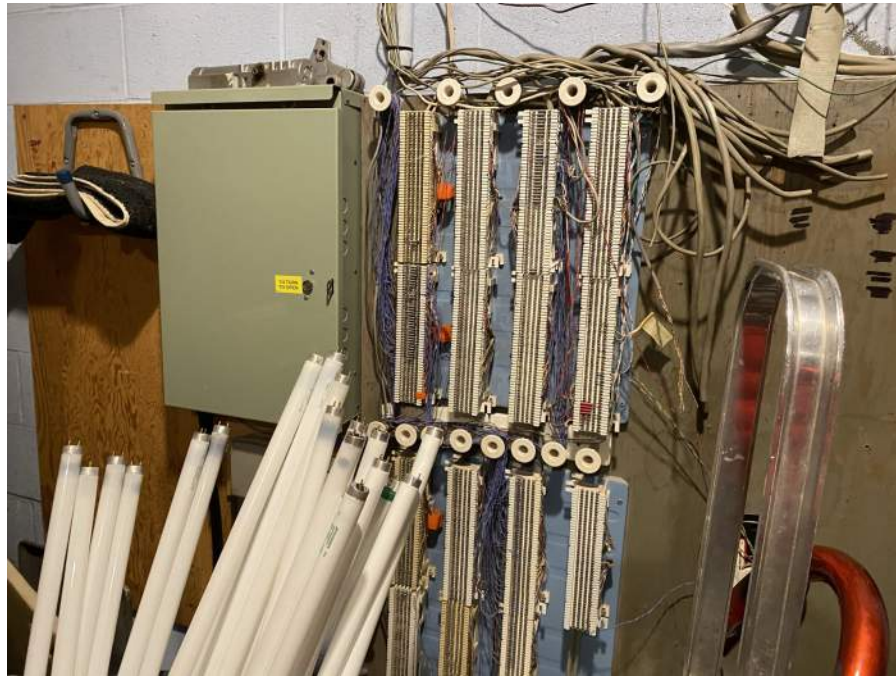
● D2. 59: Telephone Service Distribution.

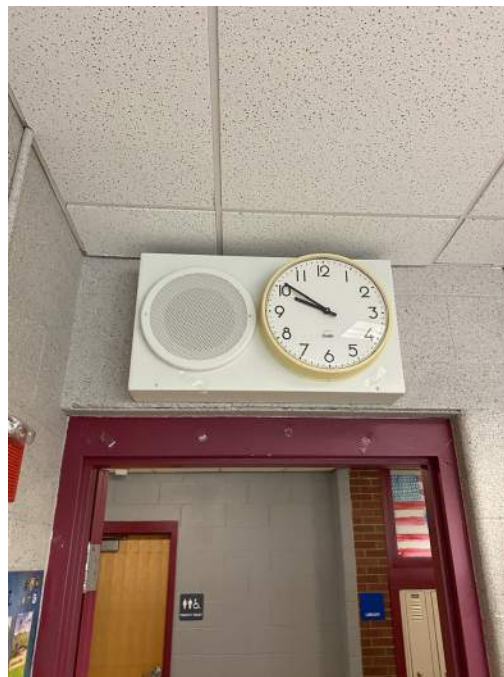
● D2. 60: Typical Classroom Speaker.
