# FACILITY CONDITION ASSESSMENT

## **DLR Group**

Washington STEAM Multilingual Academy  
1505 Marengo Avenue  
Pasadena, California 91103

154554.22R000-017.354

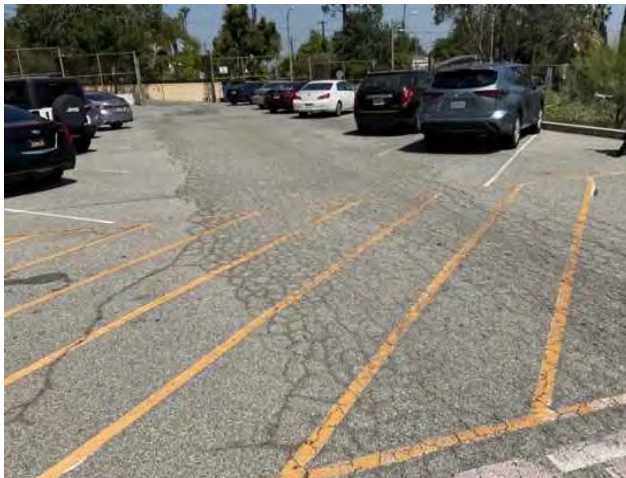
9 - ASPHALT PAVED PARKING

The school campus is provided with asphalt paved parking, landscaping, and concrete sidewalks. The parking lots and drive lanes had extensive deterioration in multiple areas. The sidewalk on the south side of Building A has multiple deteriorated areas that could pose a trip hazard. The steps between Building A and Building C on the east side of the campus have a heaved area of concrete that could pose a trip hazard. The steps into Building A on the east side of the building have 2 deteriorated areas of concrete with exposed rebar.

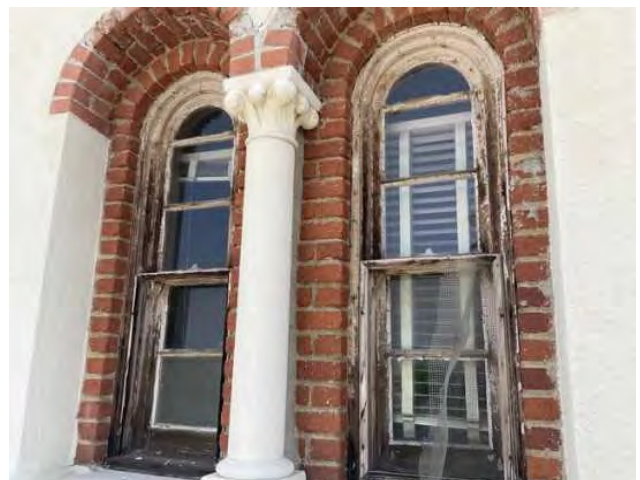
18 - WOOD EXTERIOR WINDOWS

Wooden windows in poor condition throughout - AssetCALC ID: 3864503

Uniformat Code: B2020  
Recommendation: **Replace in 2023**

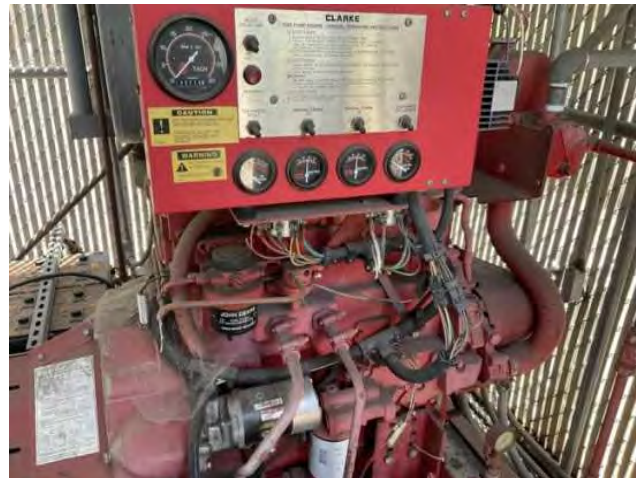
28 - FIRE PUMP

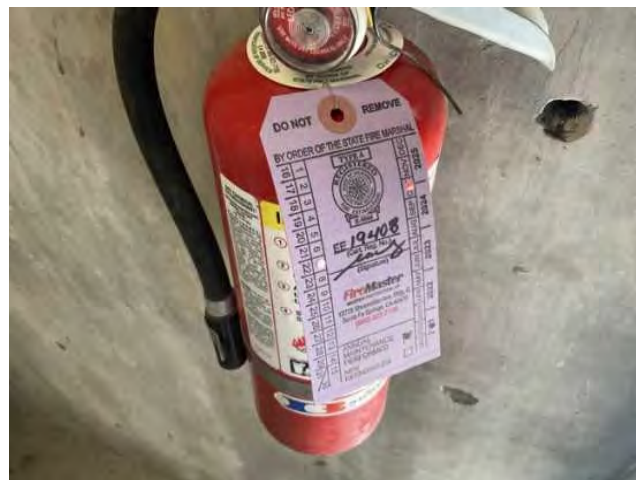
30 - FIRE EXTINGUISHER

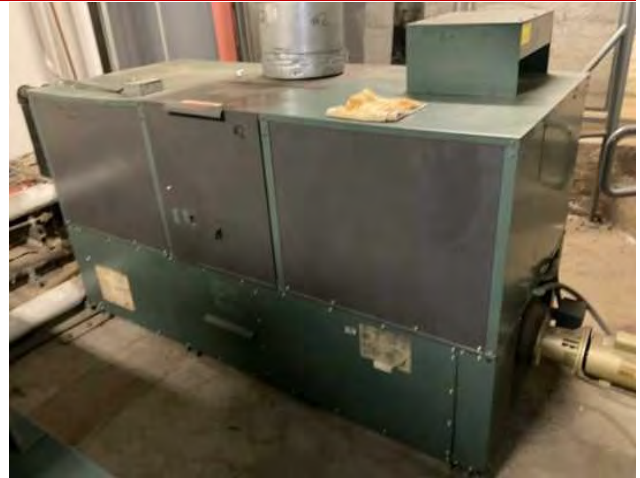
32 - HVAC BOILER

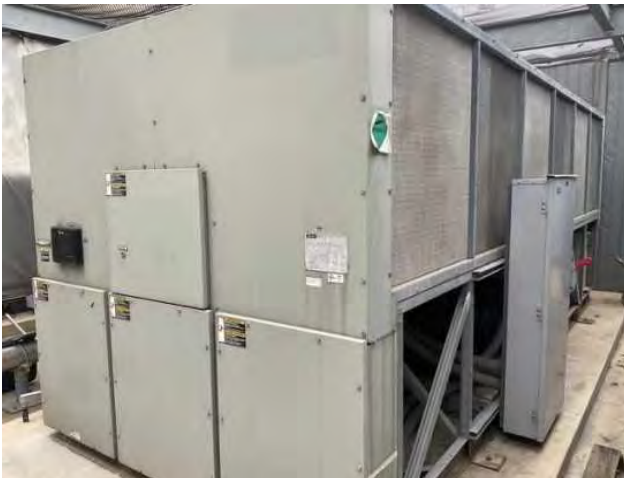
33 - CHILLER

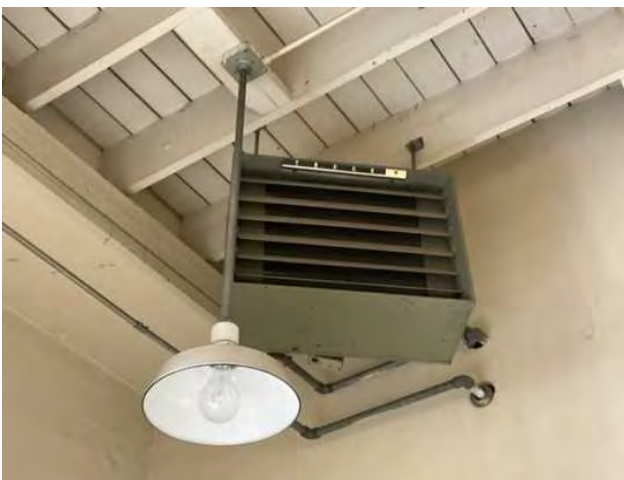
35 - UNIT HEATER

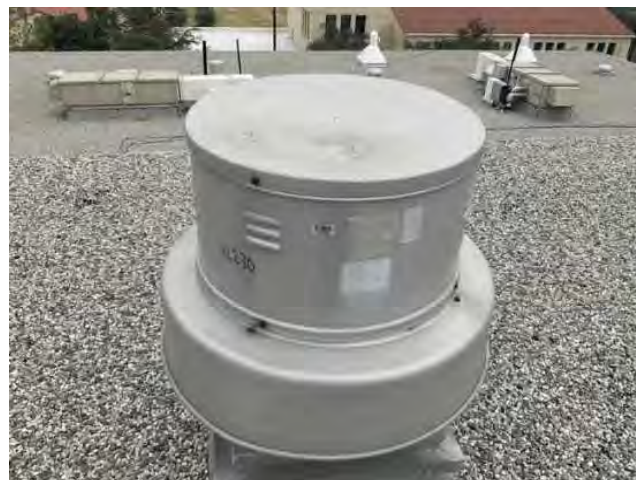
36 - EXHAUST FAN

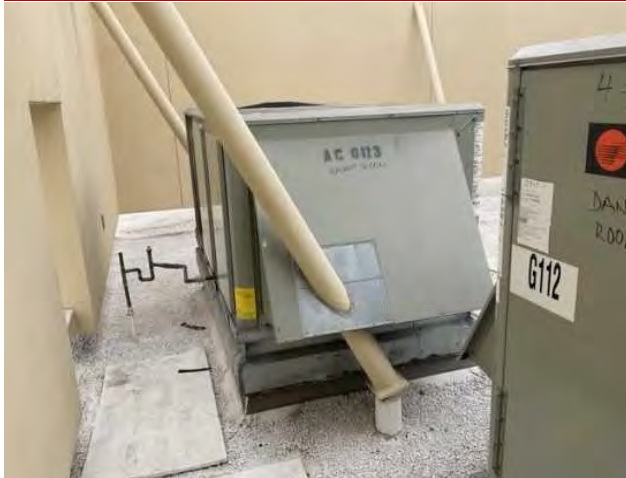
37 - PACKAGED UNIT

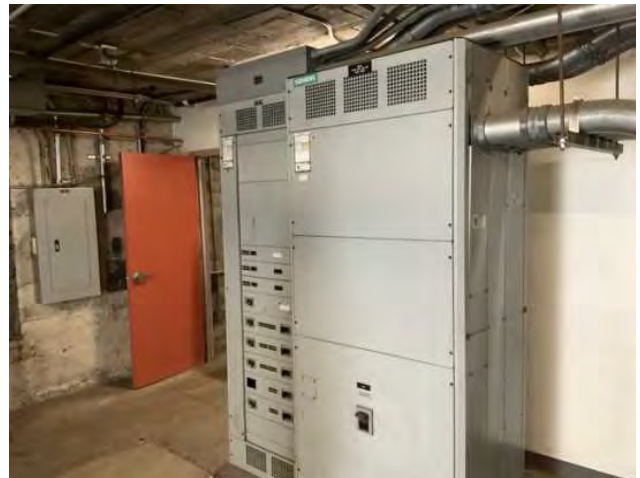
40 - SWITCHBOARD

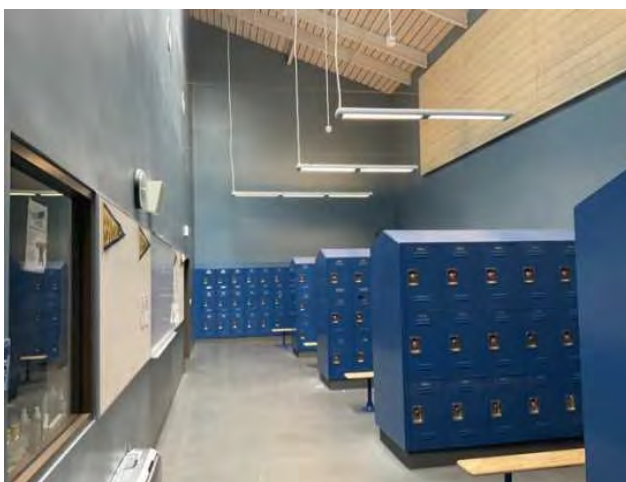
41 - LOCKER ROOM

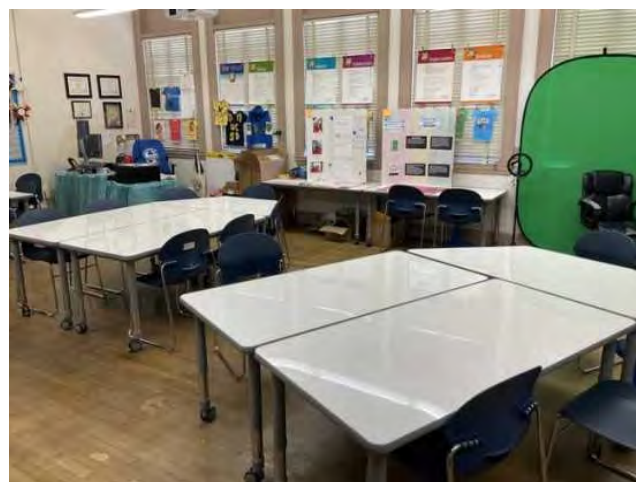
42 - CLASSROOM

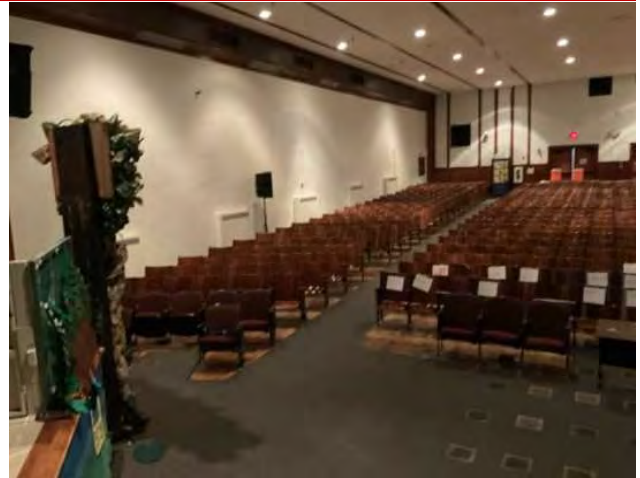
44 - AUDITORIUM

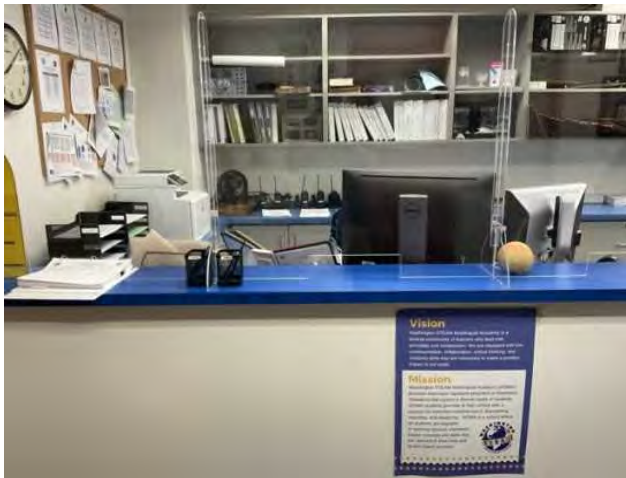
45 - OFFICE

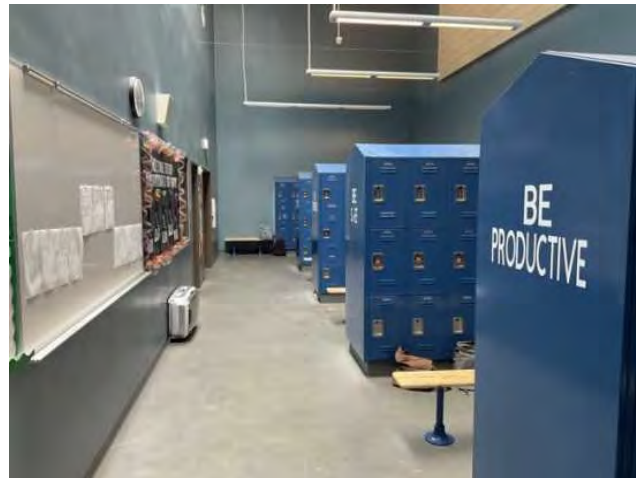
46 - LOCKER ROOM

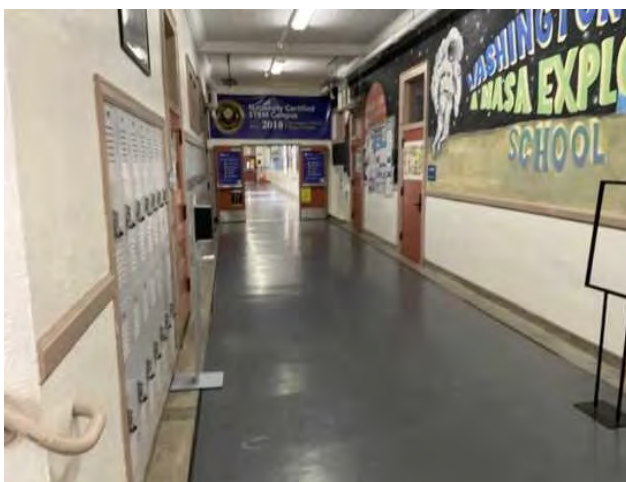
47 - HALLWAY

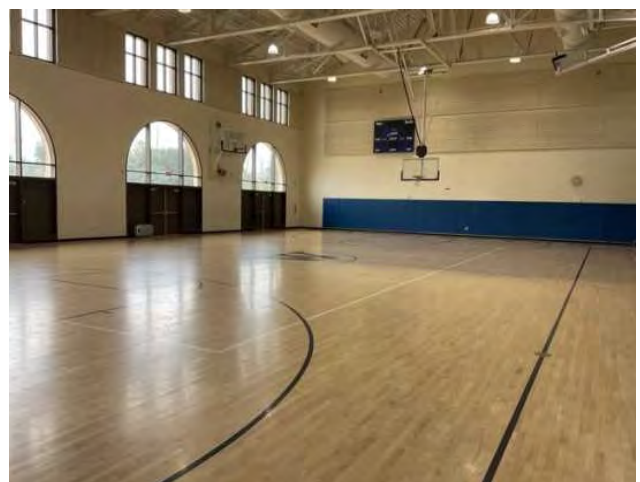
48 - GYMNASIUM

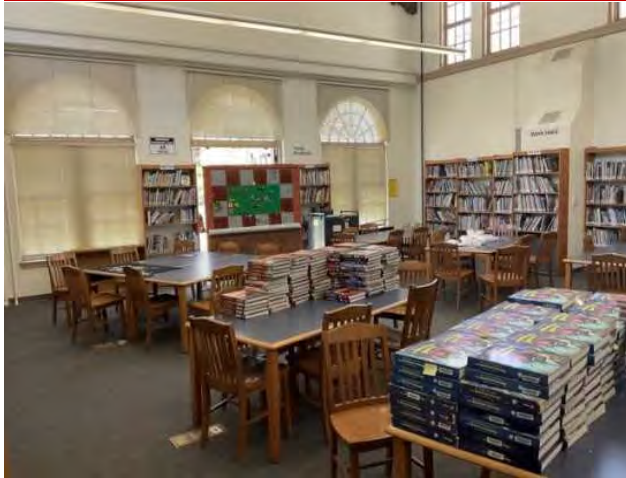
49 - LIBRARY

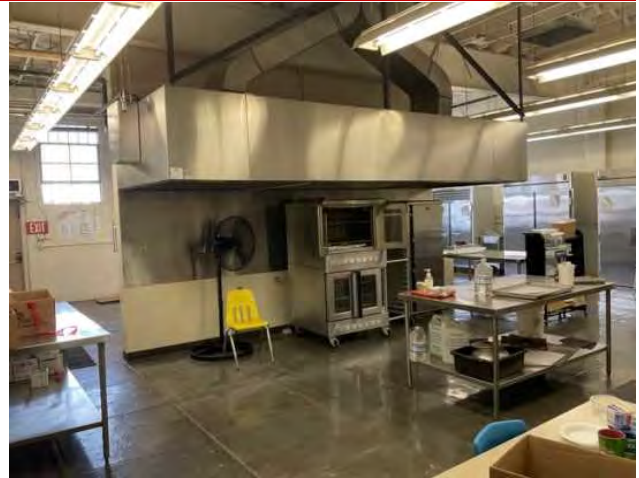
50 - KITCHEN

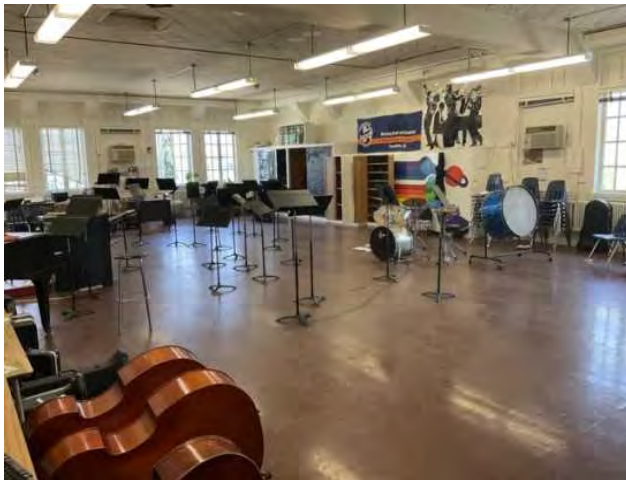
51 - BAND ROOM

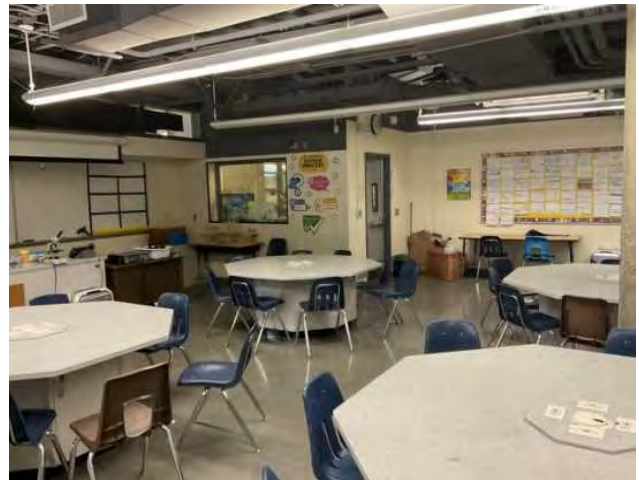
52 - CLASSROOM
