# FACILITY CONDITION ASSESSMENT

Washington Elementary Stem Magnet  
1520 North Raymond Avenue  
Pasadena, California 91103

154554.22R000-011.354

September 8, 2022

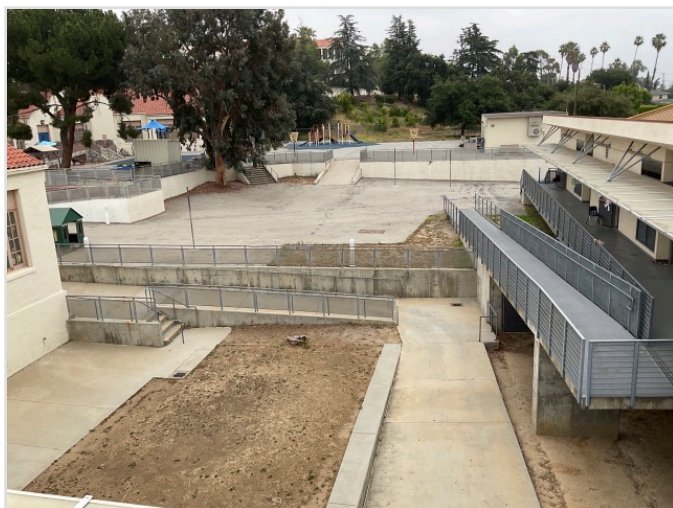
ACCESSIBLE RAMP

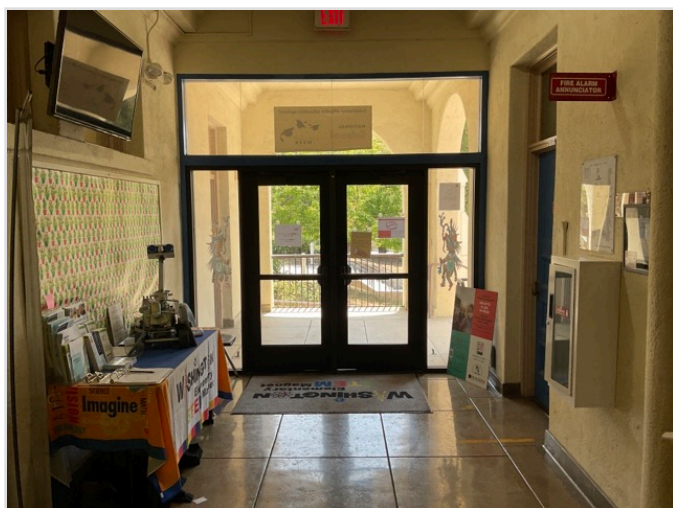
MAIN ENTRANCE

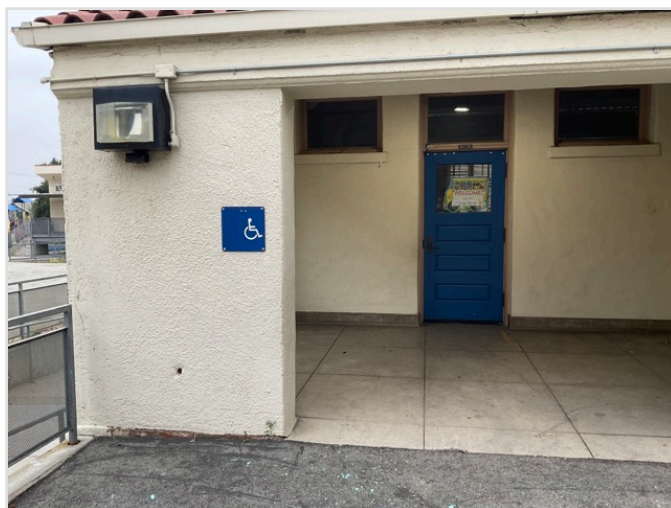
SIGNAGE

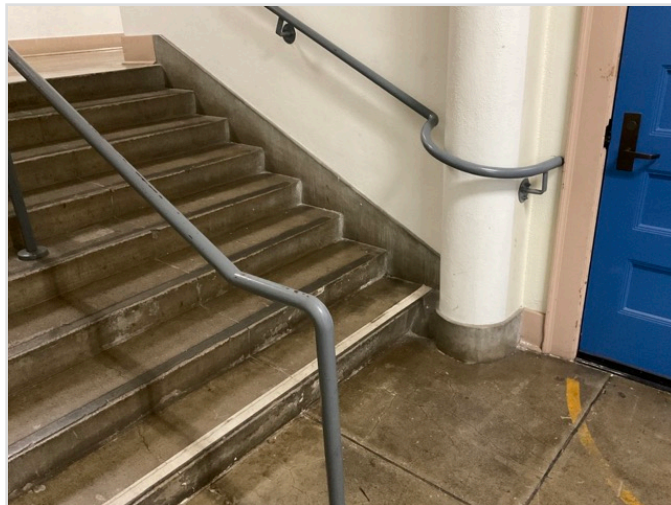
STAIR RAILS

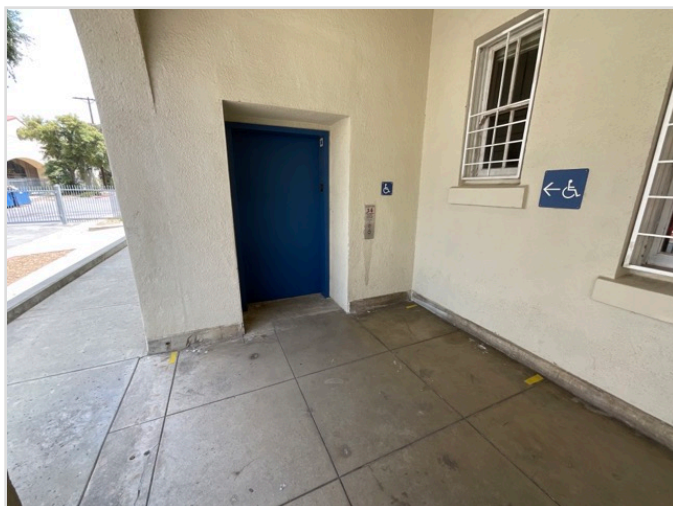
LOBBY LOOKING AT CAB

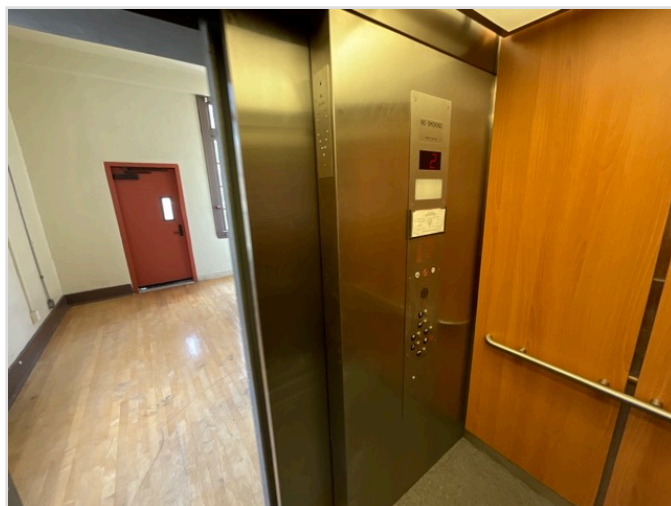
IN-CAB CONTROLS

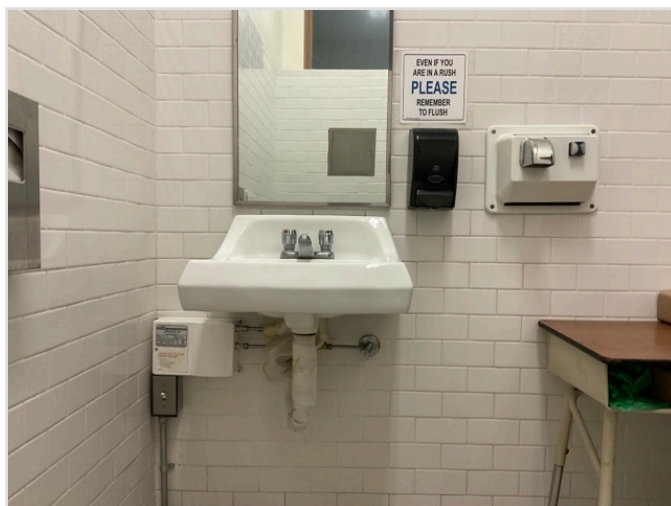
SINK, FAUCET HANDLES AND ACCESSORIES

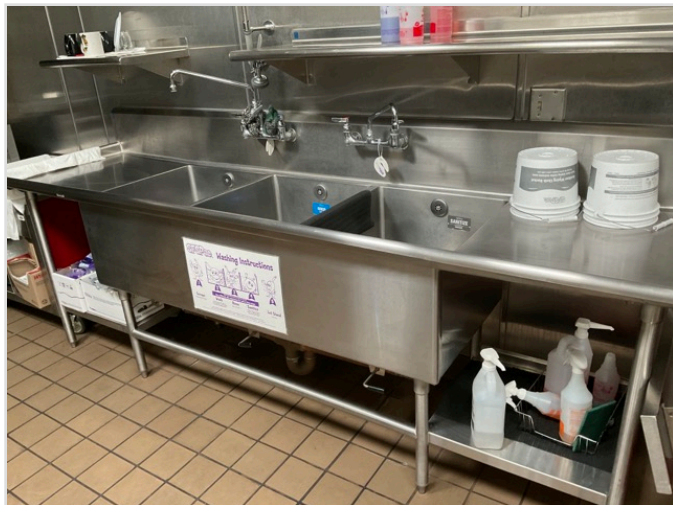
SINK CLEARANCE

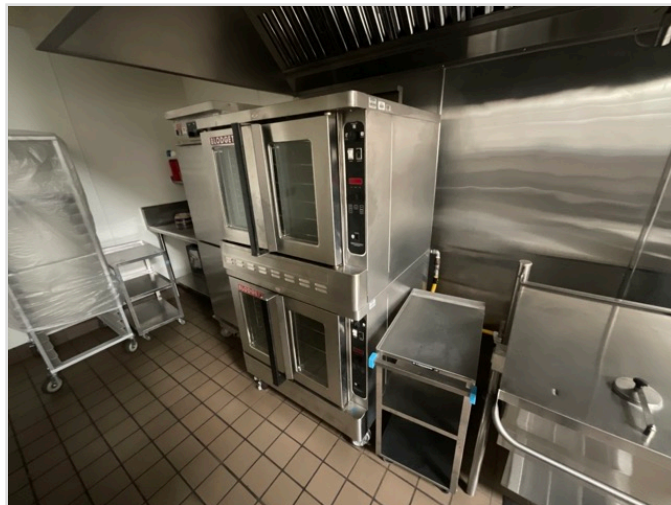
OVEN WITH CONTROLS

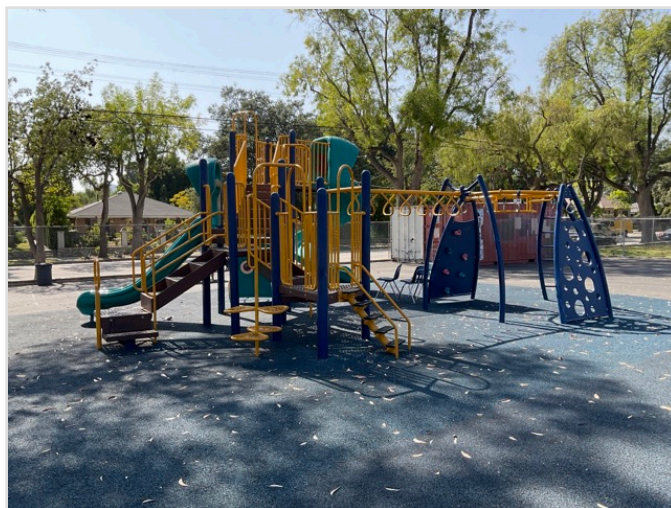
OVERVIEW OF PLAYGROUND
