# FACILITY CONDITION ASSESSMENT

Madison Elementary  
515 Ashtabula Street  
Pasadena, California 91105

154554.22R000-007.354

September 8, 2022

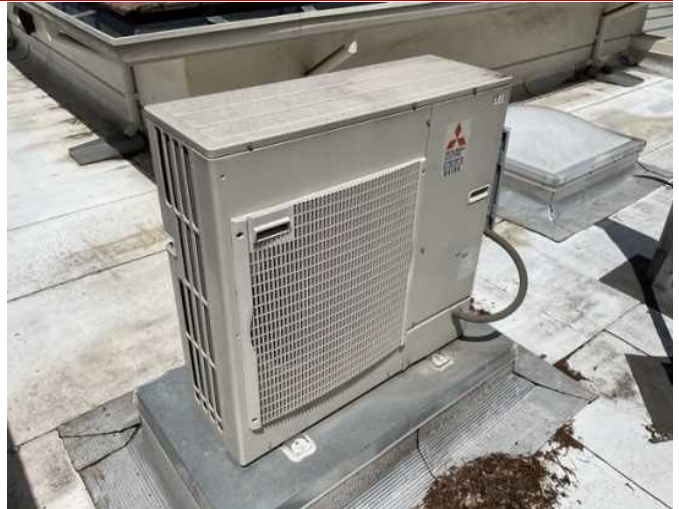
32 - SPLIT SYSTEM DUCTLESS CONDENSER

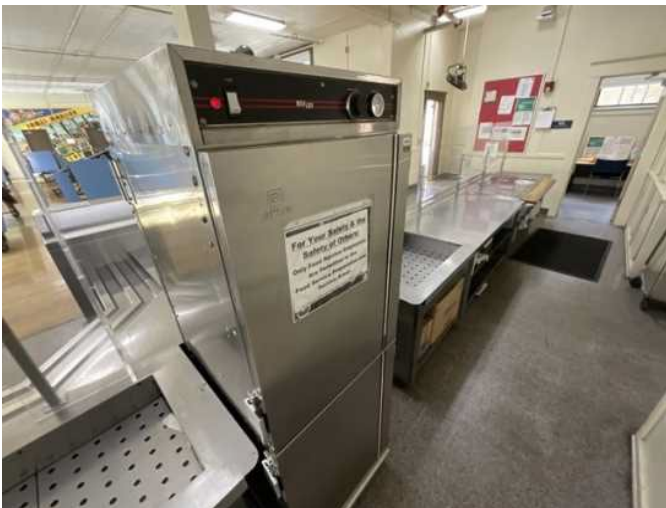
33 - CAFETERIA SERVING LINE

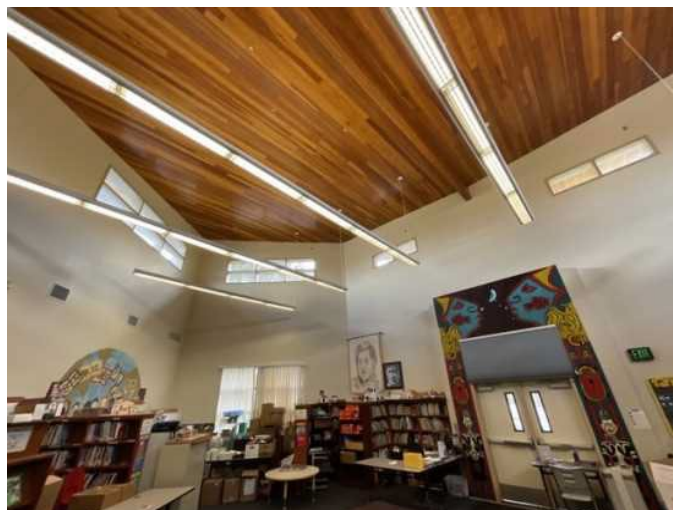
36 - LIBRARY WOOD CEILING
