# FACILITY CONDITION ASSESSMENT

Willard Elementary  
301 Madre Street  
Pasadena, California 91107

154554.22R000-013.354

September 8, 2022

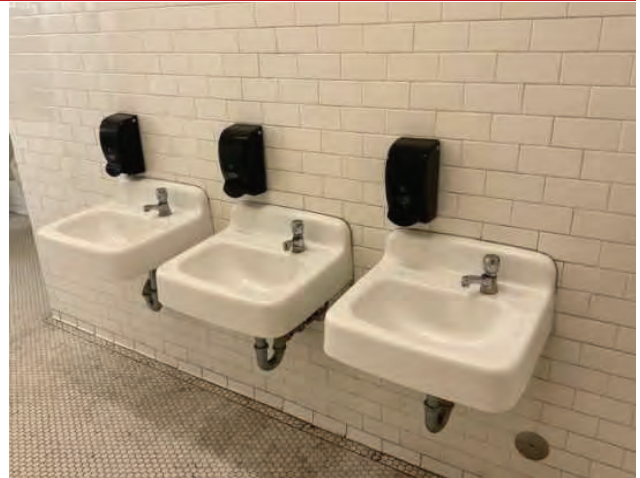
20 - RESTROOM SINKS

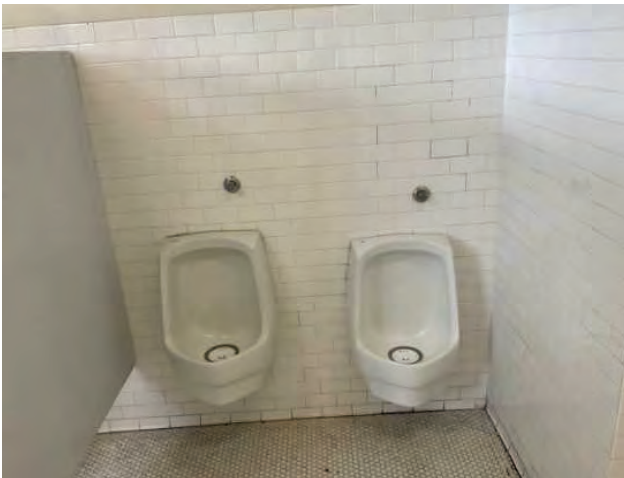
21 - URINALS

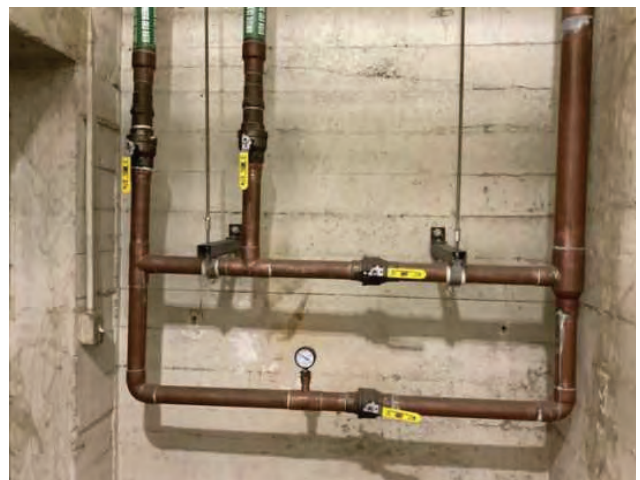
24 - PLUMBING SYSTEM

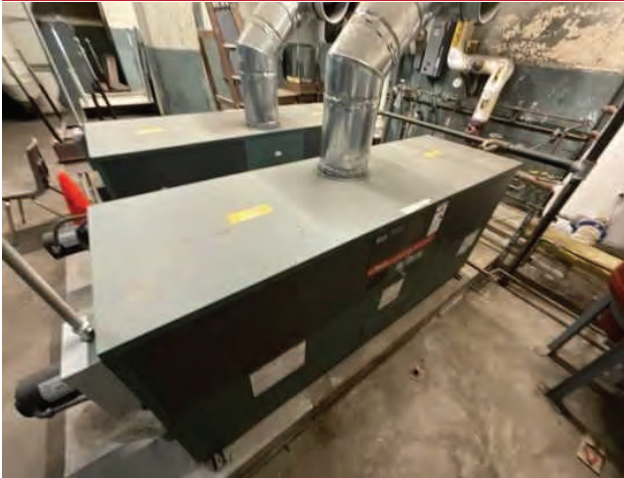
25 - HVAC BOILERS

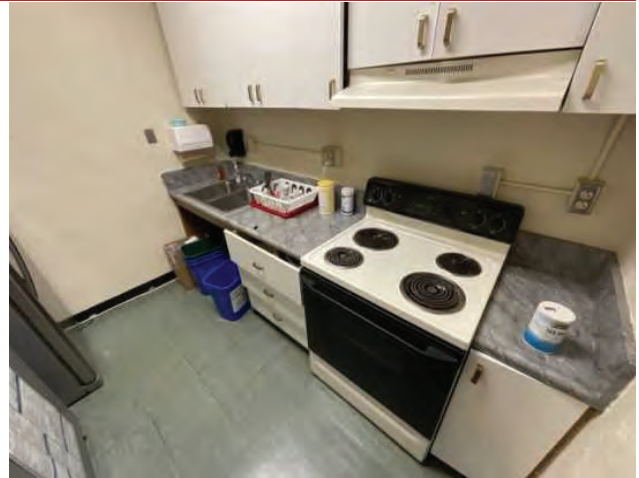
26 - TEACHER'S LOUNGE KITCHENETTE

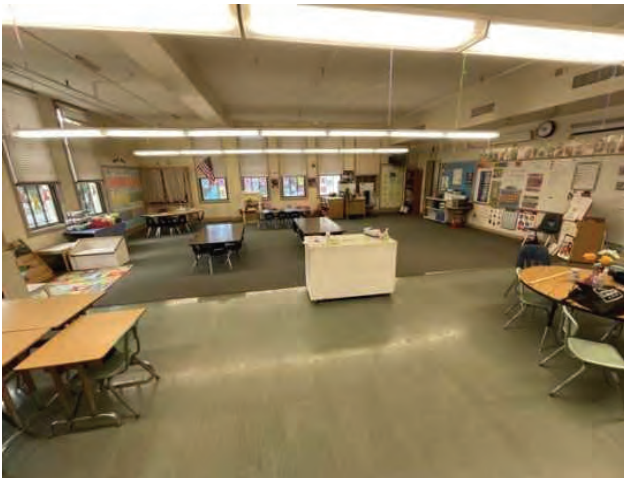
27 - VCT FLOORING

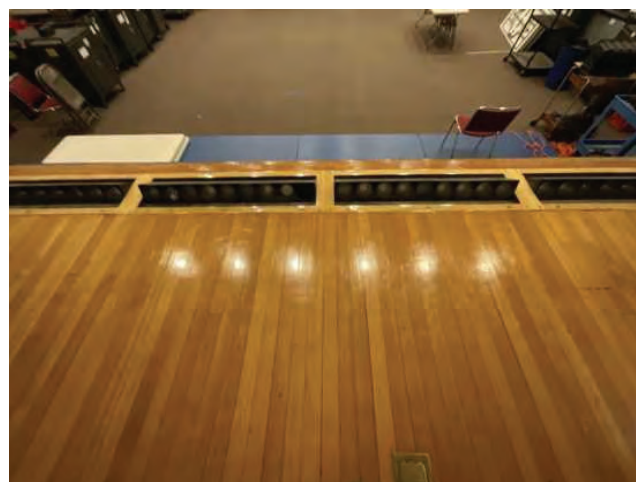
30 - WOOD PANEL FLOORING

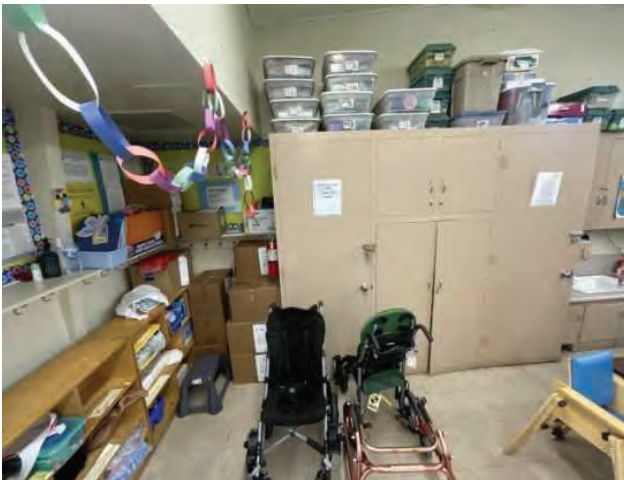
33 - ECONOMY CABINETRY
